## City of North Port

National Pollutant Discharge Elimination System (NPDES)  
Municipal Separate Storm Sewer System (MS4)  
Permit # FLS000004

### Year 2 Annual Report

**Report period Jan 1, 2015  
to December 31, 2015**

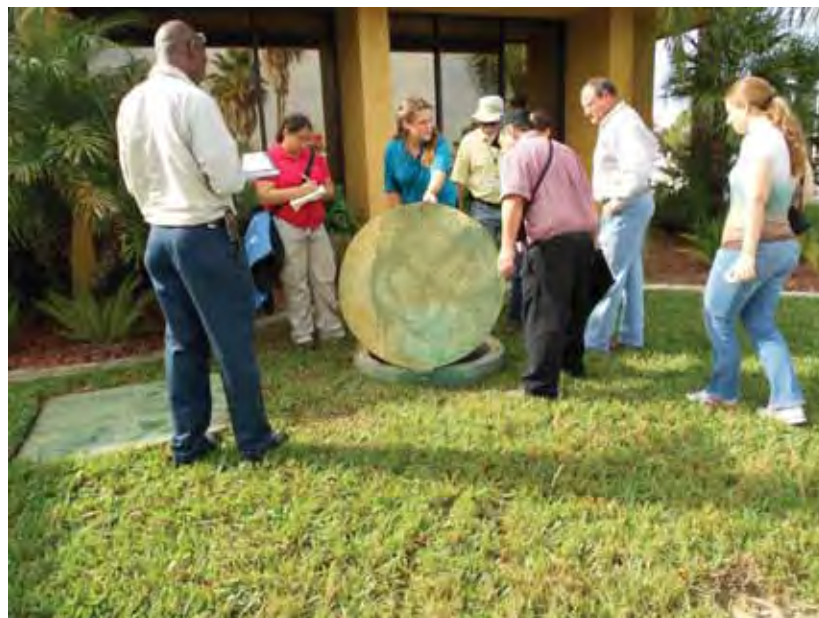
*Figure 2. Private Lift Station – Provision Eye Center.*

WTW Team inspecting lift station.

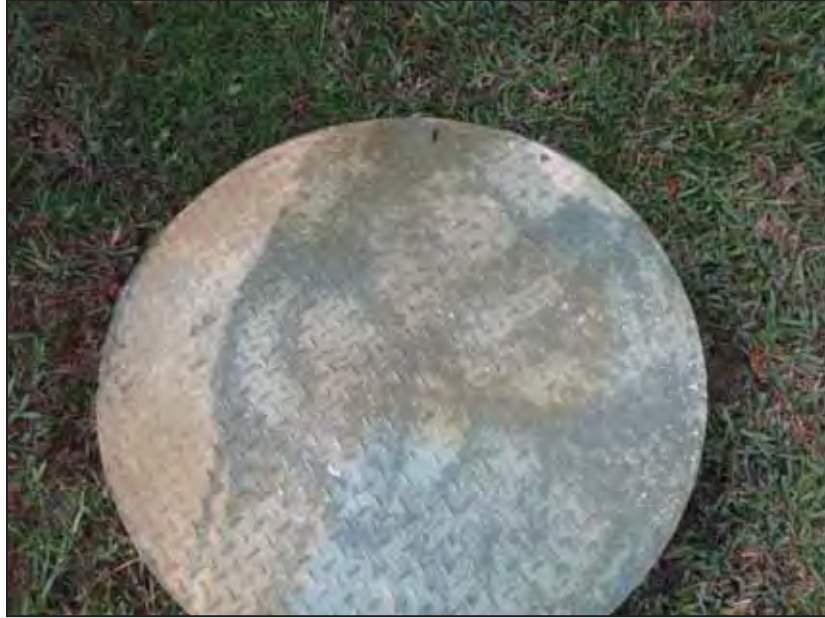
*Figure 3. Private Lift Station – Provision Eye Center*

Private lift station for Provision Eye Center, located at 473 S. Indiana Avenue needed a lock on the pump well cover and contact information for notification in case of an emergency. All of the lift stations inspected are included in Appendix B.

Action Item: Lock needed on pump well.

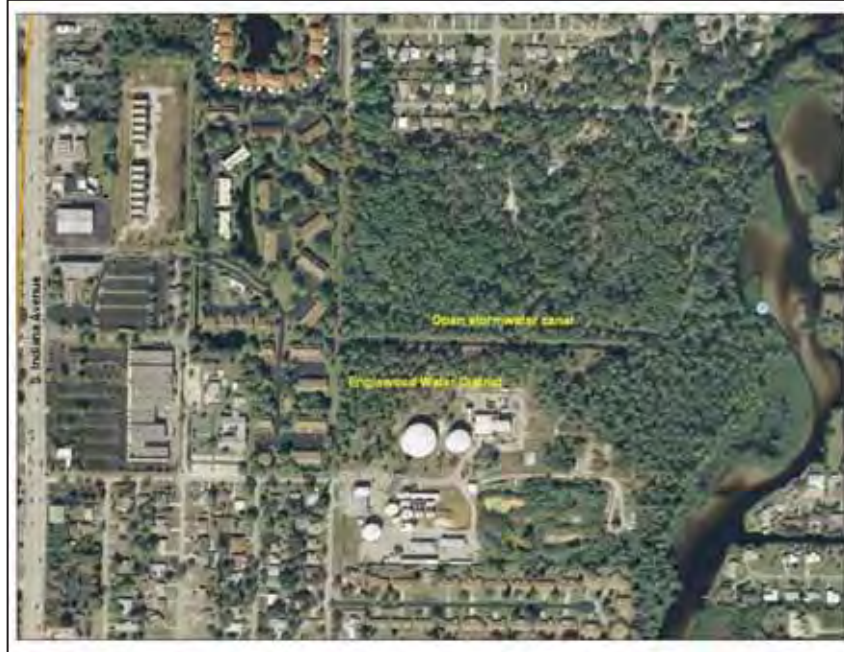
*Figure 5. Open Stormwater Canal, 201 Selma Avenue – Aerial View.*

Canal collects stormwater runoff from commercial and residential district and flows eastward into Gottfried Creek (blue circle).

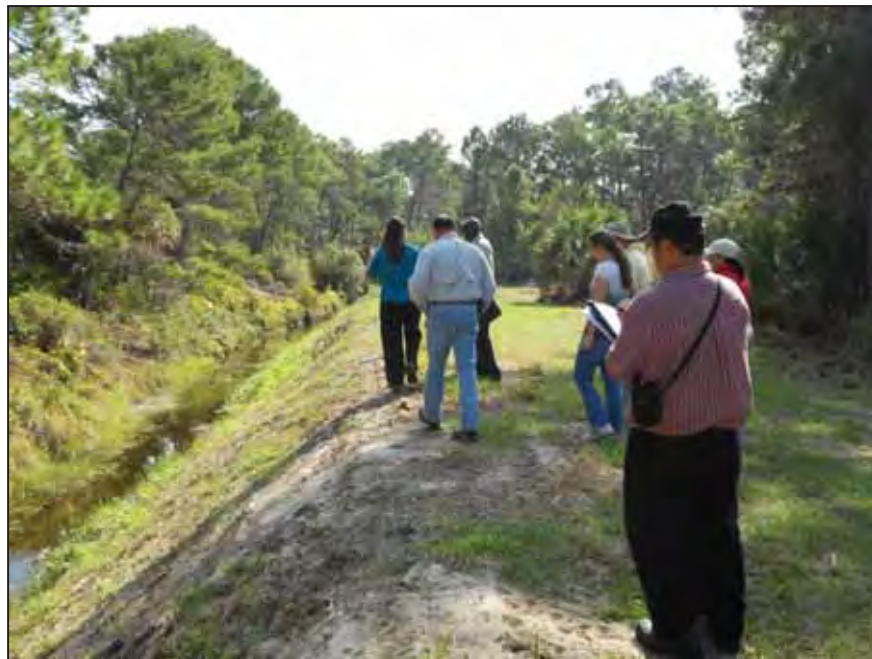
*Figure 6. WTW Team inspecting open stormwater canal.*

Canal is well maintained, open to UV light, and flows at low velocity except during significant rainfall events. No action item was necessary.

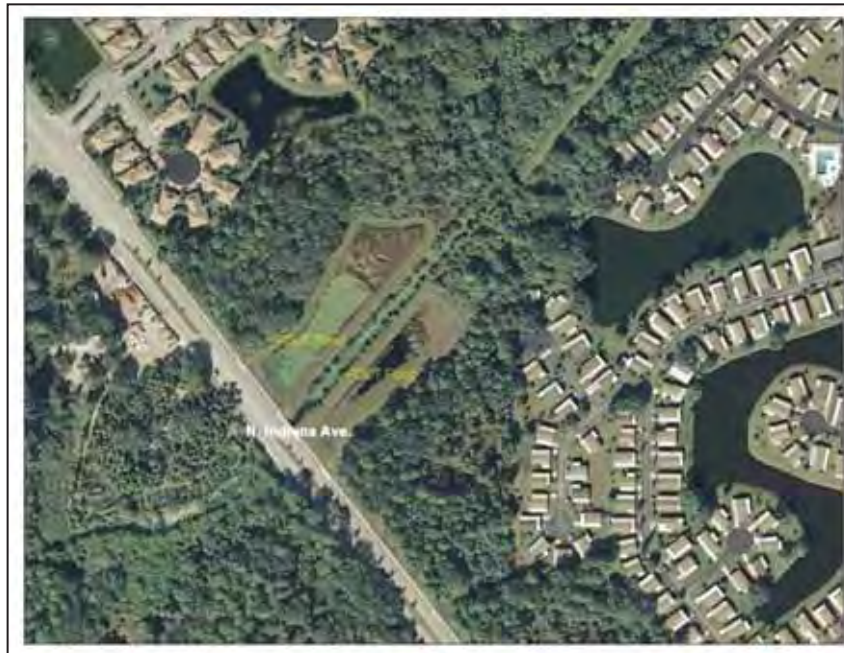
*Figure 8. FDOT Stormwater Ponds.*

The ponds were overgrown with cattails which could impair treatment capacity and efficiency.

Action Item: Notify FDOT to remove cattails.

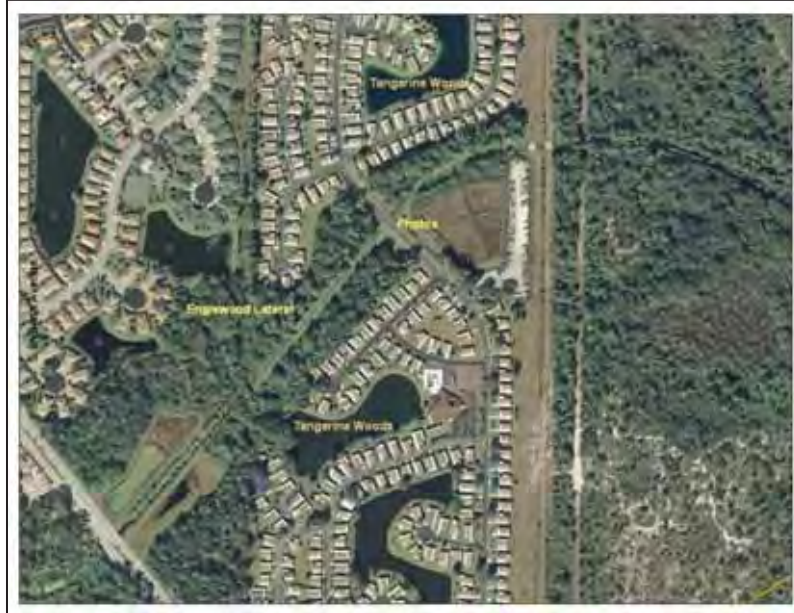
*Figure 9. Englewood Lateral Stormwater Canal at Tangerine Woods - Aerial View.*

Englewood Lateral flows through Tangerine Woods, a 368 manufactured home community, from southwest to northeast and joins Gottfried Creek on the Thomas Ranch property.

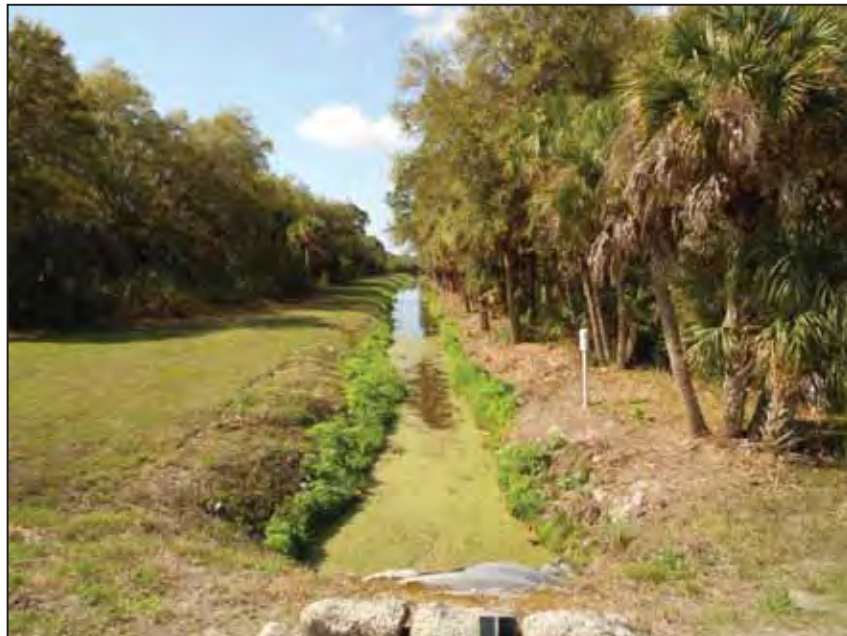
*Figure 10. Englewood Lateral at Tangerine Woods Boulevard – Upstream.*

The canal is county maintained, open to sunlight, and shallow with low flow. Duckweed is only present periodically, and not considered an ongoing issue for blocking UV treatment.

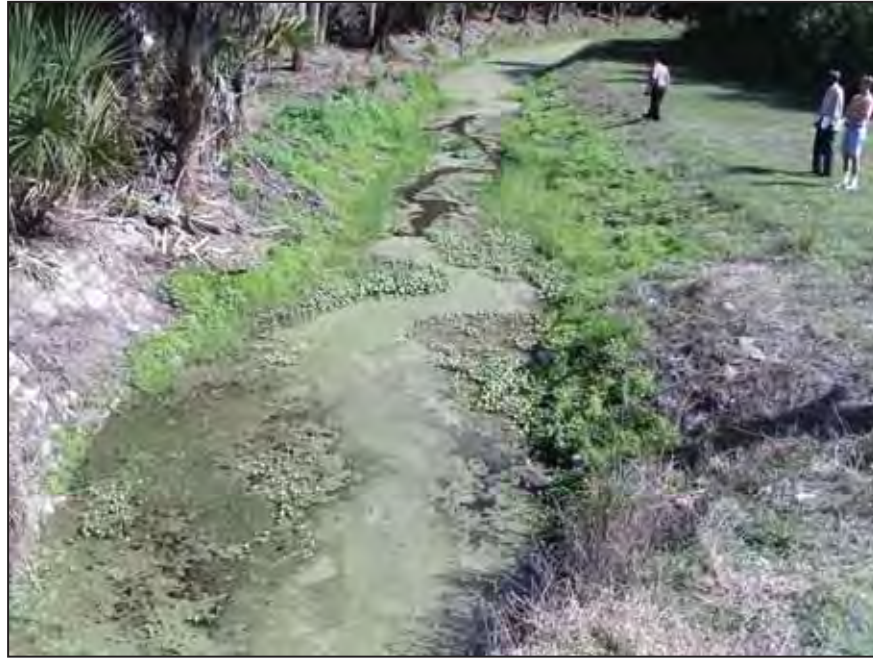
*Figure 11. Englewood Lateral at Tangerine Woods Boulevard – Downstream.*

Surface periodically covered with duckweed.

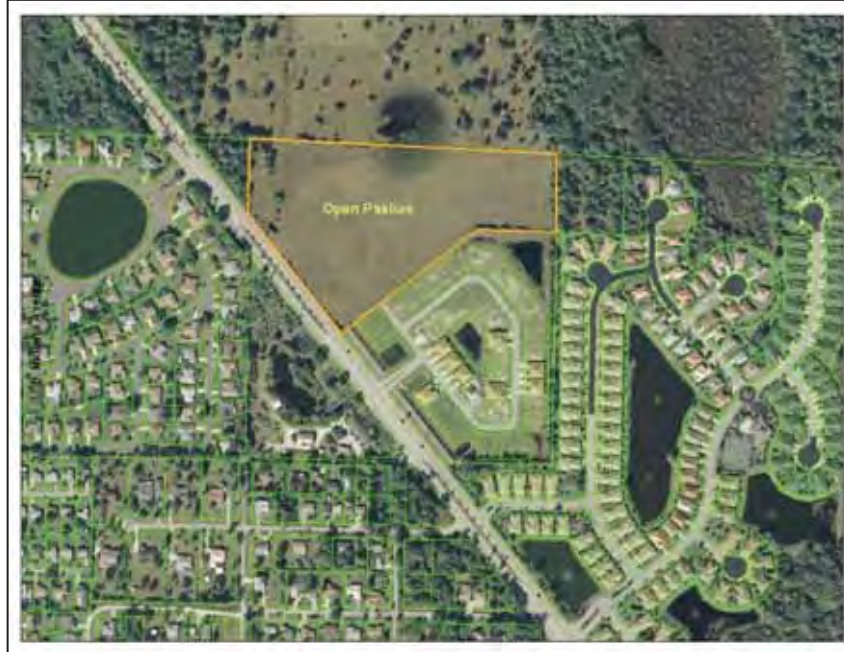
*Figure 13. Open Pasture – N. Indiana Avenue – Aerial View.*

No cattle present; cattle routinely rotated to other pastures; property bermed; no cow patties observed.  
Action Item: Determine if runoff flows to Gottfried Creek.

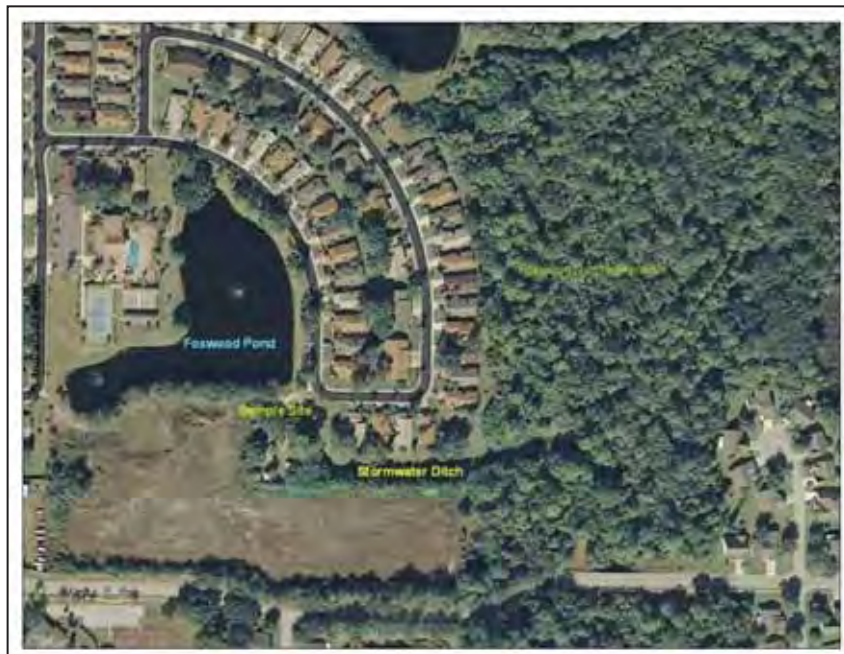
*Figure 14. Foxwood Development – Aerial View.*

The stormwater ditch flows from the stormwater pond through a natural area to Gottfried Creek.

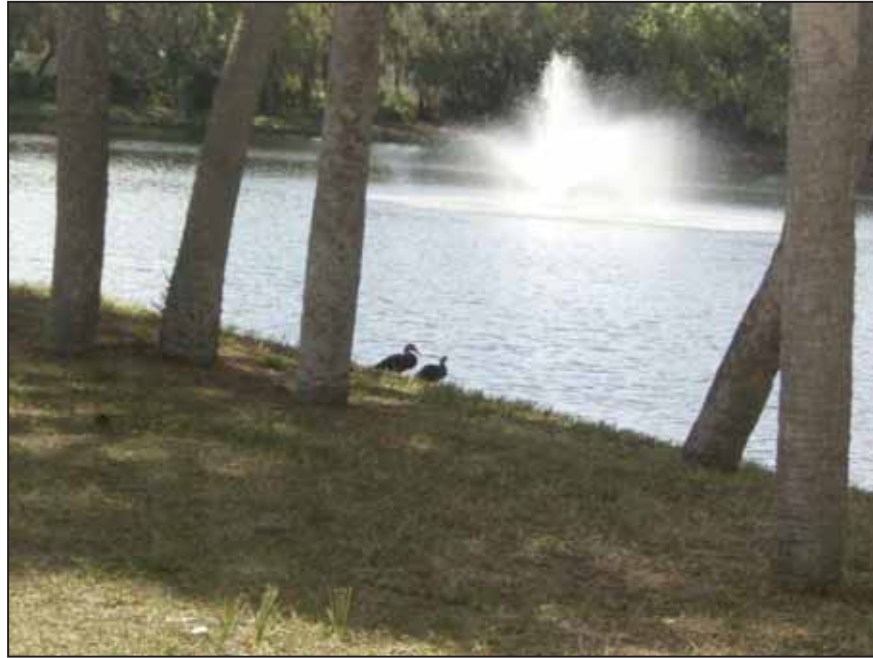
*Figure 15. Foxwood Stormwater Pond.*

Ducks and wading birds observed in and around pond.

- Figures 15, 20, 21, 22, 26, 47, 48, 50, 56, 66, 67, and 68 show evidence of wildlife in close proximity to the Gottfried Creek watercourse, including: raccoon prints, waterfowl, feral hogs, and feces.
- Bacterial re-growth is probable in ditches and natural watercourses given the sediments observed. See Figures 18, 20, 21, 22, 25, 64, 66, 69, 70, and 71.
- Natural canopy cover is not a contributor, but does prevent UV rays from reaching the water column. UV rays kill pathogens and fecal coliforms. See Figures 23, 25, 31 and 32.
- Natural tannins from decomposing plant material in the water also shade out UV rays. See Figures 10, 11, 12, 16, 23, 25, and 32.

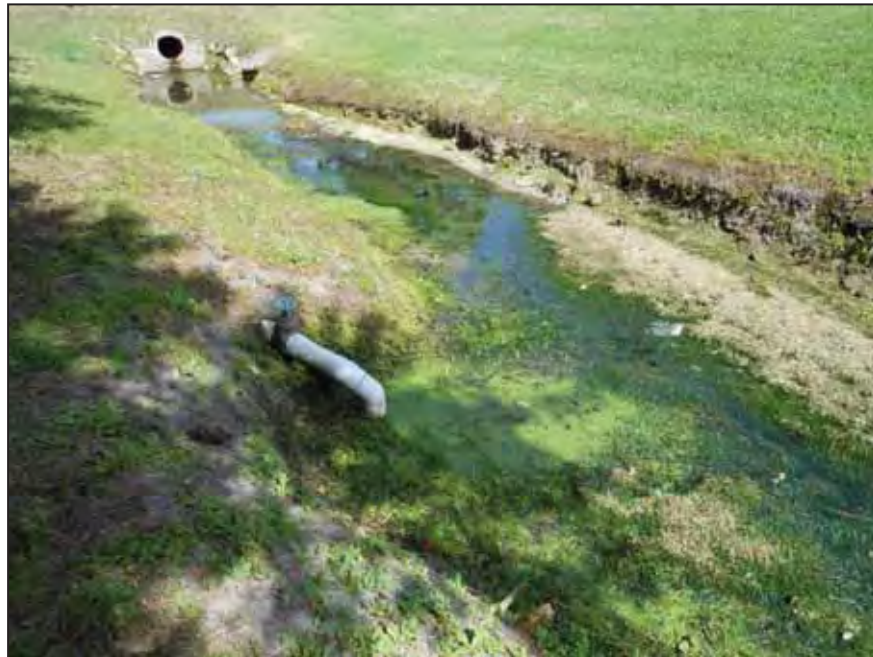
*Figure 16. Foxwood Stormwater Ditch – View Toward Upstream.*

The stormwater pond overflows into the ditch; irrigation pipes observed (foreground).

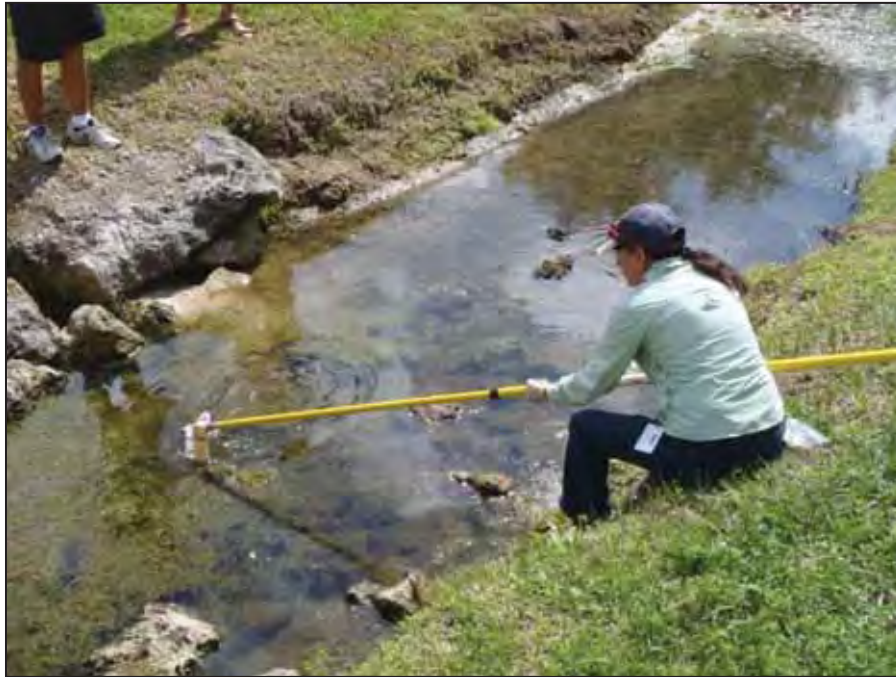
*Figure 17. WTW Team Collecting Sample for Fecal Coliform Testing.*

Action Item: Sample ditch because of strong pet waste odor.

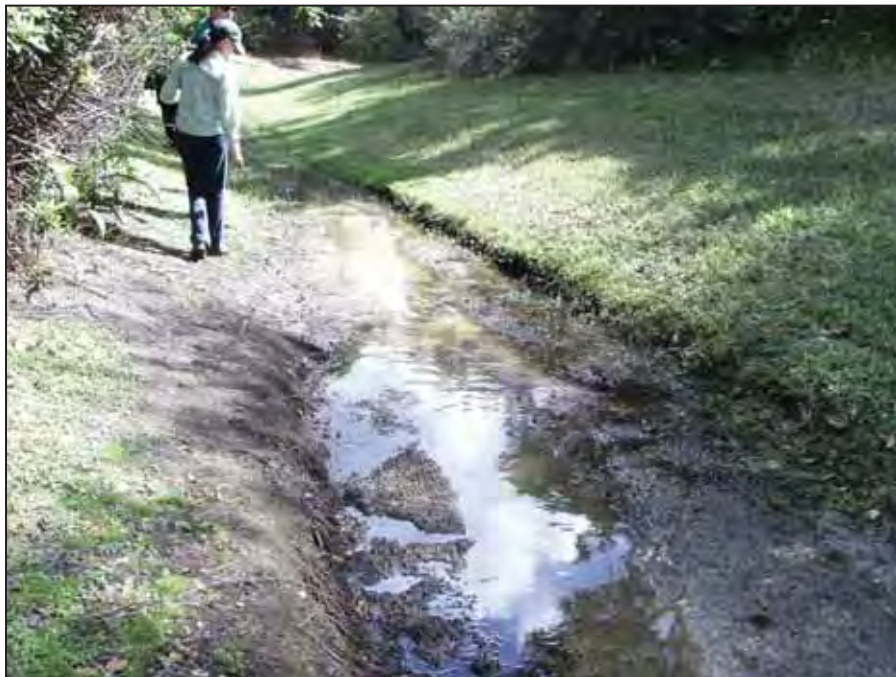
*Figure 18. Foxwood Stormwater Ditch – View Toward Downstream.*

Ditch flows to through Foxwood Nature Preserve to Gottfried Creek.

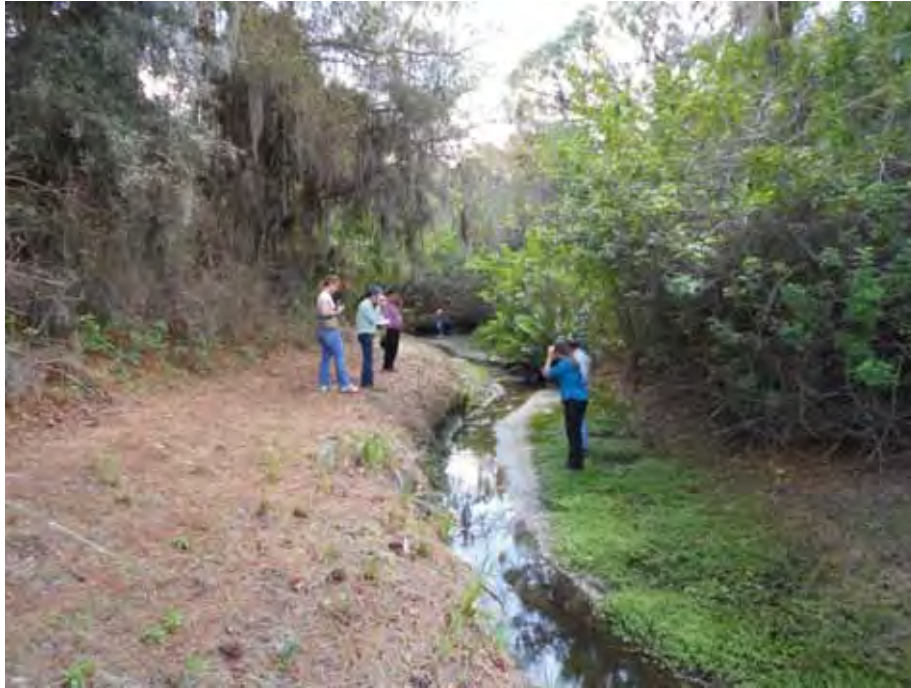
*Figure 19. Foxwood Stormwater Ditch.*

Ditch just upstream of nature preserve.

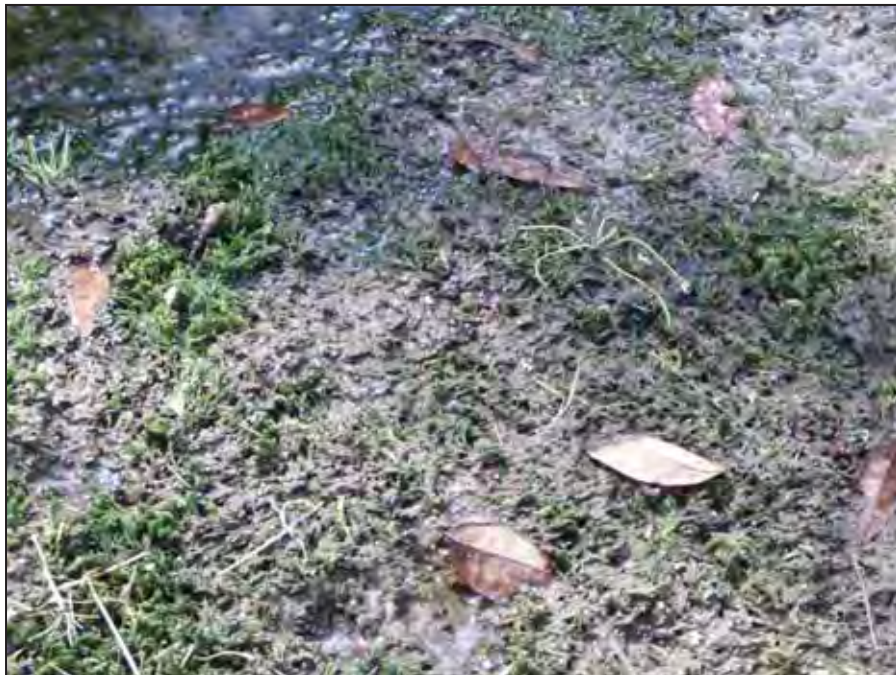
*Figure 20. Foxwood Stormwater Ditch-Wildlife Tracks.*

Deer or Hog Tracks

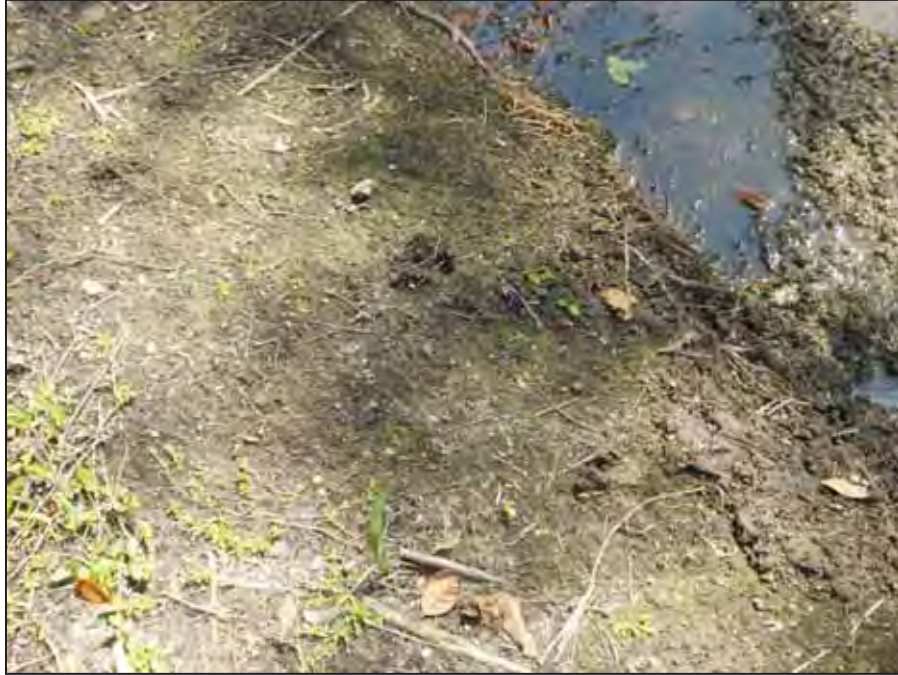
*Figure 21. Foxwood Stormwater Ditch-Wildlife Tracks.*

Deer or Hog Tracks

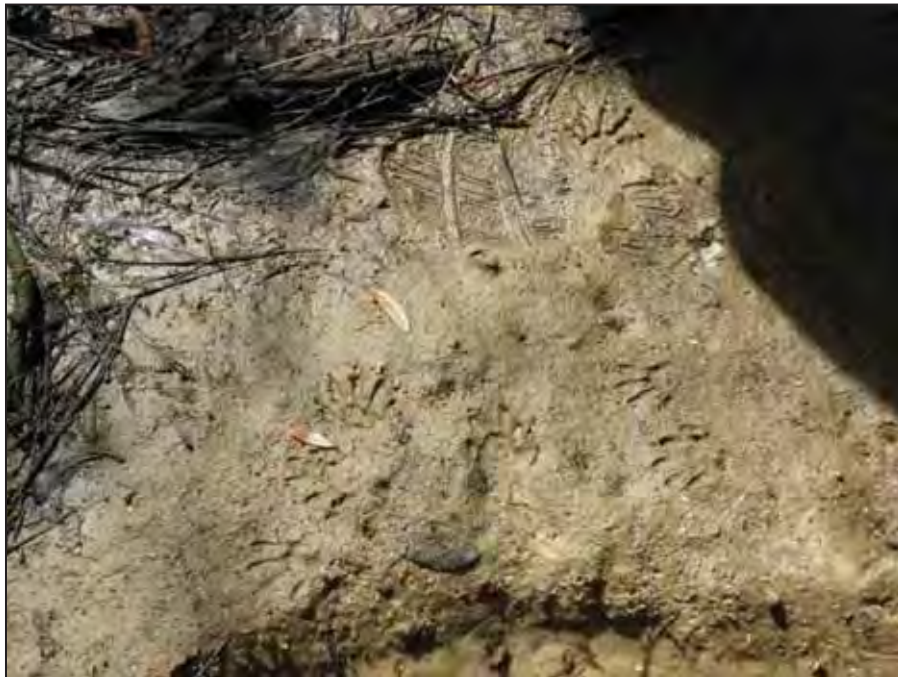
*Figure 22. Foxwood Stormwater Ditch.*

Raccoon Tracks

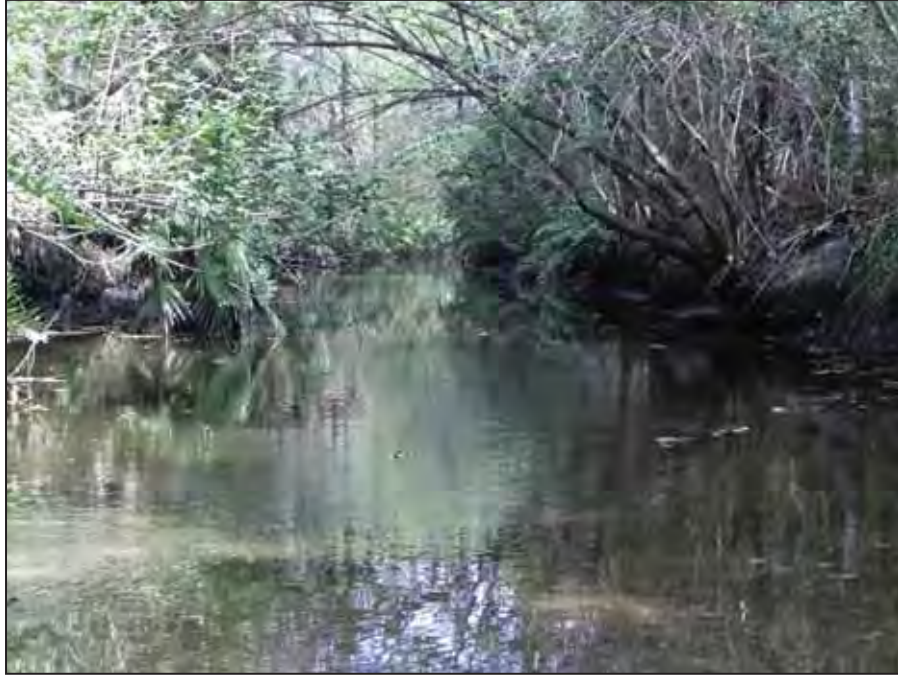
*Figure 23. Foxwood Nature Preserve Creek – View Downstream.*

Foxwood stormwater ditch merges with creek at this point.

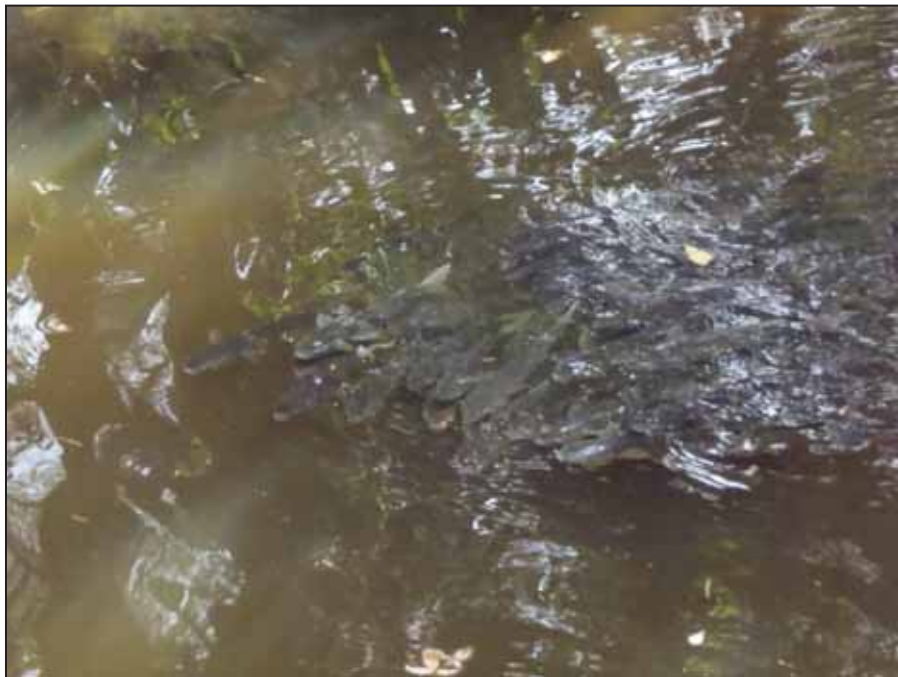
*Figure 24. Foxwood Nature Preserve Creek – Large School of Mullet.*

Creek is tidally influenced.

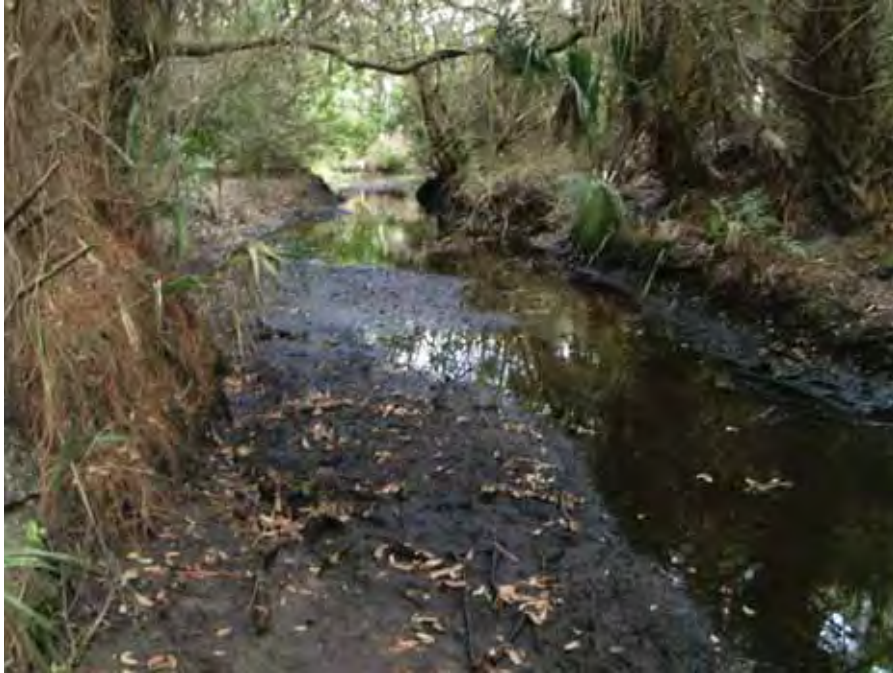
*Figure 25. Foxwood Nature Preserve Creek.*

Creek is shallow and heavily shaded. This segment flows to Gottfried Creek.

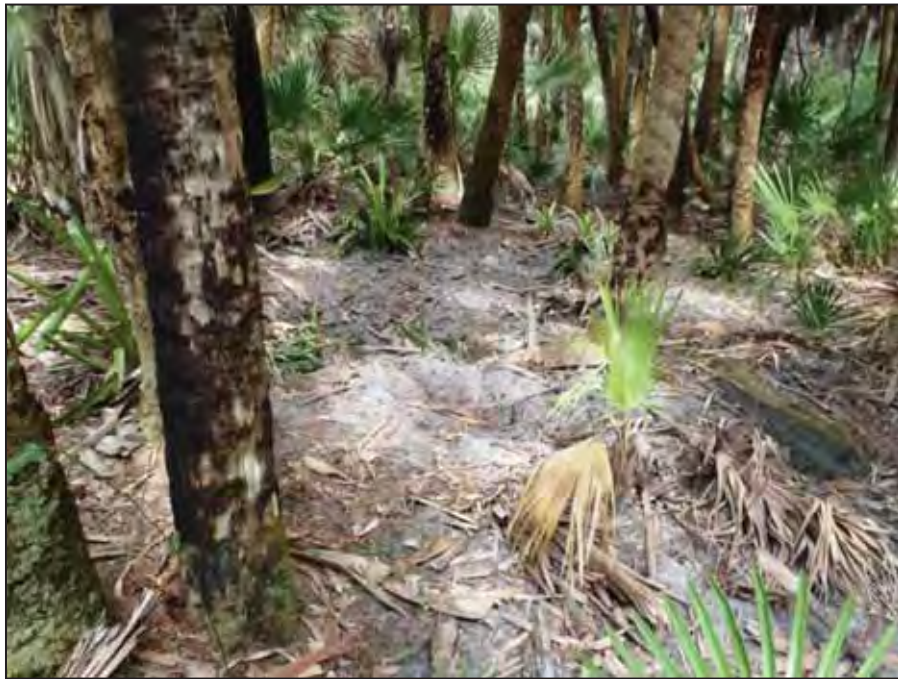
*Figure 26. Foxwood Nature Preserve.*

Evidence of wild hog activity.

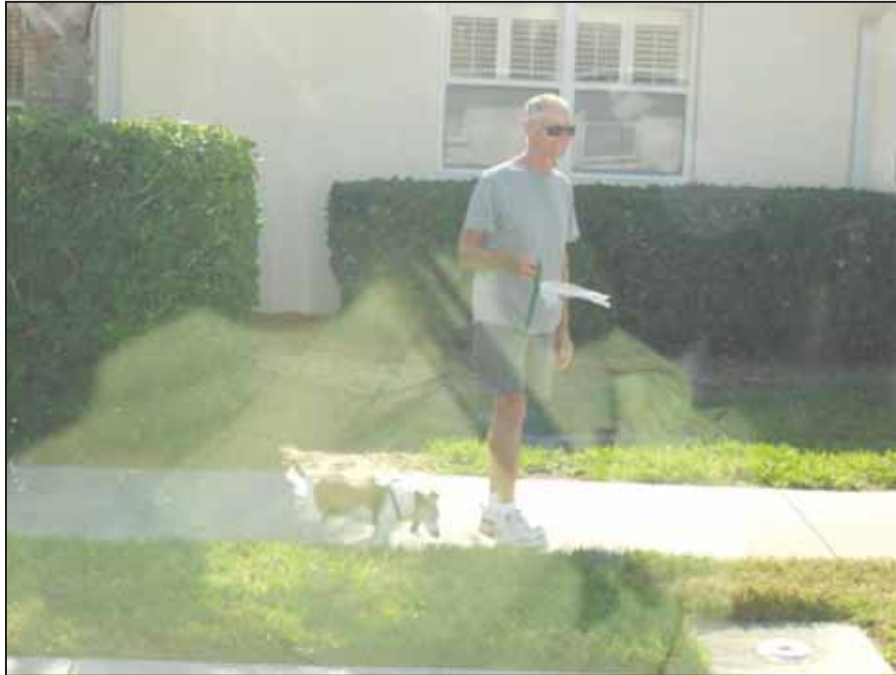
*Figure 27. Oak Forest Subdivision, N. Indiana Avenue.*

Proper pet waste management

team even observed a resident carrying a pet waste bag while walking his dog (Figure 27).

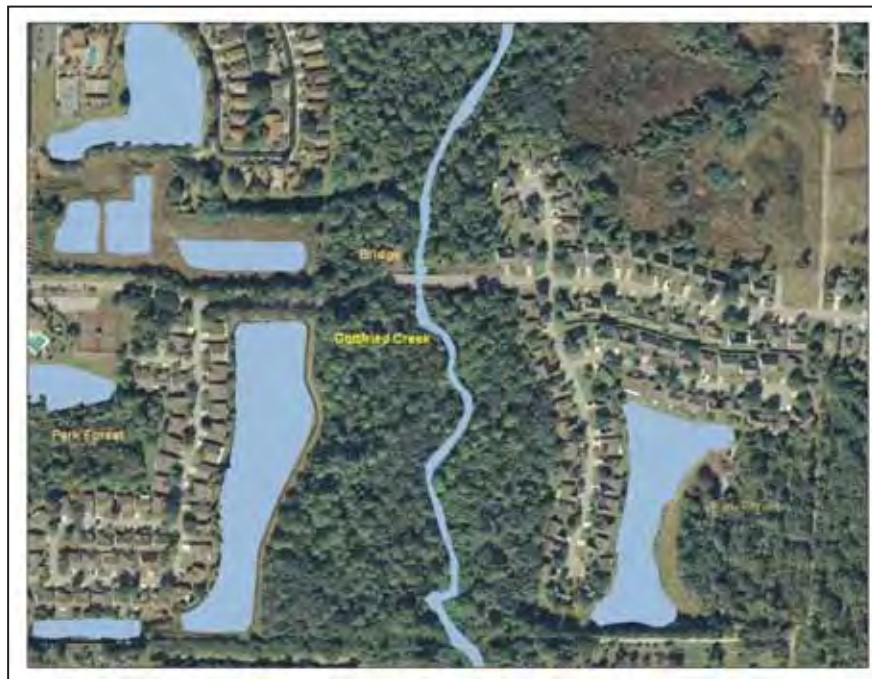
*Figure 28. Park Forest Development, N. Indiana Avenue– Aerial View.*

Sarasota County conducts monthly water quality sampling at the bridge on Gottfried Creek.

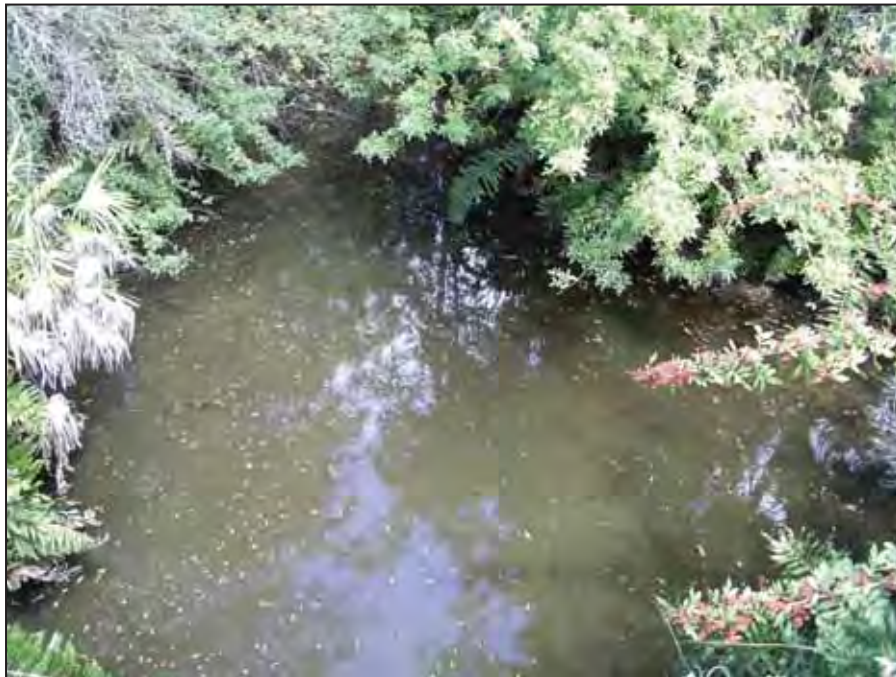
*Figure 30. Gottfried Creek at Park Forest Bridge.*

View Facing Upstream. : Heavily Shaded

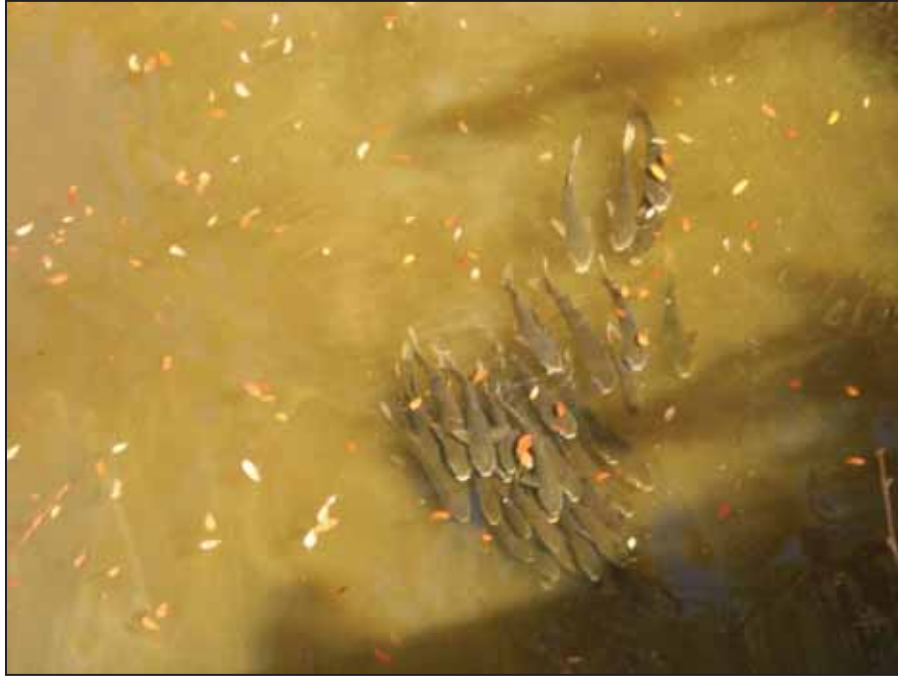
*Figure 31. Gottfried Creek at Park Forest Bridge – Mullet in Creek.*

Sarasota County conducts monthly sampling at station 21FLFTM SARABY0022FTM, which is also one of the stations sampled by the FDEP to establish impairment and adopt the fecal coliform TMDL. During the WTW Field Exercise on February 28, 2012, the site was inspected by the WTW Team. While observing a large school of mullet at the site (Figure 31), the team realized that creek waters were tidally influenced up to and possibly upstream of that point. Since the creek is very narrow and shallow at the site, it was suggested that large schools of fish such as mullet reaching the site during a high tide could potentially stir up sediments causing a spike in fecal coliform values.

Action Item: Determine tidal stage and salinity during collection of samples.

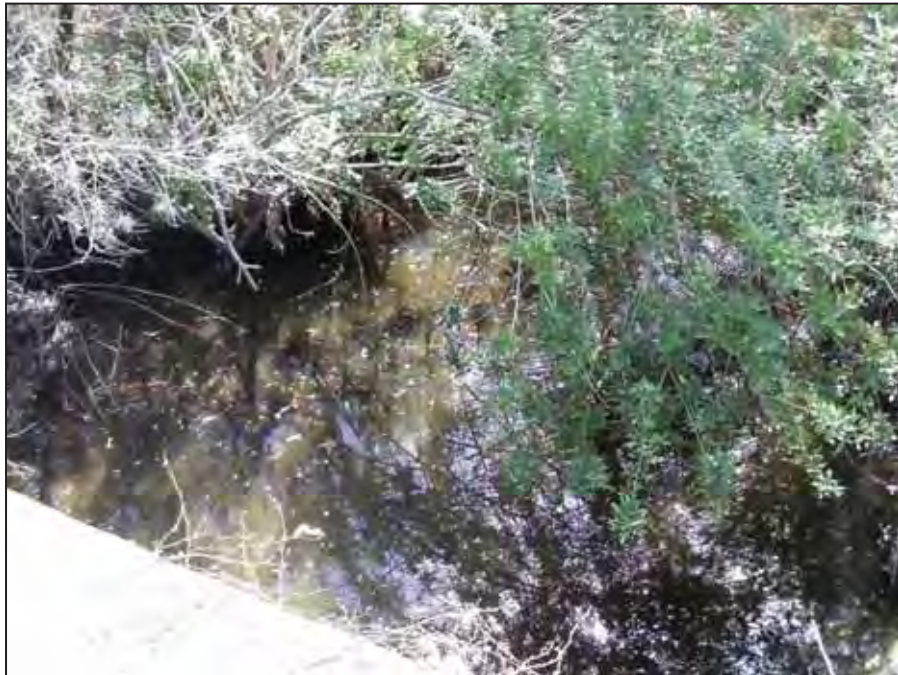
*Figure 32. Gottfried Creek at Park Forest Bridge.*

View Facing Downstream: Heavily Shaded

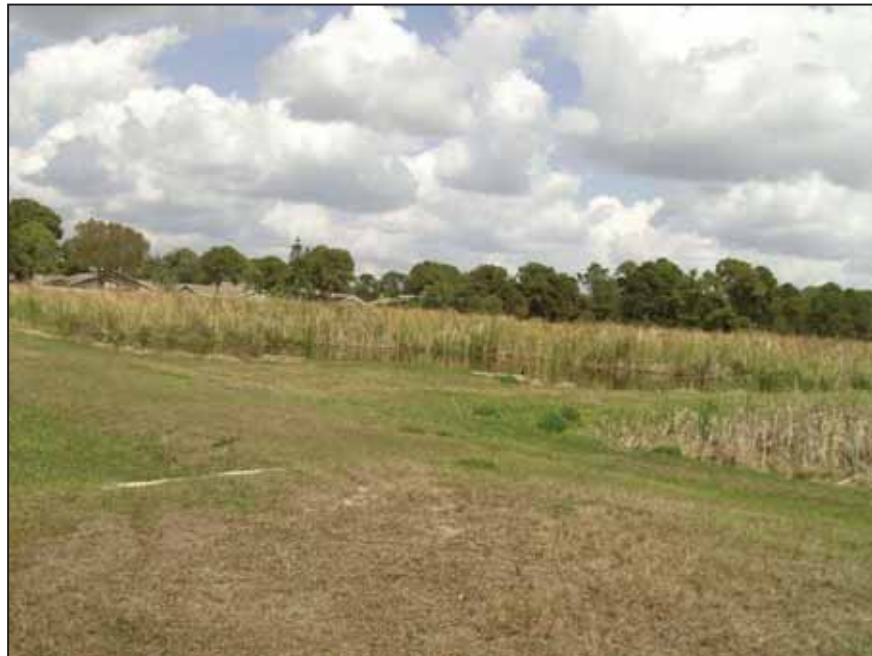
*Figure 34. FDOT Pond DP35-6 Behind the Elks Lodge – Northern Arm.*

Pond Overgrown with Cattails.

Ponds are overgrown with cattails (Figures 34 and 35).  
Action Item: Notify FDOT to remove cattails.

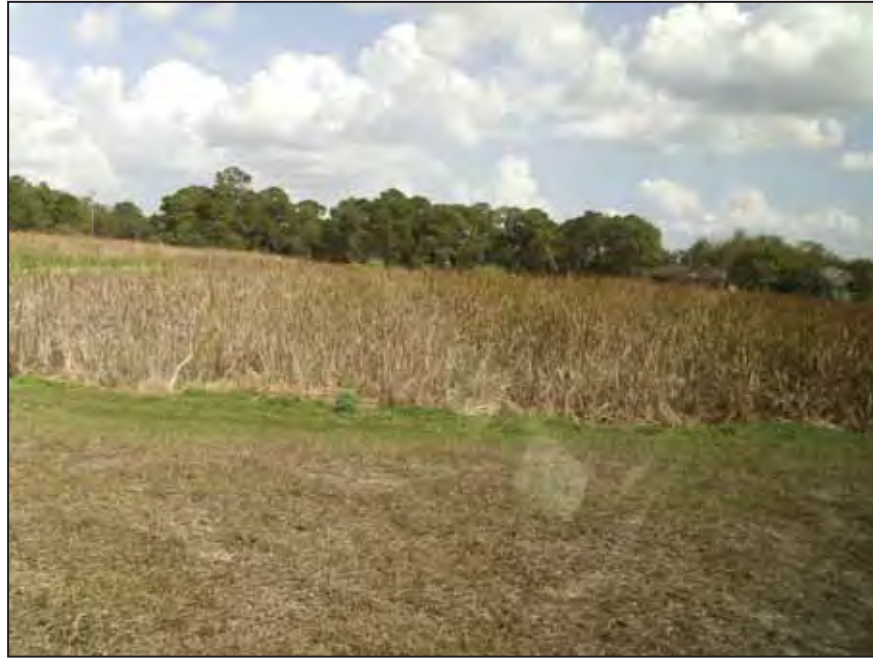
*Figure 35. FDOT Pond DO35-6 Behind Elks Lodge – Southern Arm.*

Pond Overgrown with Cattails.

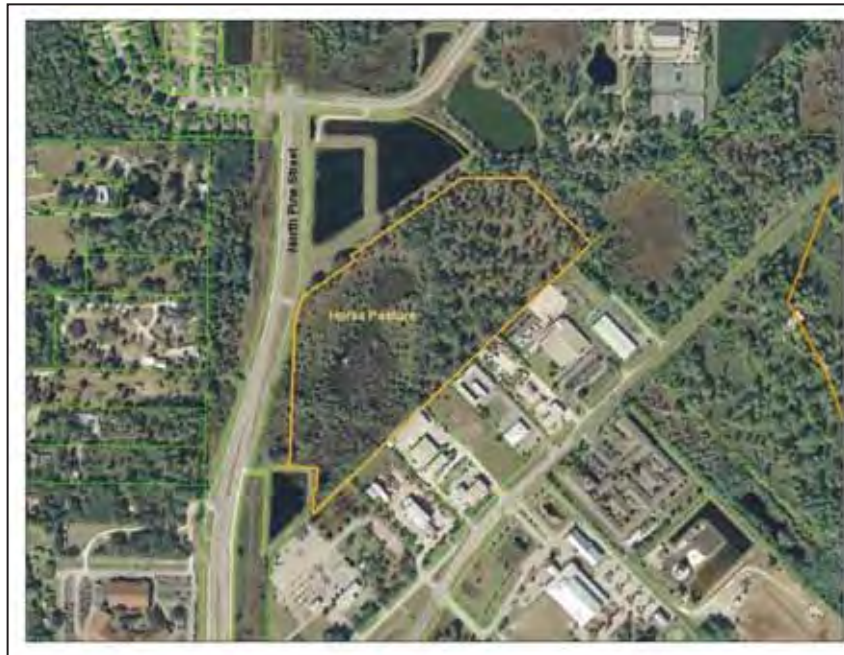
*Figure 36. Horse Pasture on North Pine Street – Aerial View.*

Improper manure disposal could impact Gottfried Creek.  
Action Item: Determine if runoff could flow to the creek.

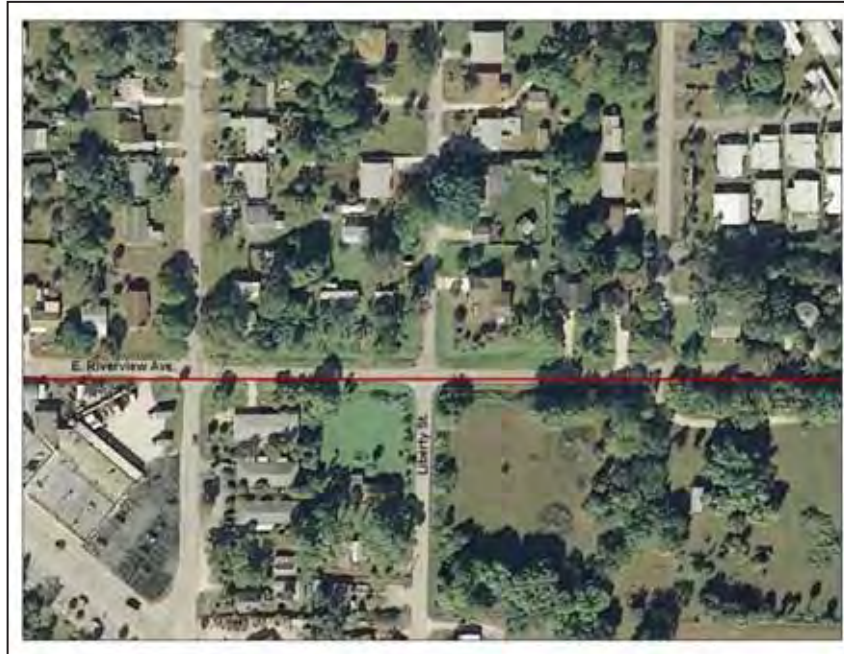
*Figure 41. E. Riverview Ave. and Liberty St. – Aerial View.*

The ditch, flowing from S. Indiana Avenue to Gottfried Creek is on the Sarasota/Charlotte County line.

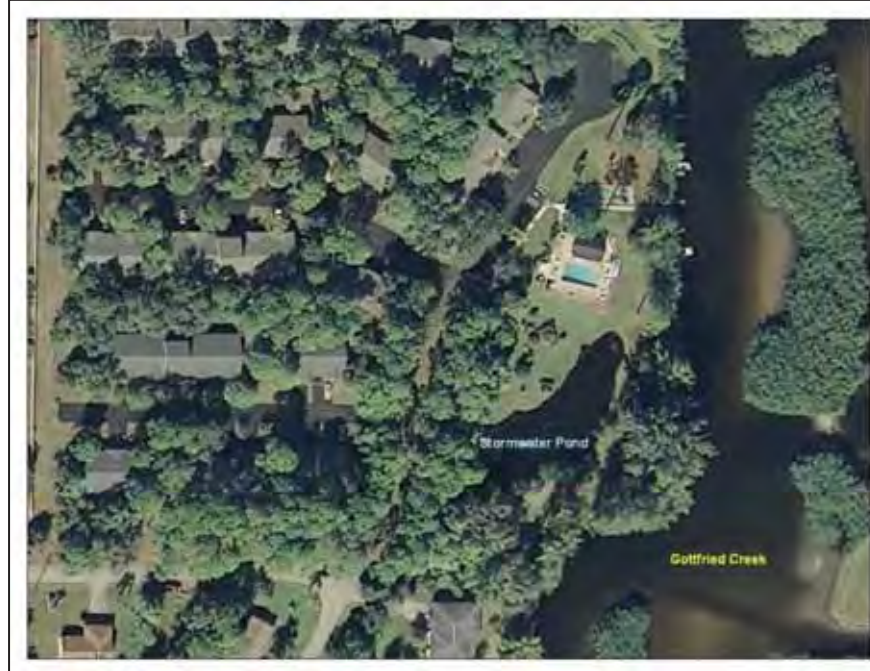
*Figure 43. Gasparilla Condominium Complex, 131 Jose Gaspar Dr. – Aerial View.*

Complex property is adjacent to Gottfried Creek.

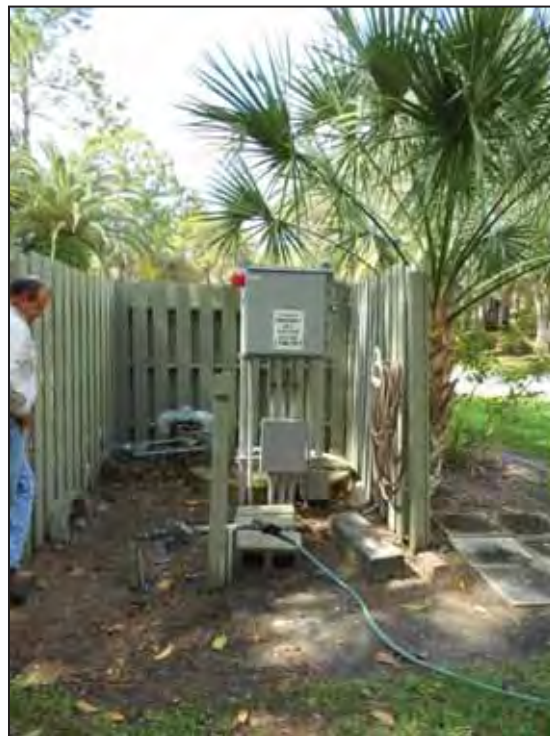
*Figure 44. Gasparilla Condominium – Private Lift Station.*

No Violations Noted.

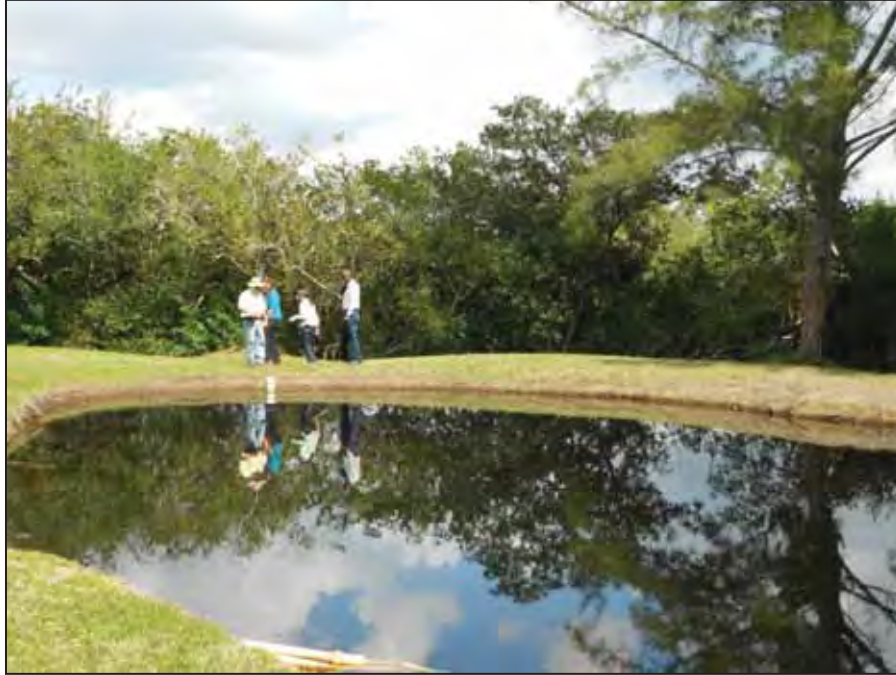
*Figure 45. Gasparilla Condominium Stormwater Pond.*

WTW Team Inspecting Berm Around Pond.

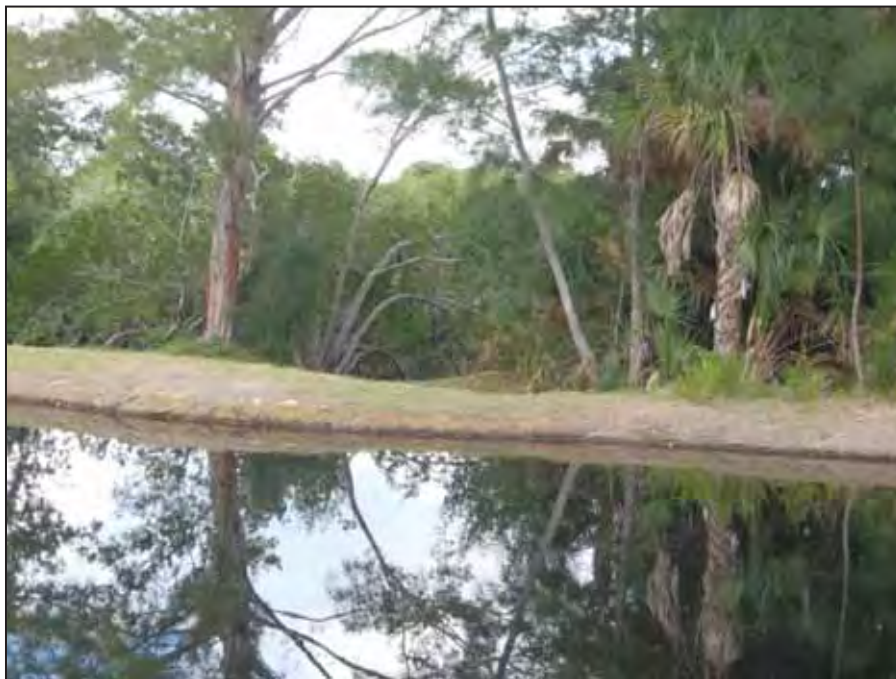
*Figure 46. Gasparilla Condominium Stormwater Pond.*

Pond Overflows Berm Directly to Creek.

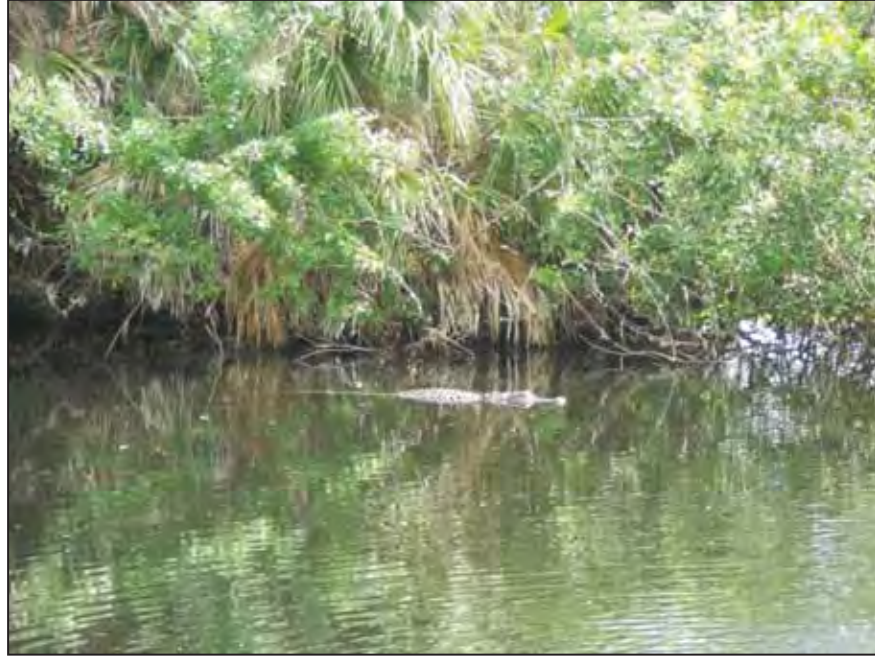
*Figure 47. Gasparilla Condominium Stormwater Pond.*

Alligator Inhabiting Pond

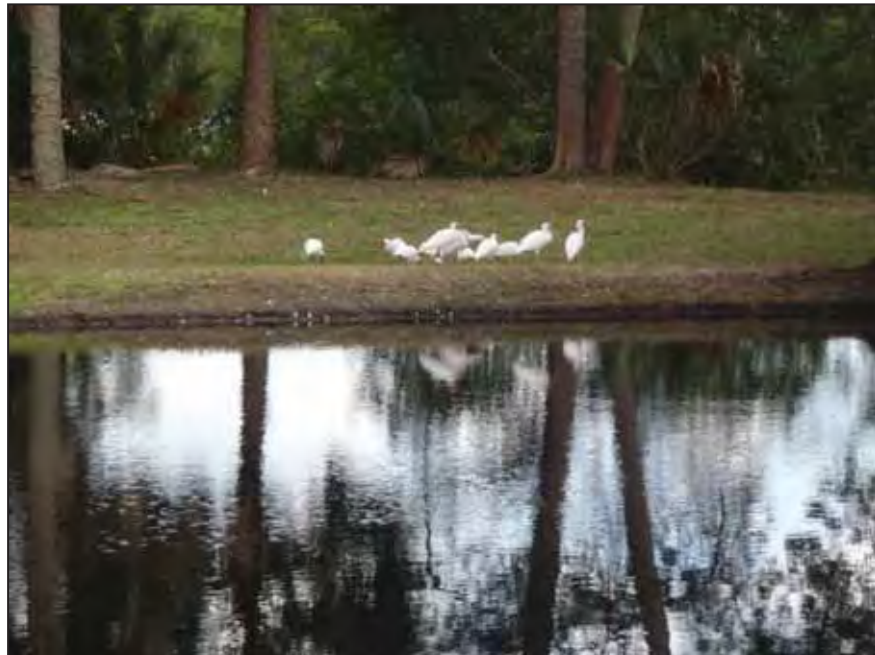
*Figure 48. Gasparilla Condominium Stormwater Pond.*

Flock of White Ibis on Pond Berm  
No issues observed. No Action Item necessary.
