## City of North Port

National Pollutant Discharge Elimination System (NPDES)  
Municipal Separate Storm Sewer System (MS4)  
Permit # FLS000004

### Year 2 Annual Report

**Report period Jan 1, 2015  
to December 31, 2015**

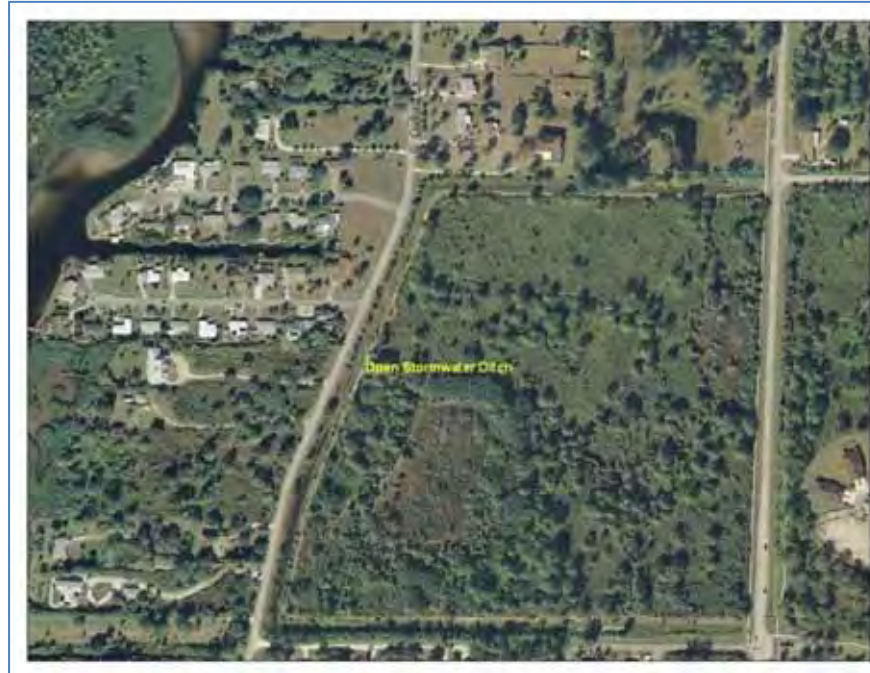
*Figure 49. South Oxford Stormwater Ditch.*

Ditch runs parallel to S. Oxford then flows west to Gottfried Creek

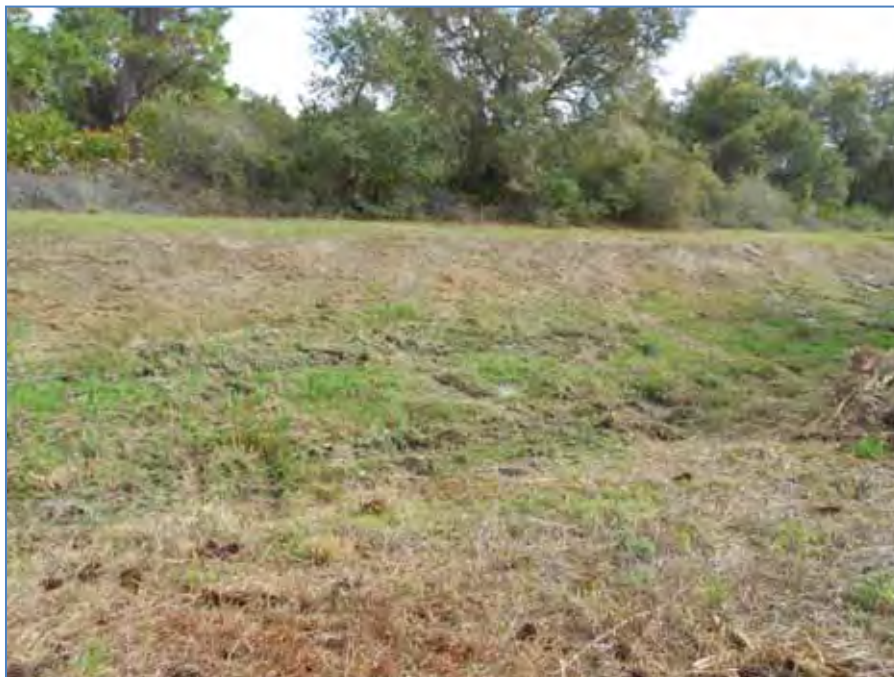
*Figure 50. South Oxford Stormwater Ditch.*

Evidence of Hog Activity in Ditch

- Figures 15, 20, 21, 22, 26, 47, 48, 50, 56, 66, 67, and 68 show evidence of wildlife in close proximity to the Gottfried Creek watercourse, including: raccoon prints, waterfowl, feral hogs, and feces.
- Bacterial re-growth is probable in ditches and natural watercourses given the sediments observed. See Figures 18, 20, 21, 22, 25, 64, 66, 69, 70, and 71.
- Natural canopy cover is not a contributor, but does prevent UV rays from reaching the water column. UV rays kill pathogens and fecal coliforms. See Figures 23, 25, 31 and 32.
- Natural tannins from decomposing plant material in the water also shade out UV rays. See Figures 10, 11, 12, 16, 23, 25, and 32.

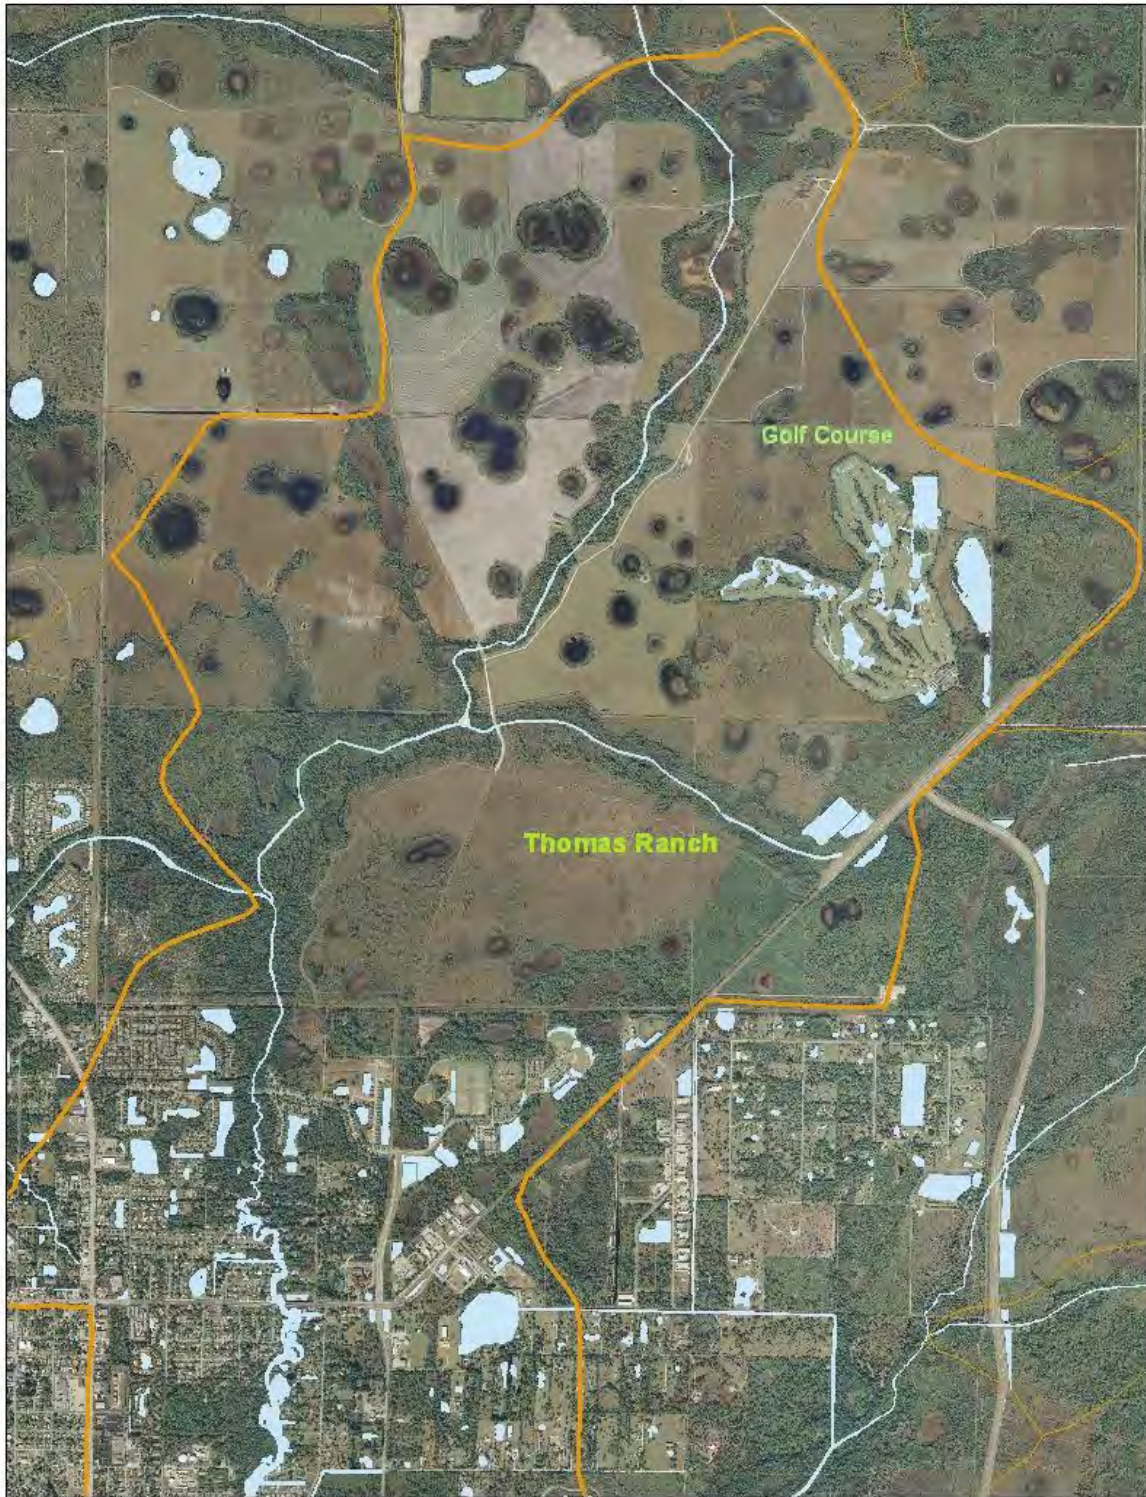
*Figure 53. Thomas Ranch Aerial Overview.*

On May 10, 2012, representatives from the FDEP, Sarasota County, FDACS, and Thomas Ranch conducted a tour of the ranch (**Figure 53**), a portion of which (about 2088 acres) occupies the upper third of the Gottfried Creek Basin. Thomas ranch, an 11,000 acre working ranch, runs a low-density livestock grazing operation with approximately 800 head of cattle. The remaining acreage is located in the City of North Port where a portion contains residential, commercial, and retail development. There were no immediate plans for further development of the ranch property during the inspection.

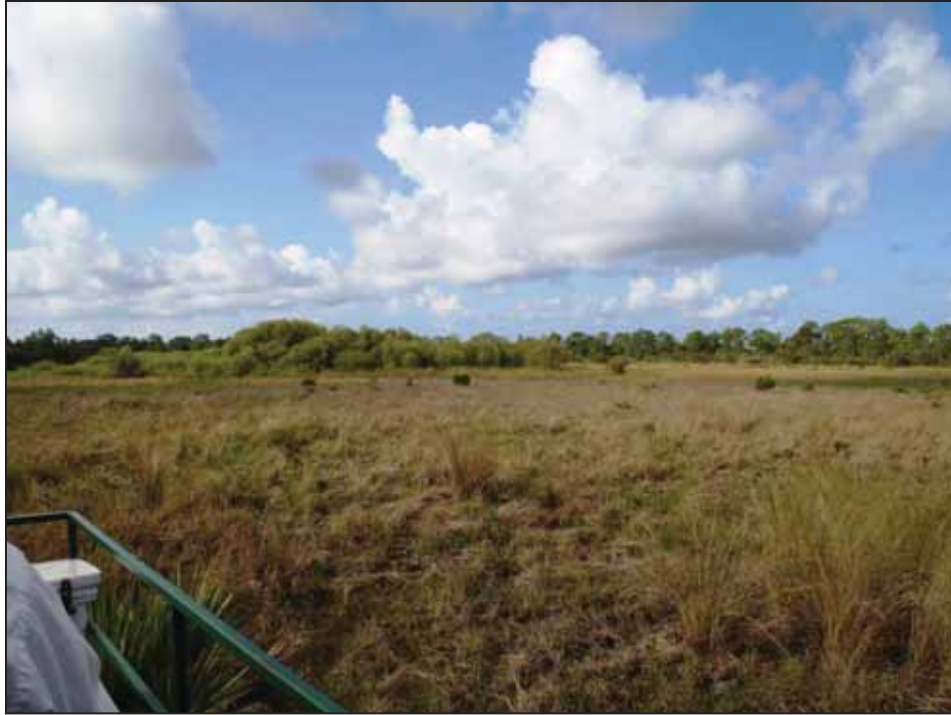
*Figure 56. Thomas Ranch – One of Many Wetlands.*

While no evidence was found of any sizeable wildlife populations inhabiting the ranch, evidence was found of feral hog activity both on the property and in several areas of the creek (**Figures 56 and 66-69**). No bird colonies were found in the areas of the ranch that were visited.

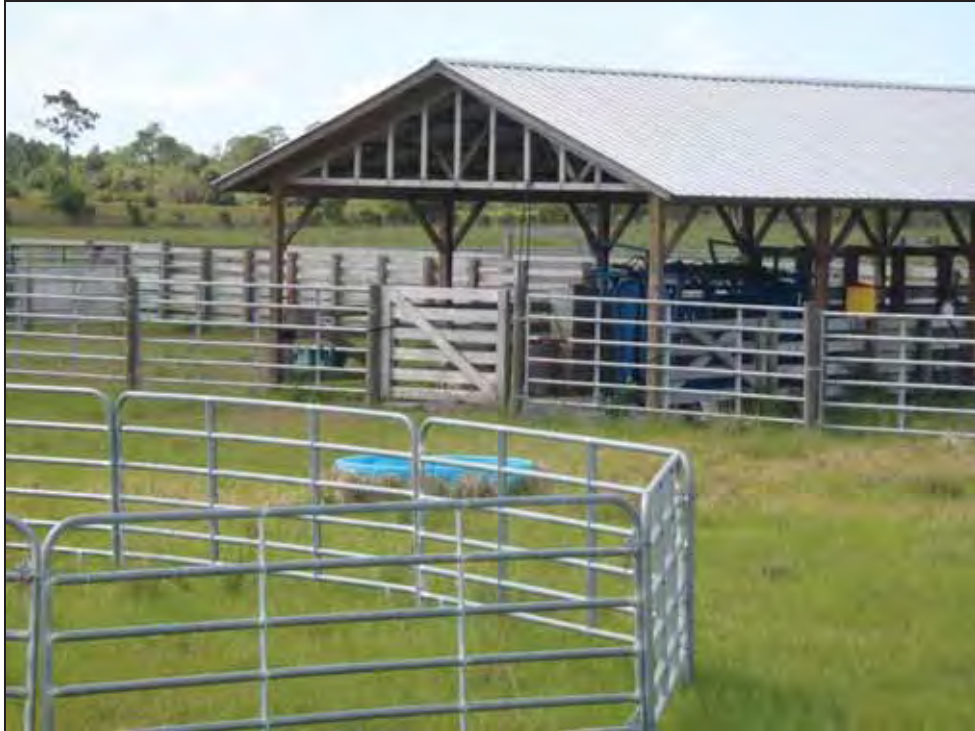
*Figure 74. Thomas Ranch-Pole Barn, Corrals, Watering Trough.*

The Cattle operation included approximately 800 head of cattle that were separated into smaller herds and routinely rotated among different pastures. The thick vegetation along the banks of the creek restricted cattle access to the creek. The creek bed is also dry most of the year, limiting its availability as a water supply. Therefore, fresh water is provided in round troughs dispersed throughout the ranch (**Figures 74 and 75**).

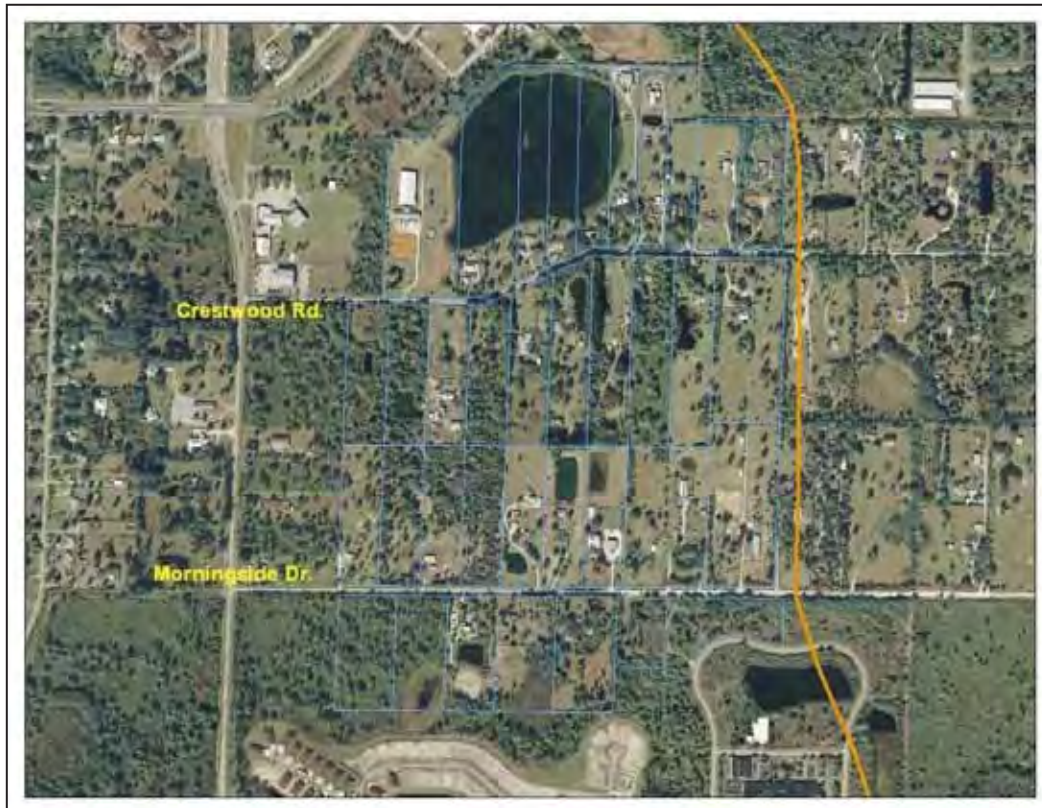
Figure 78. Crestwood Rd. and Morningside Dr. Ranchettes – Aerial View.

On May 10, 2012, after the tour of Thomas Ranch, representatives from the FDEP, Sarasota County, and FDACS conducted a tour of an area of small ranchettes and horse farms in the southeastern portion of the WBID (Figure 78) on Crestwood Rd. and Morningside Dr. The lots range in size from 5 to 10 acres, and some property owners provide boarding services, horseback riding lessons, trail rides, horsemanship and dressage training, jumping instruction, horse training and sales, or maintain private horse facilities (Figures 79-81 and 84-89). There is also a cat and dog kennel (Figure 82) on Morningside Dr. and an exotic bird breeder (Figure 83) on Crestwood Rd. Stormwater runoff from the properties, which could contain fecal coliform bacteria, flows westward through a large open stormwater canal to Gottfried Creek. The large pond on the north side of Crestwood Rd. collects stormwater runoff from several parcels and discharges to the open stormwater canal previously mentioned. During the survey, no obvious issues were observed. However, it was determined that the community could benefit from a public meeting conducted by FDACS and Sarasota County to provide information about the importance of proper manure management and waste disposal. The workshop was added as a follow-up WTW action item.

Ranchette Parcels Are Highlighted in Blue

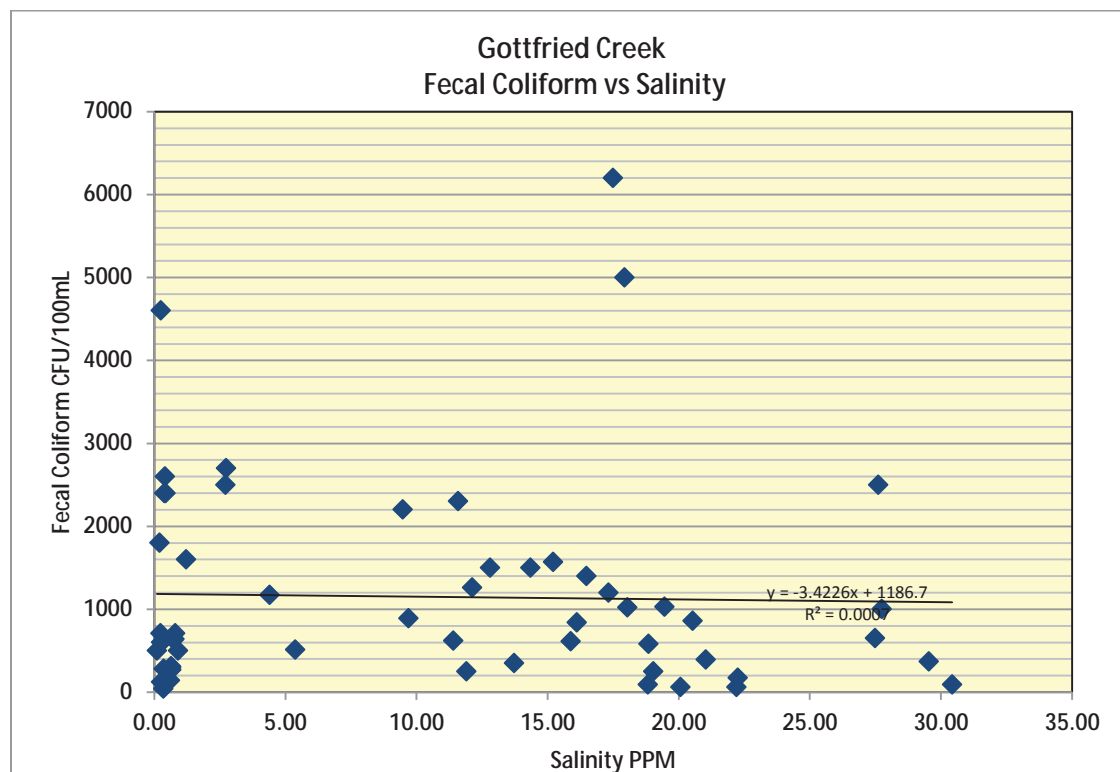
Figure 90. Fecal Coliform vs. Salinity

There is no significant correlation between fecal coliform and salinity (Figure 108). While there are a couple of high fecal coliform values at a higher tide (6200 fecal/17.50 ppt; 5000 fecal/17.94 ppt), there is an inverse relationship between fecal coliforms and salinity most of the time. In addition, fecal coliform bacteria do not survive very long in salt water. The results are an indication that marine life is probably not a factor in causing re-suspension of fecal coliform enriched sediments into the water column.

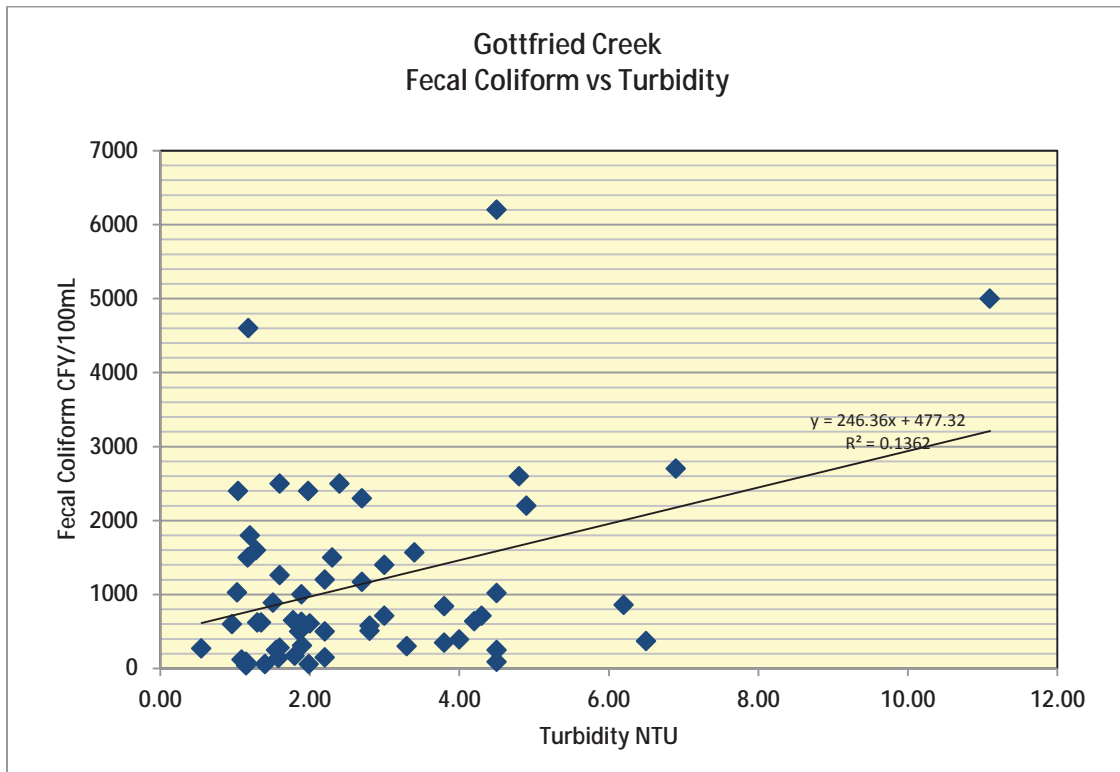
Figure 91. Fecal Coliform vs. Turbidity

There is a closer correlation between fecal coliform and turbidity (Figure 109). Forty percent of the samples displayed a positive relationship, while 60% displayed an inverse relationship.

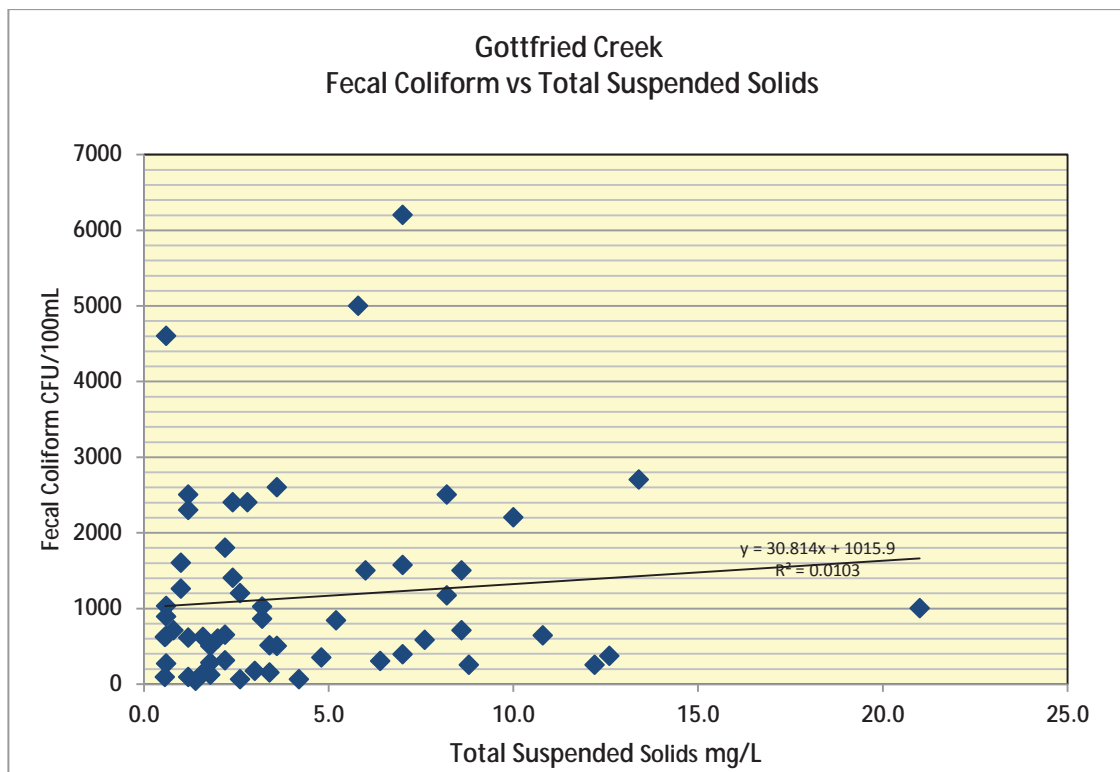
Figure 92. Fecal Coliform vs. Total Suspended Solids

There is also a closer relationship between fecal coliform and TSS (Figure 110). Thirty-five percent of the samples displayed a positive relationship, while 65% displayed an inverse relationship.

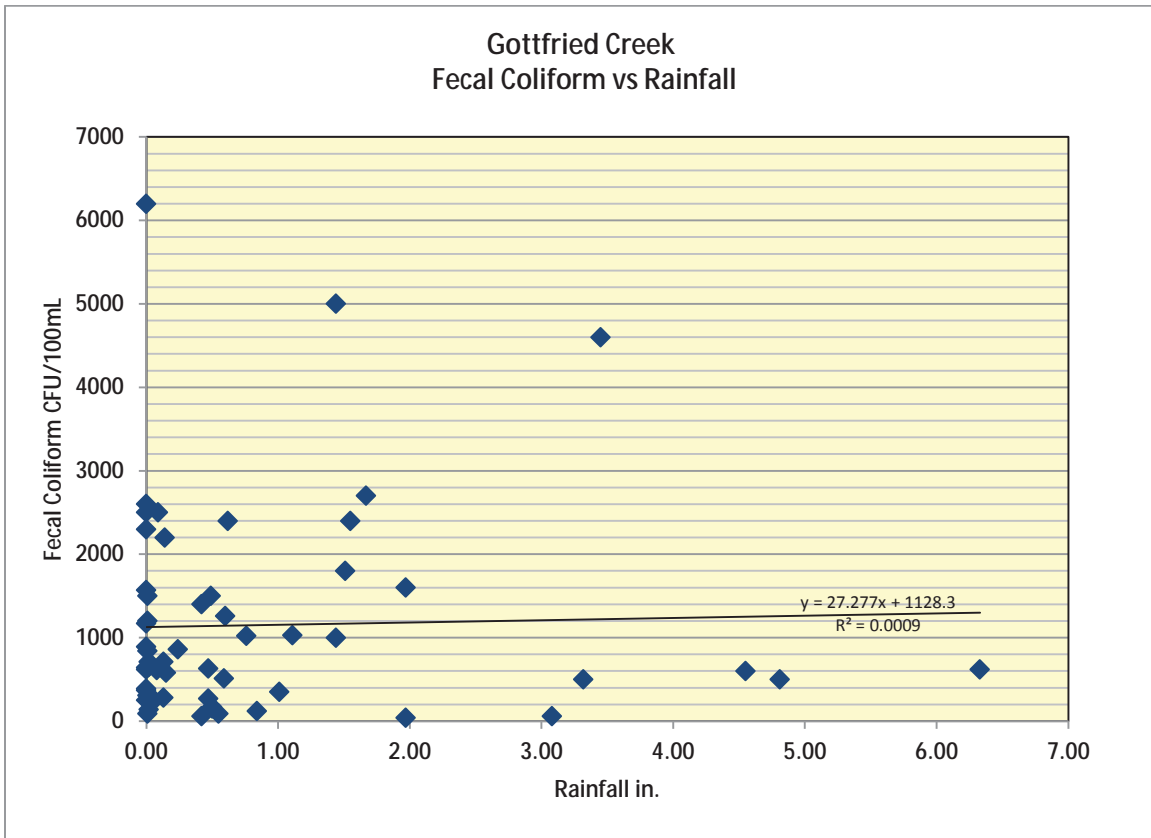
Figure 93. Fecal Coliform vs. Rainfall

Fecal coliform values did not correlate well with rainfall (Figure 111). Only 30% of the samples that exceeded 400 CFU were collected after a 7-day antecedent rainfall period where rainfall amounts were  $\geq 1$  inch; 70% of the samples that exceeded 400 CFU were collected after a 7-day antecedent rainfall period where rainfall amounts were  $\leq 1$  inch.

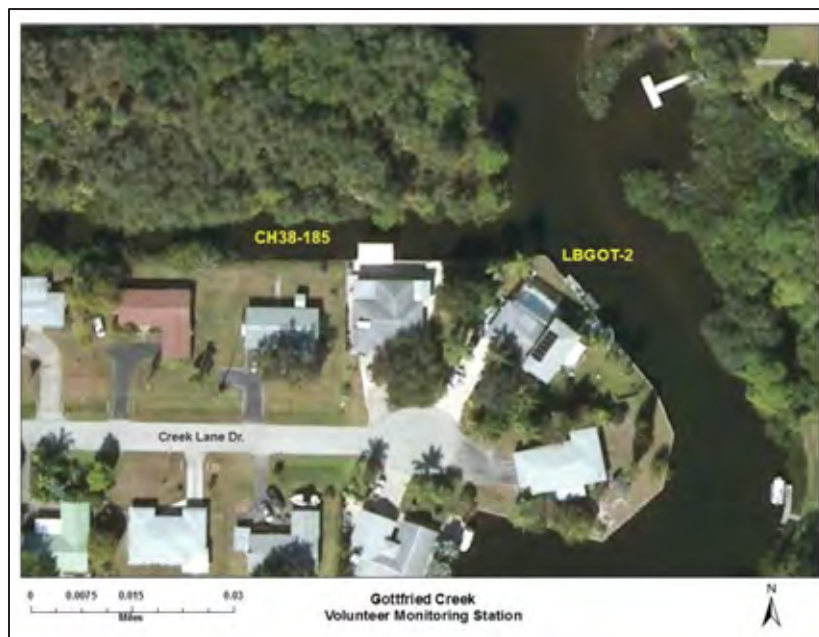
*Figure 94. Volunteer Water Quality Monitoring Station*

In addition to the preceding post-inspections, Sarasota County was asked to conduct an investigation to determine a possible explanation for consistently elevated fecal coliform values at a FDEP volunteer sampling station (LBGOT-2). The station is located at the volunteer’s residence which is on a corner lot bordered by Gottfried Creek and canal CH38-185 which flows from the west to the creek (Figure 90).

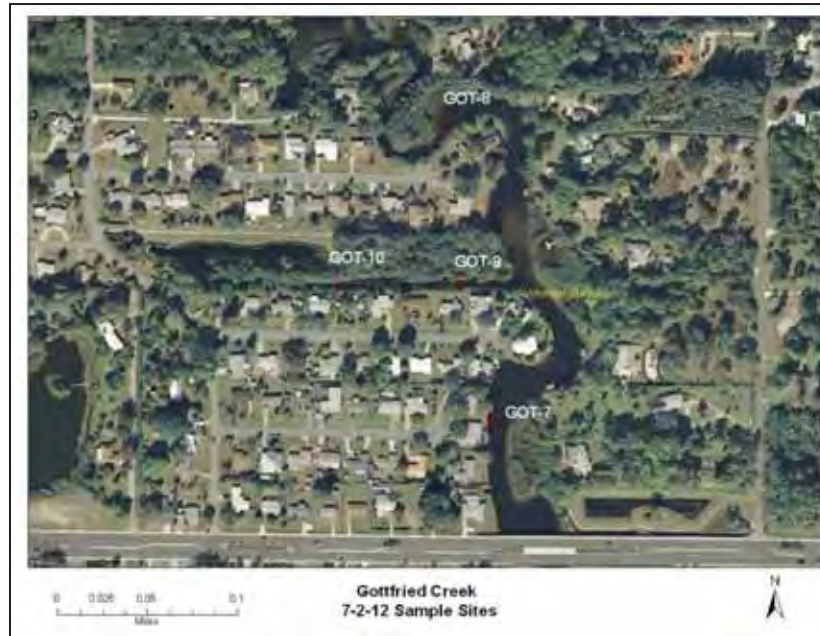
*Figure 95. Gottfried Creek Sample Sites 7-2-2012*

On July 2, 2012 Sarasota County staff collected 4 samples during an outgoing tide: GOT-7 downstream of the volunteer station; GOT-8 upstream of the sampling station; GOT-9 in CH38-185 approximately 50 ft. upstream of the Creek; and GOT-10 farthest accessible point upstream in CH38-185 (Figures 91-96).

The sample results were: GOT-7: 60 CFU/100mL; GOT-8: 250 CFU/100mL; GOT-9: 200 CFU/100mL; and GOT-10:300 CFU/100mL. The values did not exceed surface water quality standards on that date. It was determined that further investigation of the surrounding area was needed to try to determine a potential bacteria source.

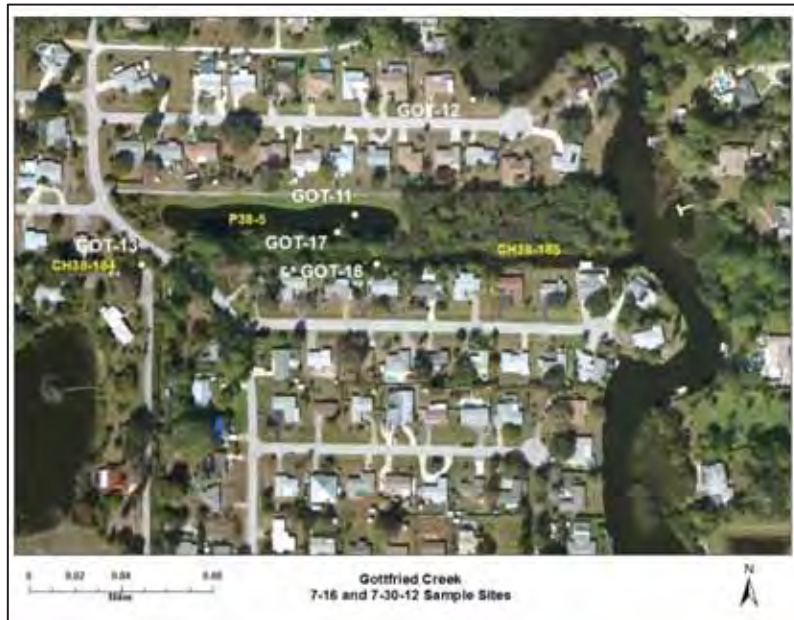
*Figure 101. Gottfried Creek Sample Sites 7-16 and 7-30-2012.*

A review of aerial maps showed that stormwater pond DP38-5 located adjacent to and north of canal CH38-185 collected and treated stormwater runoff from the surrounding area that ultimately discharged to the canal near the western end. Also, a stormwater ditch CH38-184, upstream of the pond and canal, flowed from the west to pond CP38-5 during periods of high flow. It bypasses pond DP38-5 during periods of low flow and flows directly into the west end of canal CH38-185. On July 16, 2012 county staff collected samples from stormwater pond P38-5 (GOT-11), ditch CH38-184 (GOT-13) upstream of the pond, and Gottfried Creek (GOT-12) upstream of the volunteer station (Figure 97).

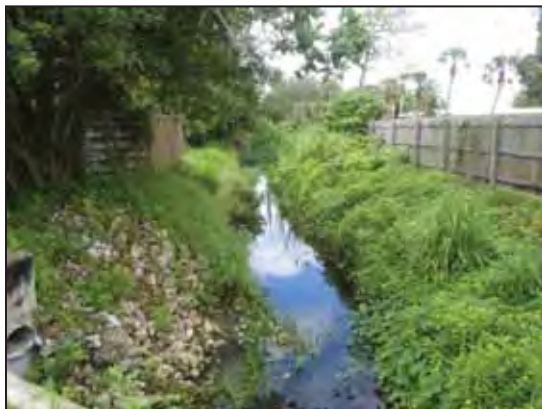
*Figure 102. Stormwater Ditch DP38-184.*

Sample Site GOT-13

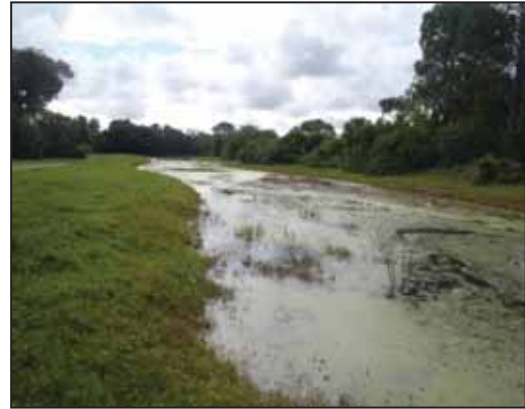
*Figure 105. Stormwater Pond DP38-5*

Figures 98-107 include photos of the sample site location. The water level in the pond (Figure 101) was low and aquatic vegetation, including hydrilla, an exotic invasive aquatic plant, had almost completely overtaken the pond bottom. The surface was covered with duck weed, which is indicative of high nutrient low flow conditions. A number of wading birds that included 2 Great Blue Herons, 1 Little Blue Herons, 2 Glossy Ibis, and 12 (4 adults and 8 juveniles) moorhens inhabited the pond. No alligators or other wildlife were observed. Sample GOT-12 was taken directly from the creek (Figure 107) upstream of the volunteer station. The water level in the ditch (Figure 102) was very low, and there was little flow. The west end of the canal is completely shaded and overgrown with heavy, entangled vegetation that consists mostly of Brazilian Pepper. A resident also reported that the canal was home to a large alligator that could be a contributor by stirring up bacteria laden sediments.

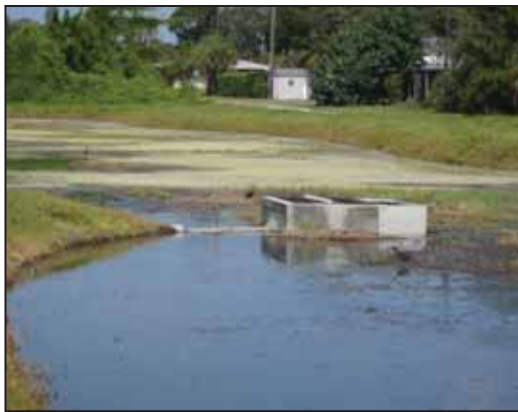
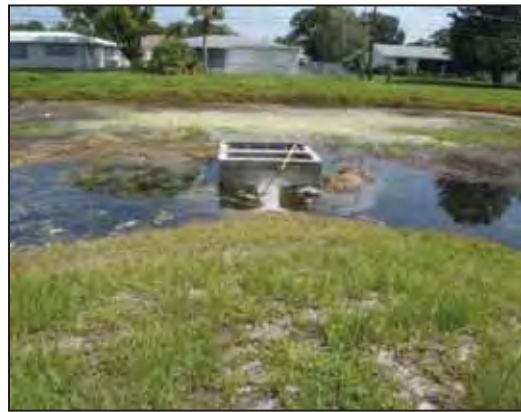
*Figure 106. Stormwater Pond DP38-5.*

Sample Site GOT-11. View West to East  
*Figure 107. Stormwater Pond DP38-5*

View East to West

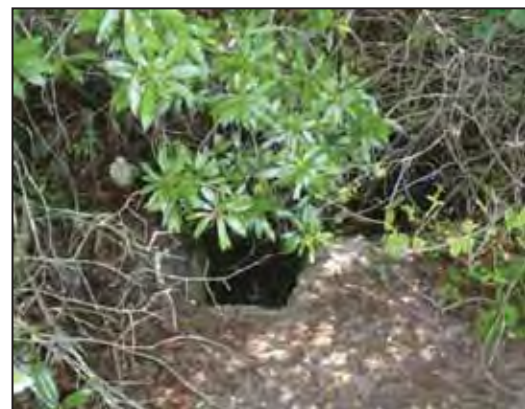
*Figure 109. Outfall to Canal*

Flow from outlet structure to canal

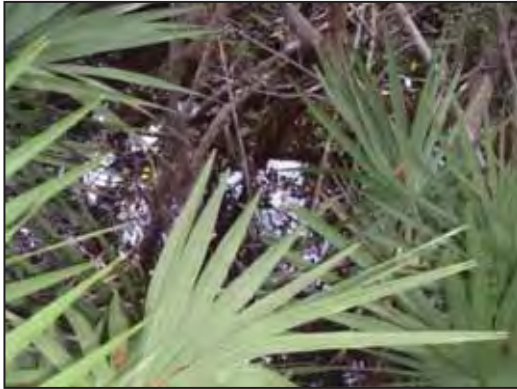
*Figure 110. Ditch Downstream of Pond Outfall*

Sample Site GOT-16

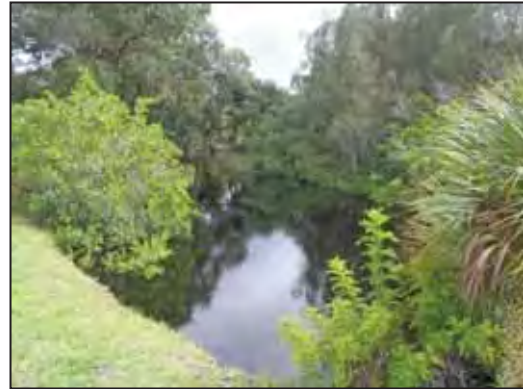
*Figure 111. Gottfried Creek Upstream of Canal*

Sample Site GOT-12

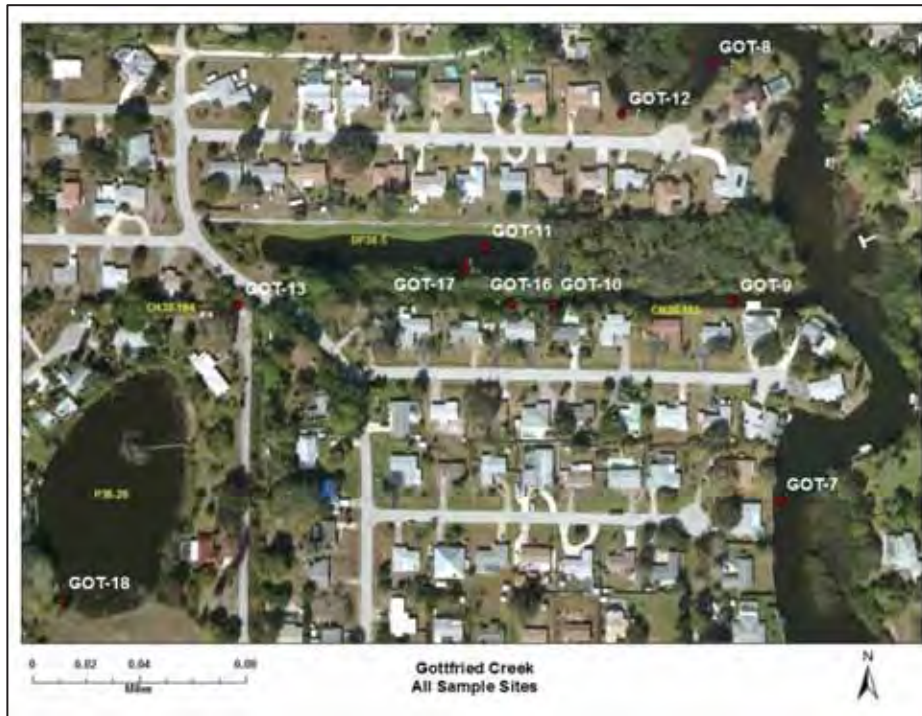
Figure 112. All Sample Sites.

The sample results were: GOT-13: 2700 CFU/100mL; GOT-16: 2800 CFU/100mL; and GOT-17: 19000 CFU/100mL. These results appeared to indicate that birds and wildlife in the pond could be contributing to the higher fecal coliform values. It also appears that the pond is providing some treatment since the levels in the ditch were 2,800 CFU/100mL. The shoreline on both sides of the ditch from the pond to approximately 525 upstream of Gottfried Creek is so heavily vegetated that very little sunlight can penetrate the canopy to afford adequate UV light treatment of the bacteria. This could be also contributing to the bacteria spikes in the volunteer samples. Approximately 1.41 inches of rain had also fallen in the area since July 2, 2012.

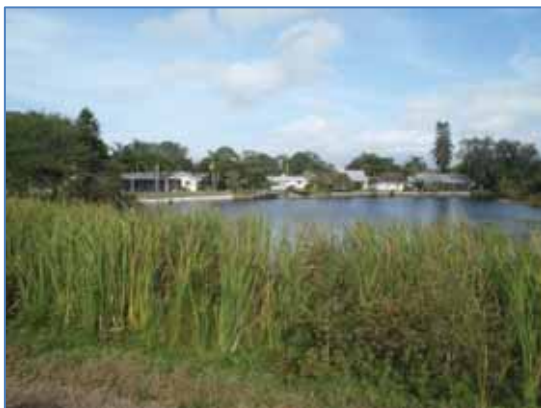
Figure 113. Pond 38-20; Sample Site GOT-18

Staff could not return until October to take additional samples. Samples were again collected from GOT-13, GOT-16, and GOT-17. An additional station (GOT-18) was added since staff was able to collect a sample from the stormwater pond P38-20 on Dearborn Avenue (Figure 109). The sample results were: GOT-13: 1700 CFU/100mL; GOT-16: 450 CFU/100mL; GOT-17: 200 CFU/100mL; and GOT-18: 170 CFU/100mL.

The bacteria levels in pond P38-20 were below standards; however, they increased in ditch CH38-134. The levels in pond P38-5 were also below standards which is an indication that runoff is receiving sufficient treatment for bacteria reduction. The levels increased slightly in canal CH38-185.
