West-Central Florida Tidal Stream Assessment Study

Prepared for the Sarasota Bay Estuary Program by the Florida Center for
Community Design and Research at the University of South Florida

December 10, 2013

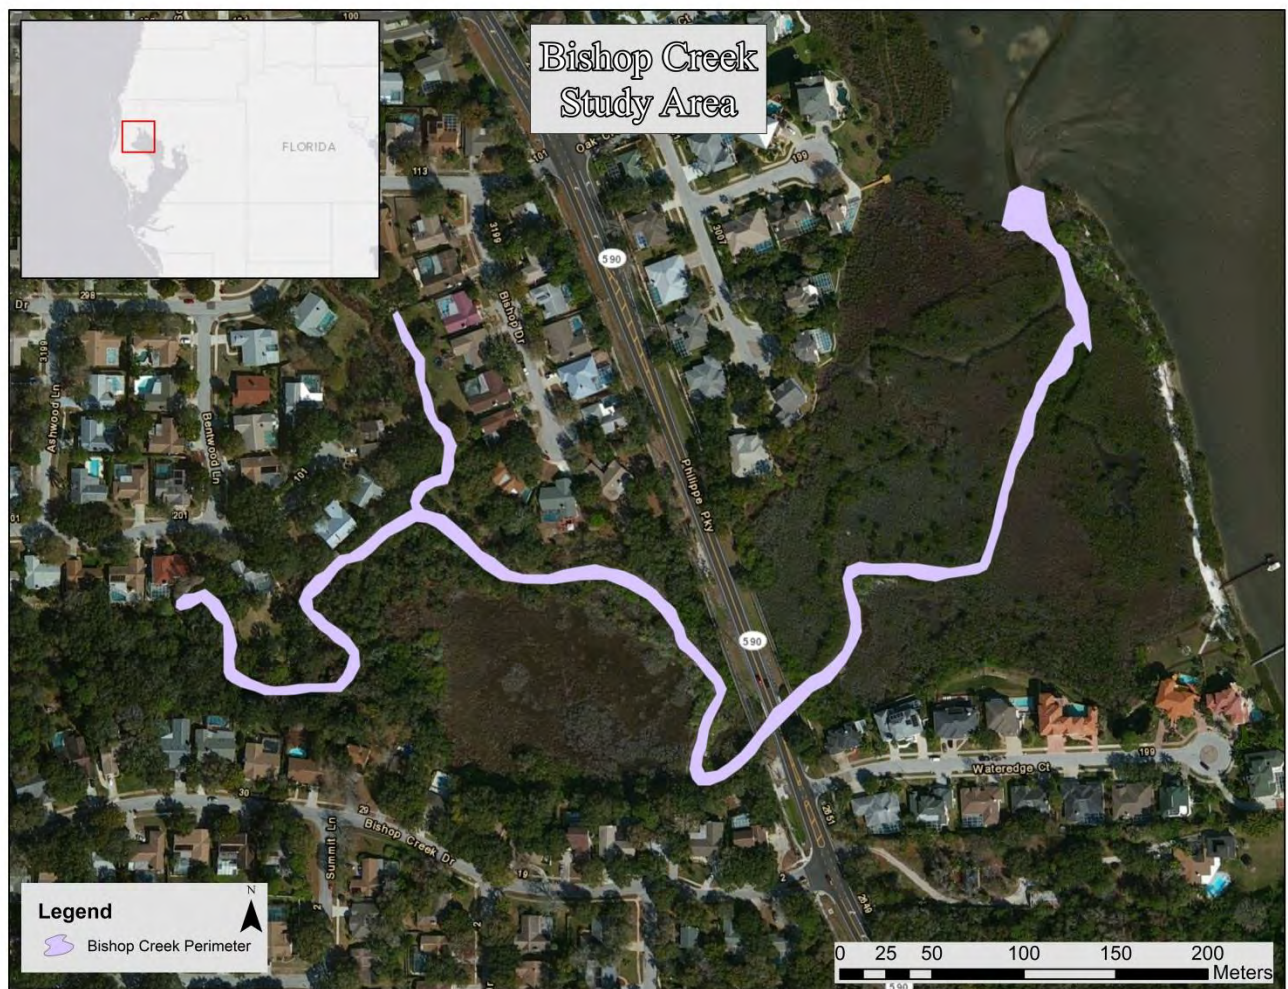
Figure 6. Bishop Creek Study Area

Bishop Creek is located in northern Pinellas County where it flows into Old Tampa Bay. Bishop Creek's watershed is highly urbanized having a watershed LDI value of 7.0 and is comprised of residential and commercial land uses. The creek is split into two upstream branches both of which flow through residential areas with some vegetation along the creek. The upstream portion of the creek has been altered and has steep ditch like banks. The lower portion of Bishop Creek, after the two branches converge, becomes more natural before it flows into Old Tampa Bay. The area immediately adjacent to the creek has a buffer LDI value of 5.6.

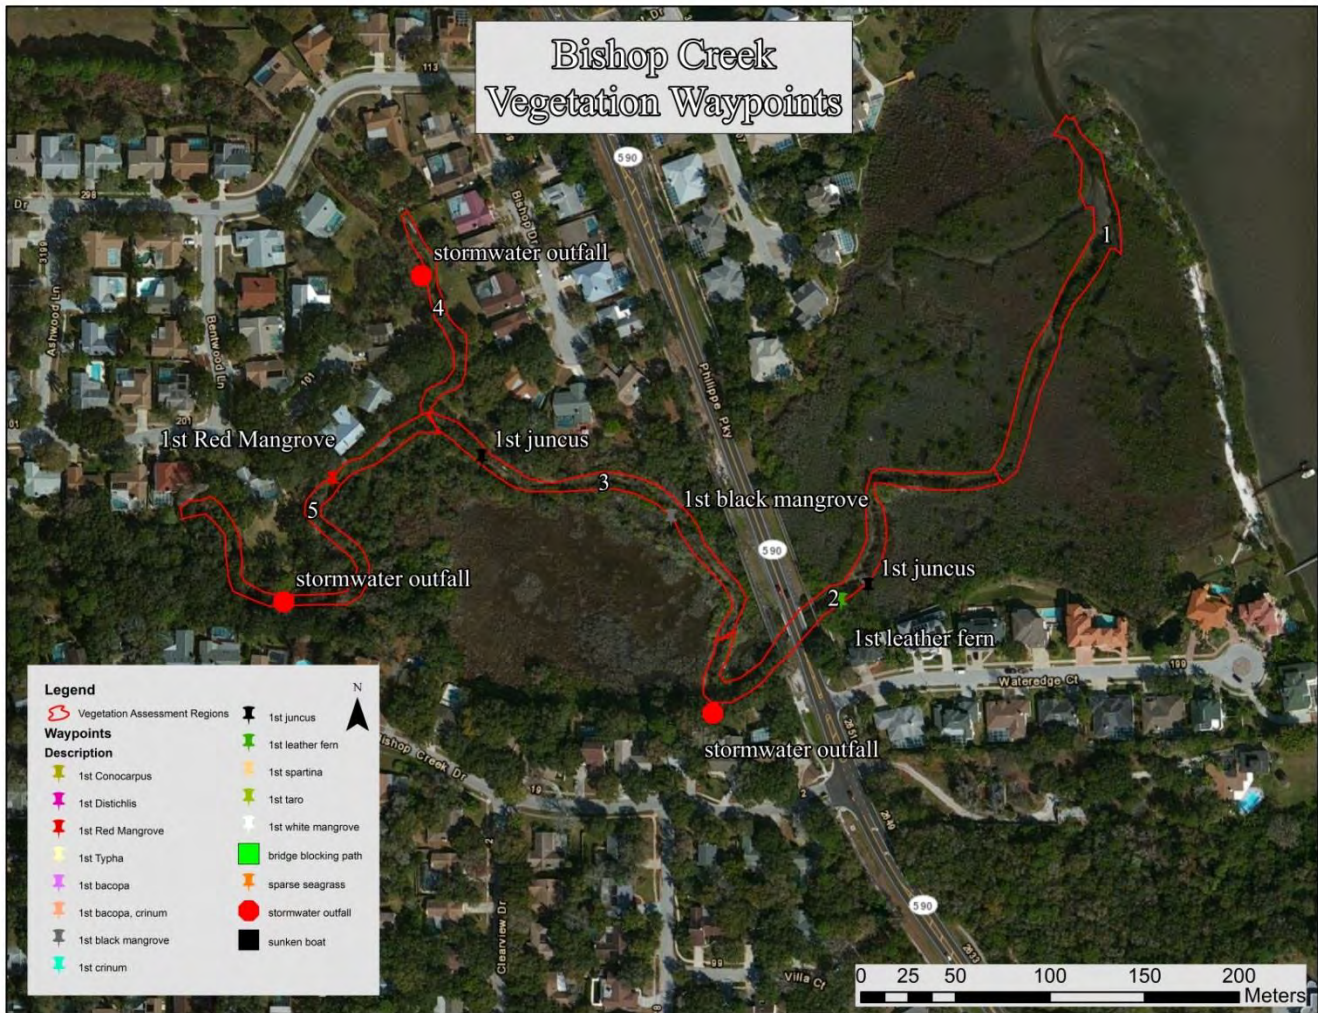
Figure 8. Bishop Creek Vegetation Waypoints

Figure 8 shows the vegetation transition zone of Bishop Creek indicating the most upstream Red Mangrove and Black Mangrove as well as the most downstream Leather Fern and *Juncus*. Based on the vegetation assessment data for Bishop Creek, regions 1 through 2 would comprise the highest salinity and tidal influence zone, Region 3 would comprise the “mixing” zone and regions 4 and 5 would comprise the freshwater dominant zone. The vegetation assessment species list is shown in Table 2.

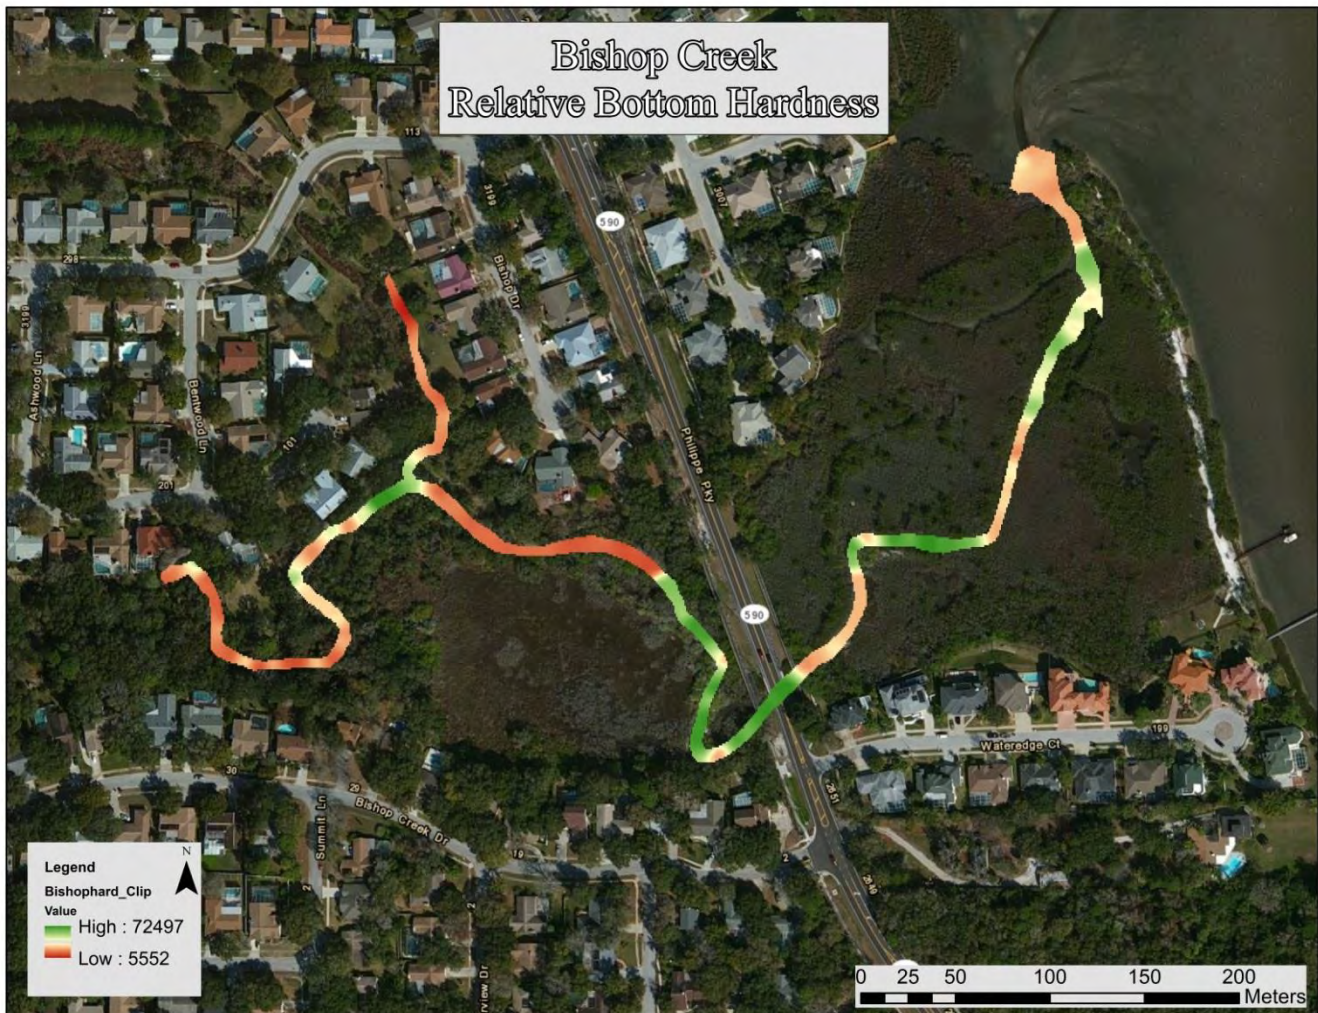
Figure 9. Bishop Creek Relative Bottom Hardness Map

Collected sonar data was processed through Dr. Depth software to analyze the strength of the return signal from the bottom to get an estimate of the relative bottom hardness for Bishop Creek. Figure 9 shows the bottom hardness raster for Bishop Creek. This map is meant to help identify locations of harder and softer bottoms for benthic invertebrate sampling, fish sampling and benthic chlorophyll sampling. The higher the hardness value, the harder the bottom substrate.

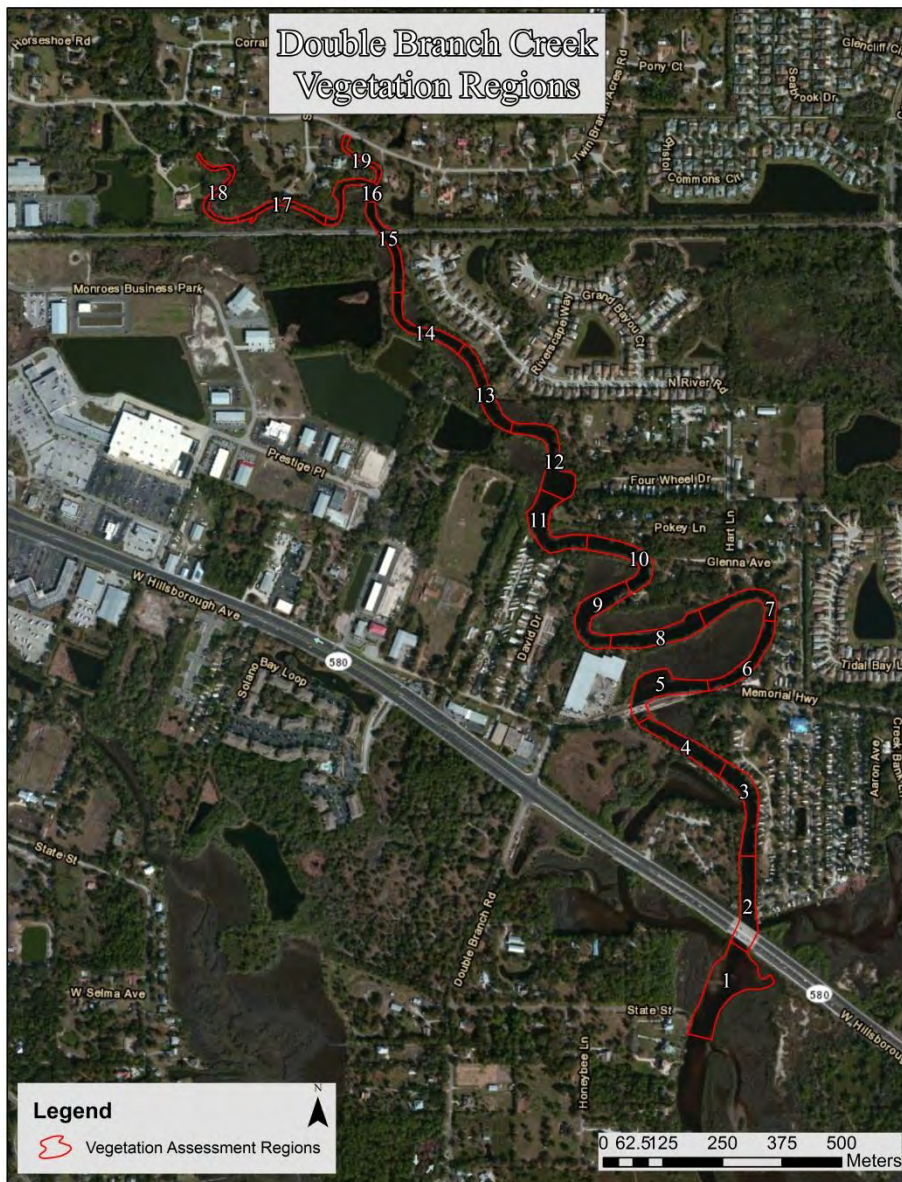
Figure 12. Overview of Double Branch Creek Vegetation Assessment Regions

The Double Branch Creek vegetation assessment encompassed 19 vegetation regions from the mouth in Old Tampa Bay to the Twin Branch Acres Road as shown in Figure 12. In these regions, 47 species of vegetation were identified. Regions 1 through 8 were dominated by mangroves (*Rhizophora mangle*, *Laguncularia racemosa* and *Avicennia germinans*) with few other salt tolerant species present. The first occurrence of Leather Fern (*Acrostichum danaeifolium*) was in Region 8. Needle Rush (*Juncus roemerianus*) was first observed in Region 3, becoming dominant in regions 5 and 9 through 17. Above Region 14 the vegetation communities are more frequently dominated by Brazilian Pepper (*Schinus terebinthifolius*) and Live Oak (*Quercus virginiana*).

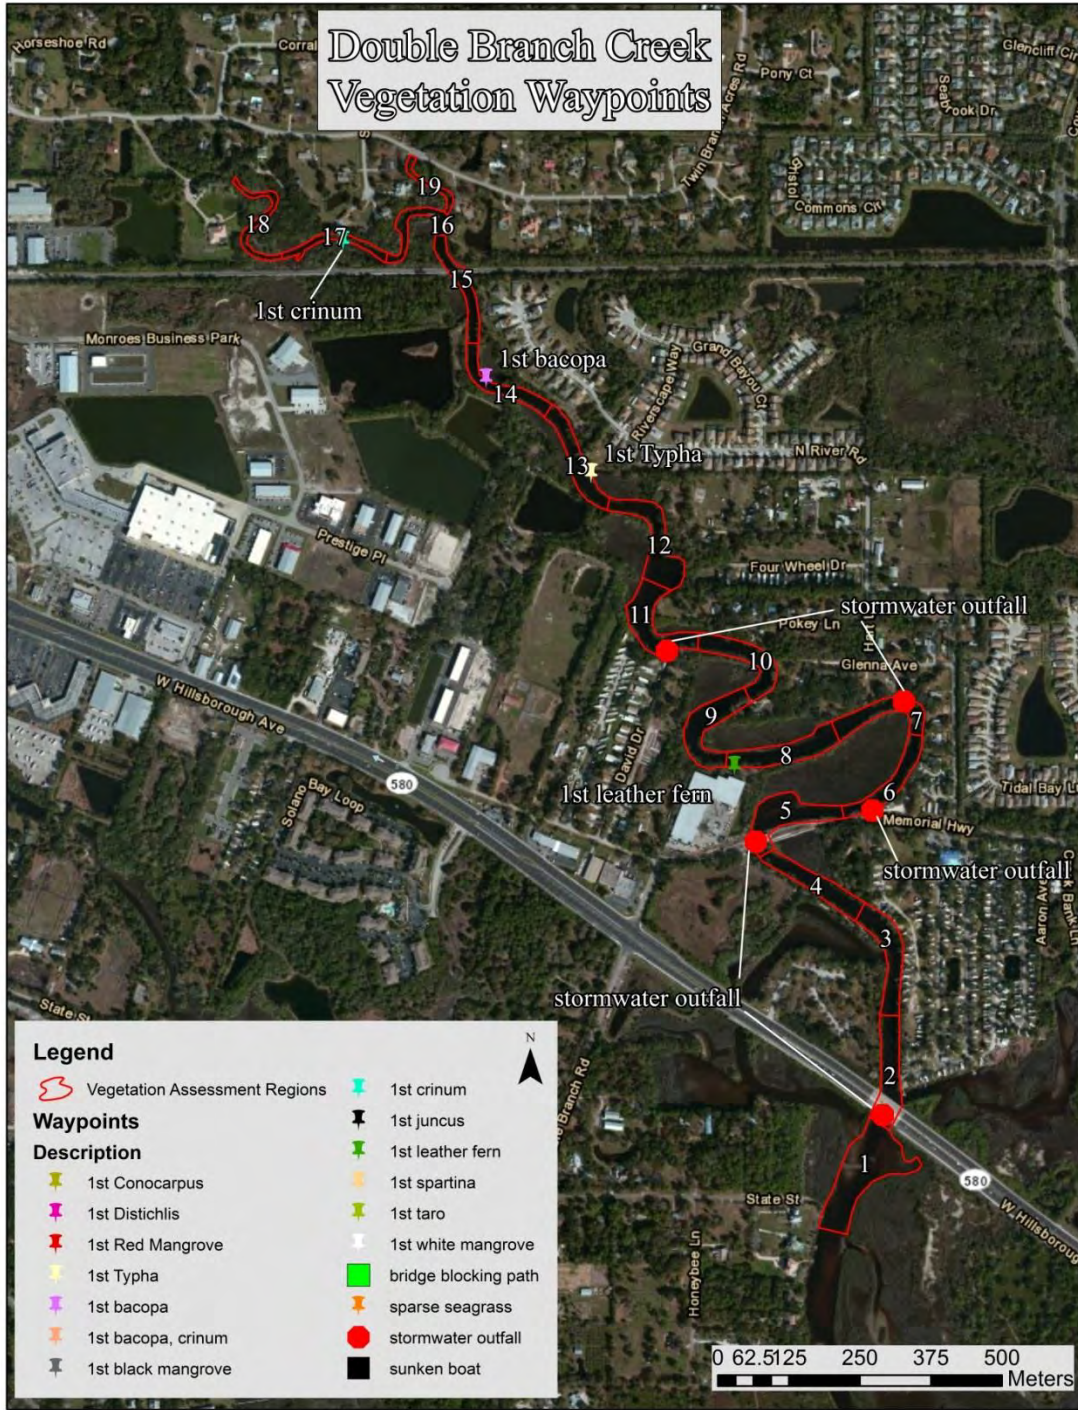
Figure 13. Double Branch Creek Vegetation Waypoints

Figure 13 shows the vegetation transition zone of Double Branch Creek indicating the most downstream Leather Fern, *Bacopa*, *Crinum* and *Typha*. Based on the vegetation assessment data for Double Branch Creek, regions 1 through 8 would comprise the highest salinity and tidal influence zone, regions 9 through 14 would comprise the “mixing” zone and regions 15 through 19 would comprise the freshwater dominant zone. The vegetation assessment species lists are shown in Table 3.

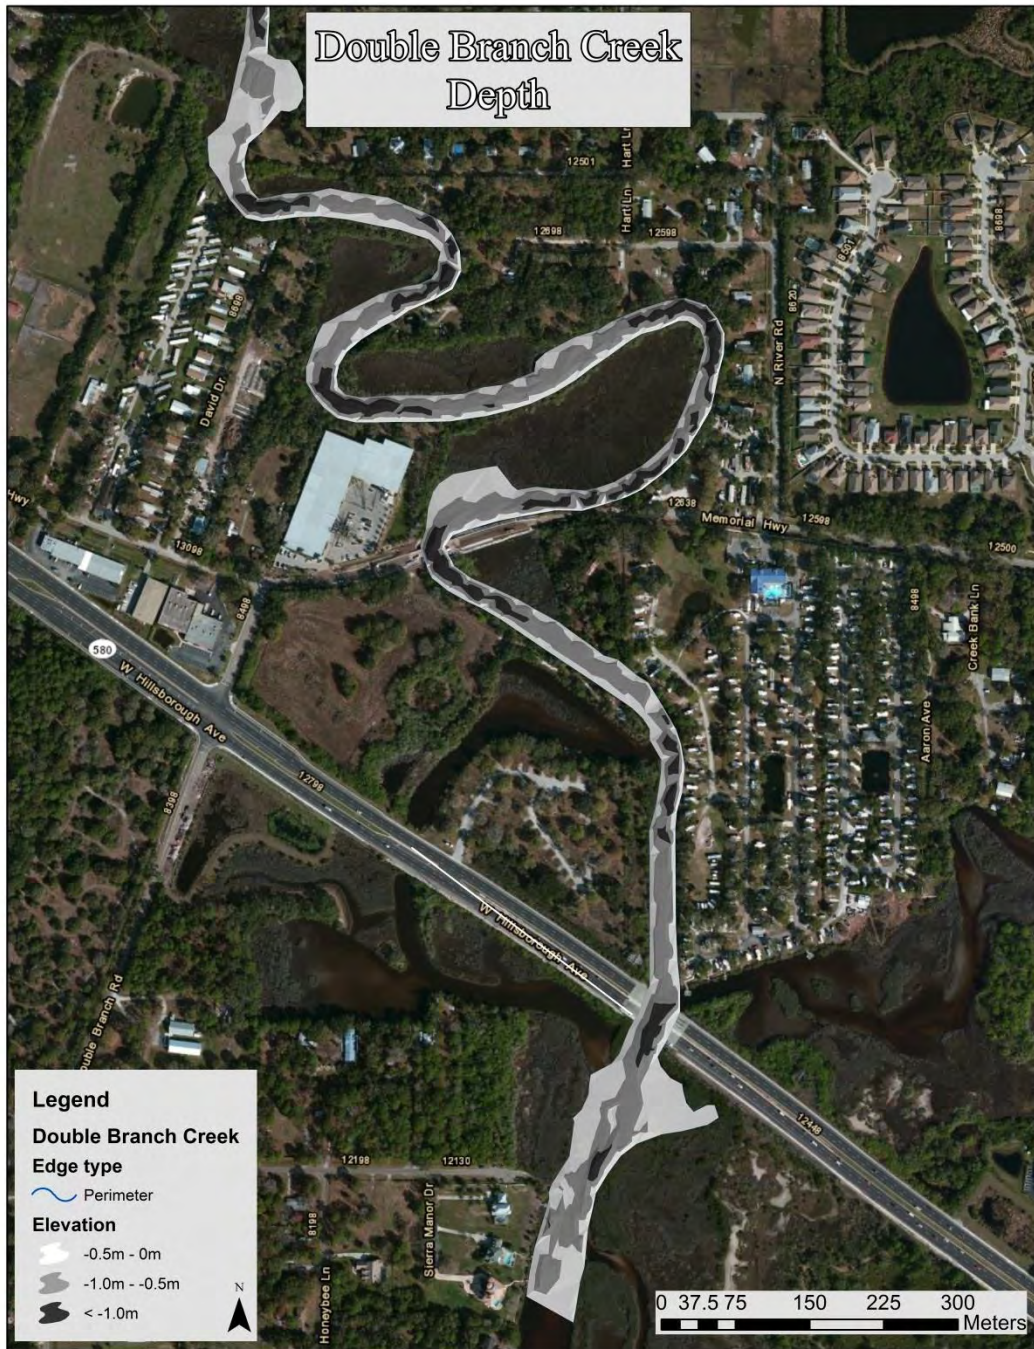
Figure 15. Double Branch Creek Bathymetric Stratum Map (1 of 2)

In the study area, Double Branch Creek had a mean depth of 3.43 feet and a maximum depth of 12.53 feet. A total of 25.64 acres of creek was mapped during the assessment. At the time of assessment, Double Branch Creek contained an estimated 15,610,182 gallons of water in the study area. Figure 15 and Figure 16 detail the bathymetric mapping for Double Branch Creek showing the three depth stratum.

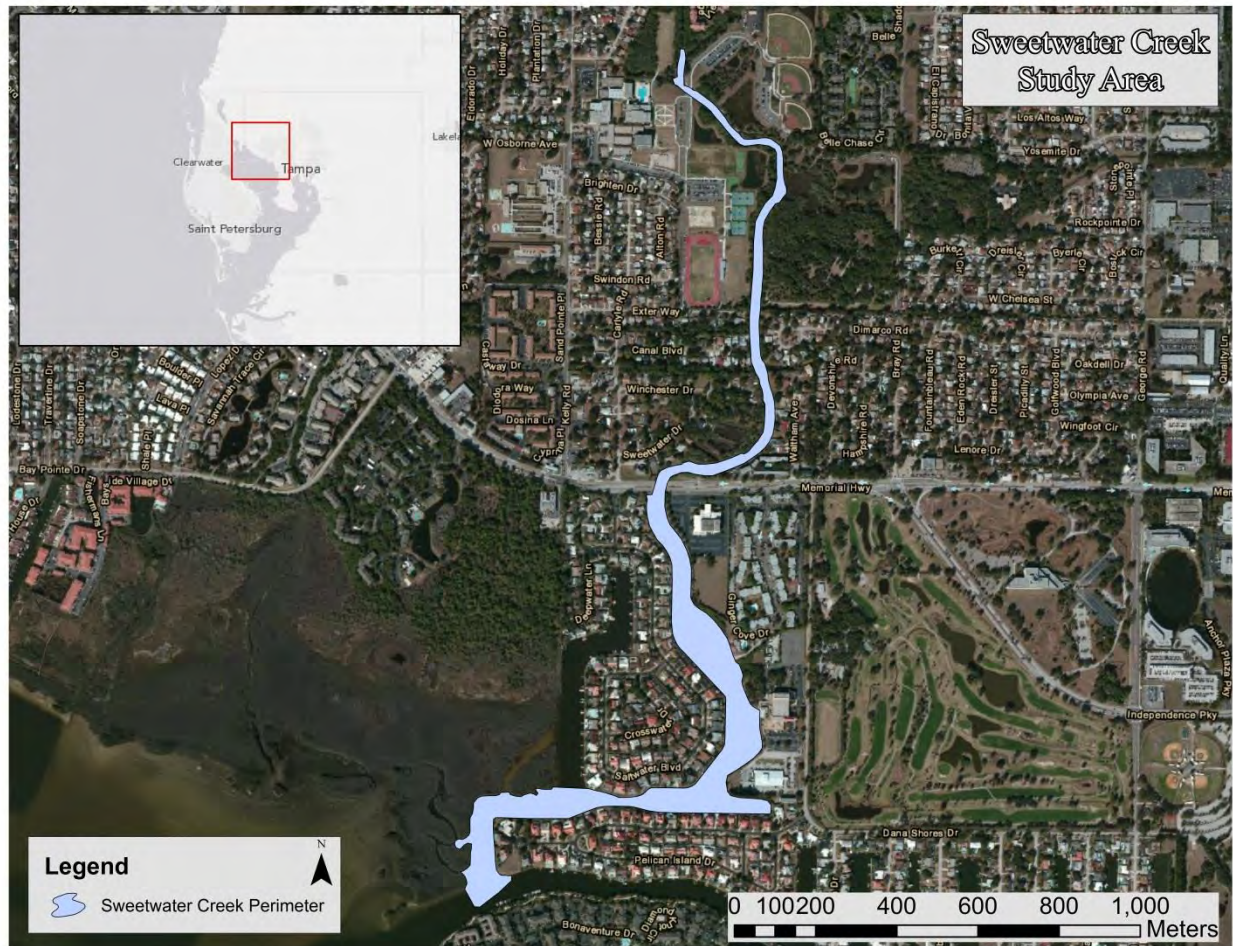
Figure 17. Overview of the Sweetwater Creek Study Area

Sweetwater Creek has a highly urbanized watershed with residential, industrial, and commercial land use. This creek is located in Hillsborough County where Tampa and Town 'n' Country meet. The upstream portion of the Sweetwater Creek is highly ditched with steep banks and little vegetation buffering the creek. As you move down the creek the creek becomes more natural with less sloping banks and more natural vegetation. As Sweetwater Creek passes under Memorial Highway the natural banks become sea walled and the creek becomes deeper until it forms into a channel.

The watershed for Sweetwater Creek has a LDI value of 7.2 from the urbanization in the surrounding areas. Sweetwater Creek flows into the northeast corner of Old Tampa Bay on the backwater side of the Courtney Campbell Causeway. Sweetwater creek is a highly urbanized system and has one of the highest buffer LDI values of the creeks selected at 6.7.

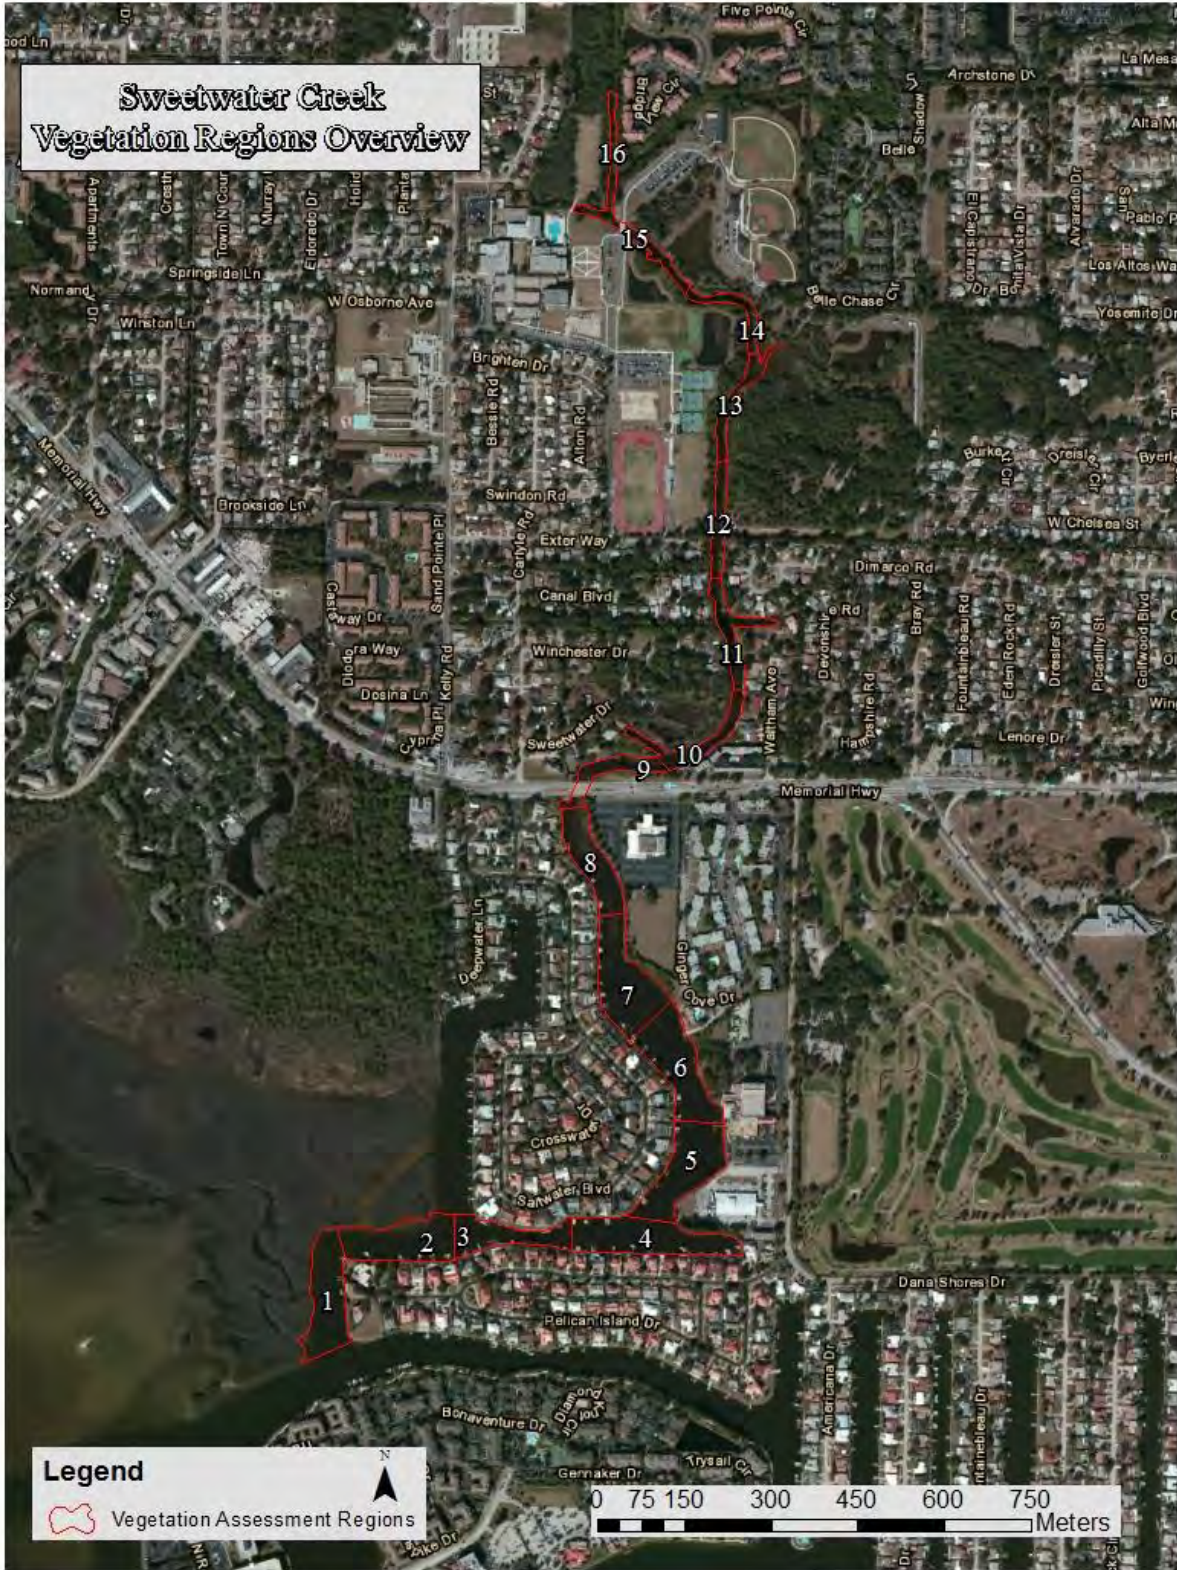
Figure 18. Overview of Sweetwater Creek Vegetation Assessment Regions

The Sweetwater Creek vegetation assessment encompassed 16 vegetation regions from the mouth in Old Tampa Bay to below SR 580 as shown in Figure 18. In these regions, 48 species of vegetation were identified. Regions 1 through 11 were dominated by mangroves (*Rhizophora mangle* and *Laguncularia racemosa*) with few other salt tolerant species present. The most upstream mangrove was *Laguncularia racemosa* in Region 16. The first occurrence of Leather Fern (*Acrostichum danaeifolium*) was in Region 11, becoming dominant in Region 14. Needle Rush (*Juncus roemerianus*) was first observed in Region 2 with the last occurrence in Region 16. Above Region 15 the vegetation communities are populated by many species indicative of dominating freshwater influence, predominantly Brazilian Pepper.

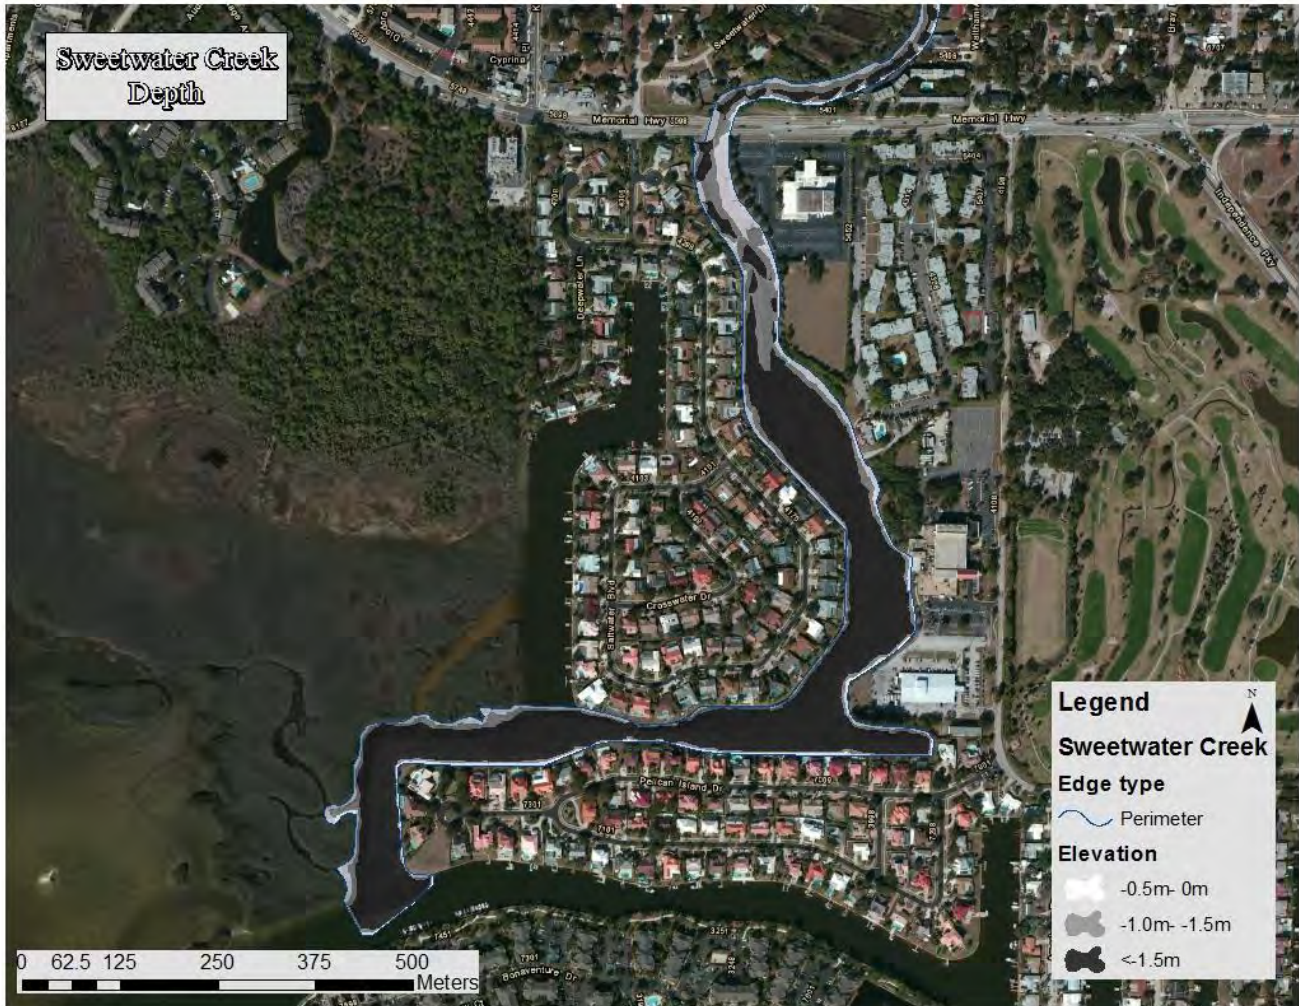
Figure 21. Sweetwater Creek Bathymetric Stratum Map (1 of 2)

In the study area, Sweetwater Creek had a mean depth of 5.16 feet and a maximum depth of 14.01 feet. A total of 34.72 acres of creek was mapped during the assessment. At the time of assessment, Sweetwater Creek contained an estimated 49,613,510 gallons of water in the study area. Figure 21 and Figure 22 detail the bathymetric mapping for Sweetwater Creek showing the three depth stratum.

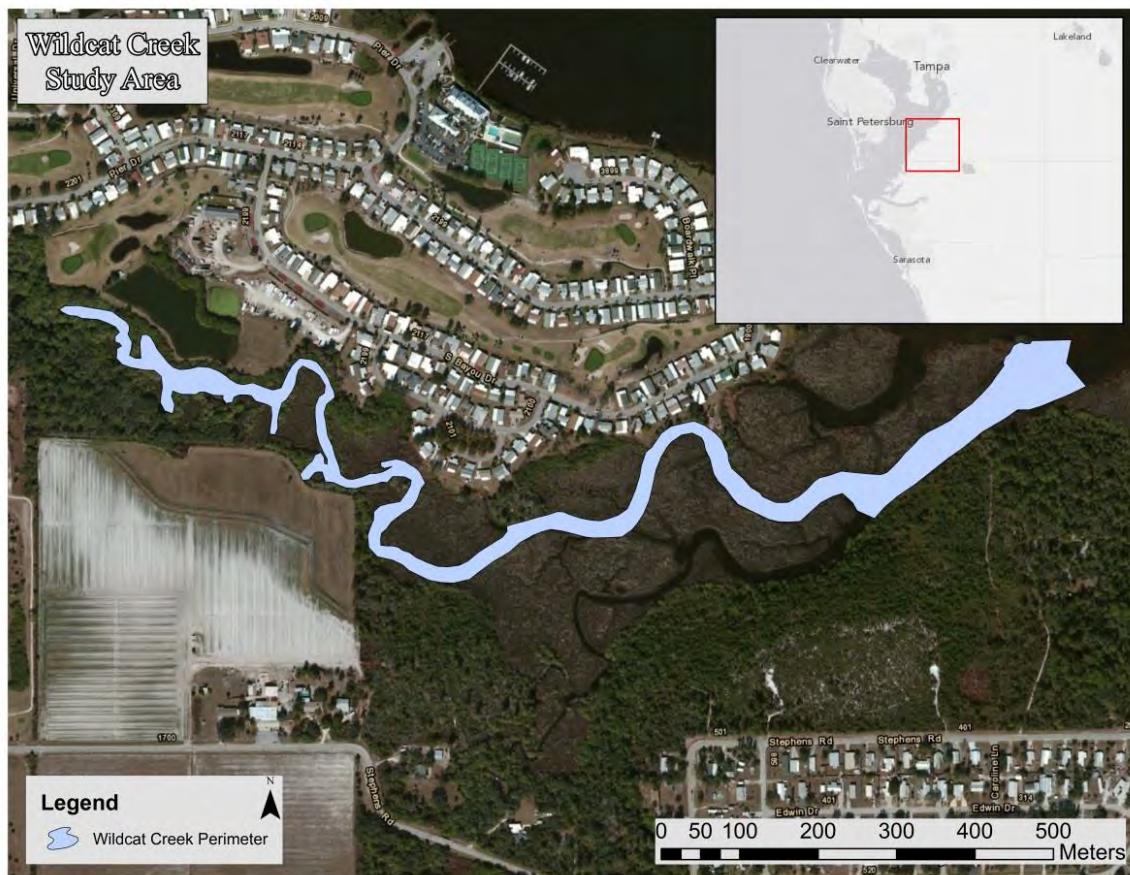
Figure 23. Overview of the Wildcat Creek Study Area

Wildcat Creek is a tributary to the Little Manatee River with a watershed that is largely made up of agricultural and natural land use switching to urban only on the one side of the creek in downstream portion. The watershed of Wildcat Creek is a more “natural” system with few obvious hydrologic changes with a LDI value of 3.8. The banks of the creek are not ditched and are gradually sloping with a large buffer of natural vegetation. Wildcat creek’s urbanized land use is to the north downstream consists of medium density residential and a golf course. Wildcat Creek flows through 20 acres of marsh in Hillsborough County into the Little Manatee River approximately 4.5 miles upstream from Middle Tampa Bay. This system is one of the only creeks with a watershed that is dominated by agriculture. Wildcat creek also has one of the lowest buffer LDI values at 1.5.

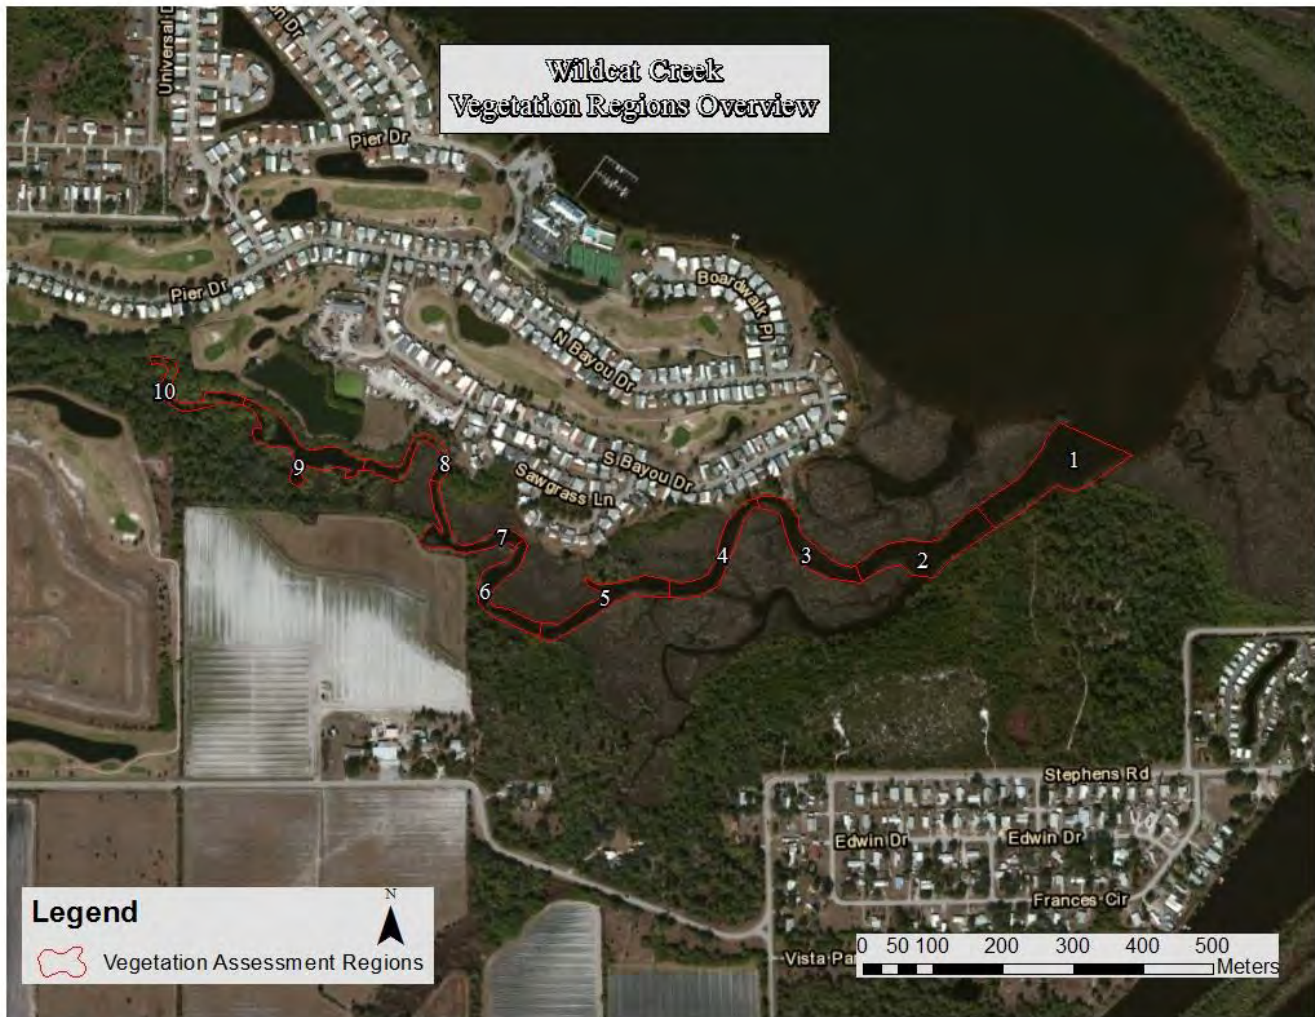
Figure 24. Overview of Wildcat Creek Vegetation Assessment Regions

The Wildcat Creek vegetation assessment encompassed 10 vegetation regions from the mouth in Hayes Bayou as shown in Figure 24. In these regions, 43 species of vegetation were identified. Regions 1 through 9 were dominated by Needle Rush (*Juncus roemerianus*) with few other salt tolerant species present. The most upstream mangrove was Red Mangrove (*Rhizophora mangle*) in Region 8. The first occurrence of Leather Fern (*Acrostichum danaeifolium*) was in Region 1, becoming dominant in regions 7-10. Above Region 8 the vegetation communities are populated by many species indicative of dominating freshwater influence.

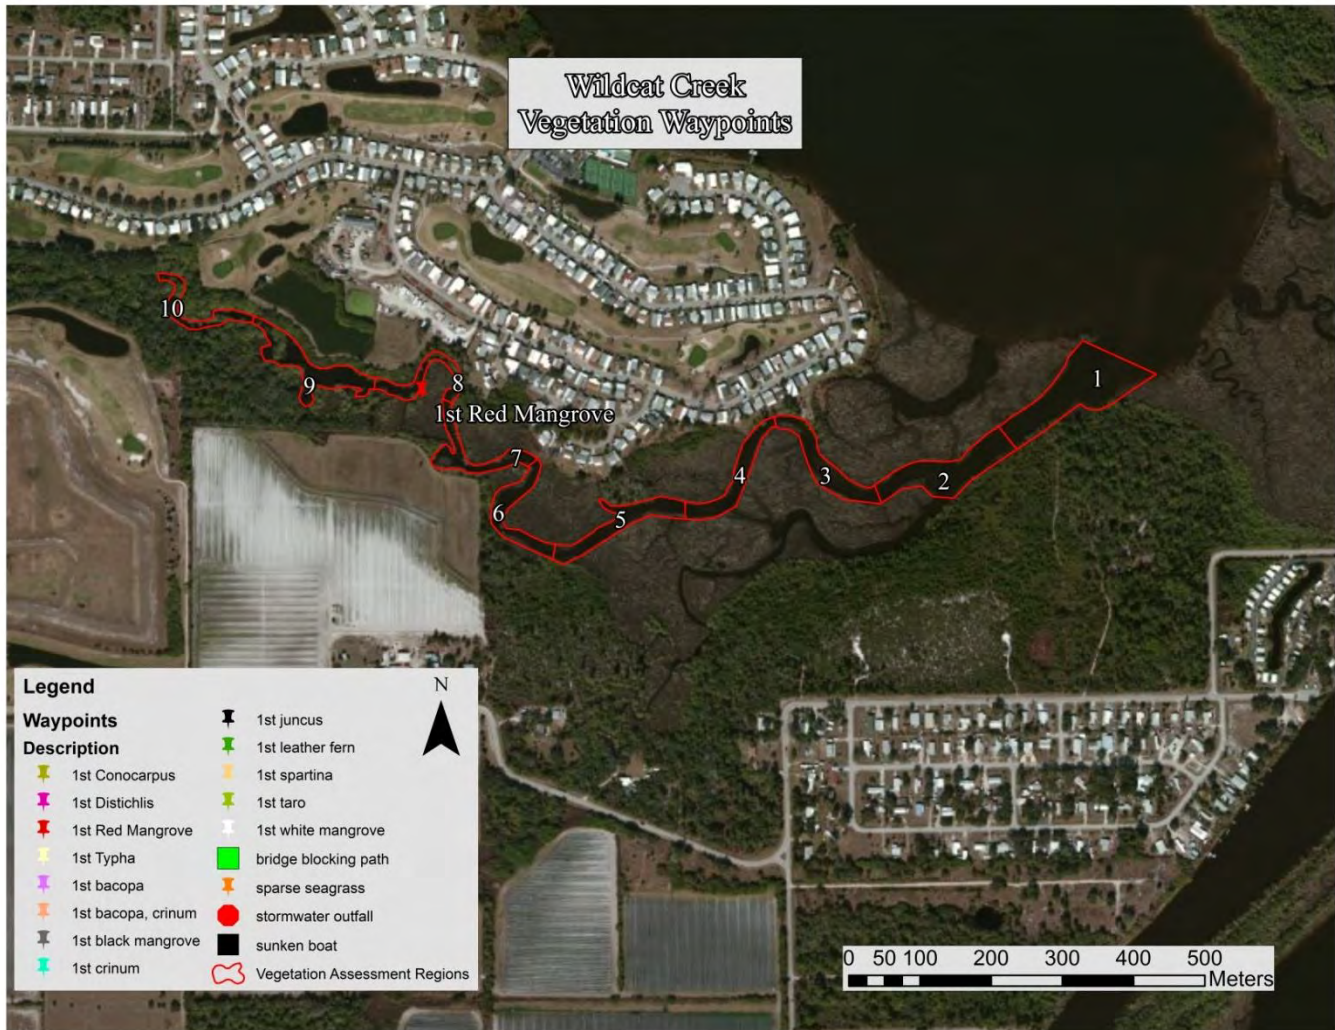
Figure 25. Wildcat Creek Vegetation Waypoints

Figure 25 shows the vegetation transition zone of Wildcat Creek indicating the most upstream Red Mangrove. Based on the vegetation assessment data for Wildcat Creek, regions 1 through 5 would comprise the highest salinity and tidal influence zone, regions 6 through 9 would comprise the “mixing” zone and above Region 9 would comprise the freshwater dominant zone. The vegetation assessment species list is shown in Table 5.

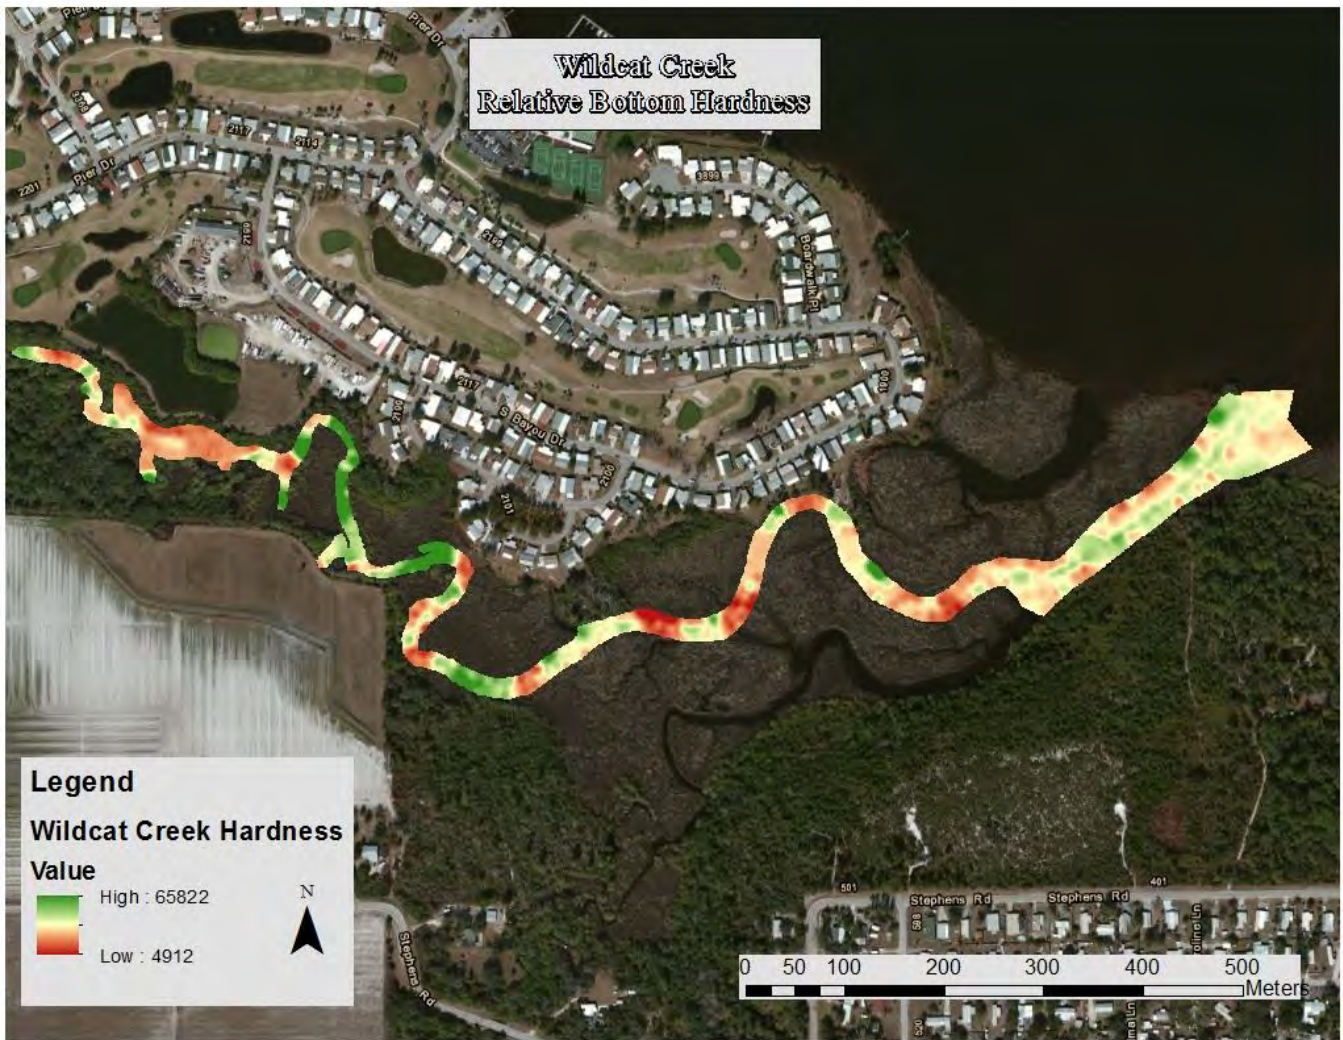
Figure 26. Wildcat Creek Relative Bottom Hardness Map

Collected sonar data was processed through Dr. Depth software to analyze the strength of the return signal from the bottom to get an estimate of the relative bottom hardness for Wildcat Creek. Figure 26 shows the bottom hardness raster for Wildcat Creek. This map is meant to help identify locations of harder and softer bottoms for benthic invertebrate sampling, fish sampling and benthic chlorophyll sampling.

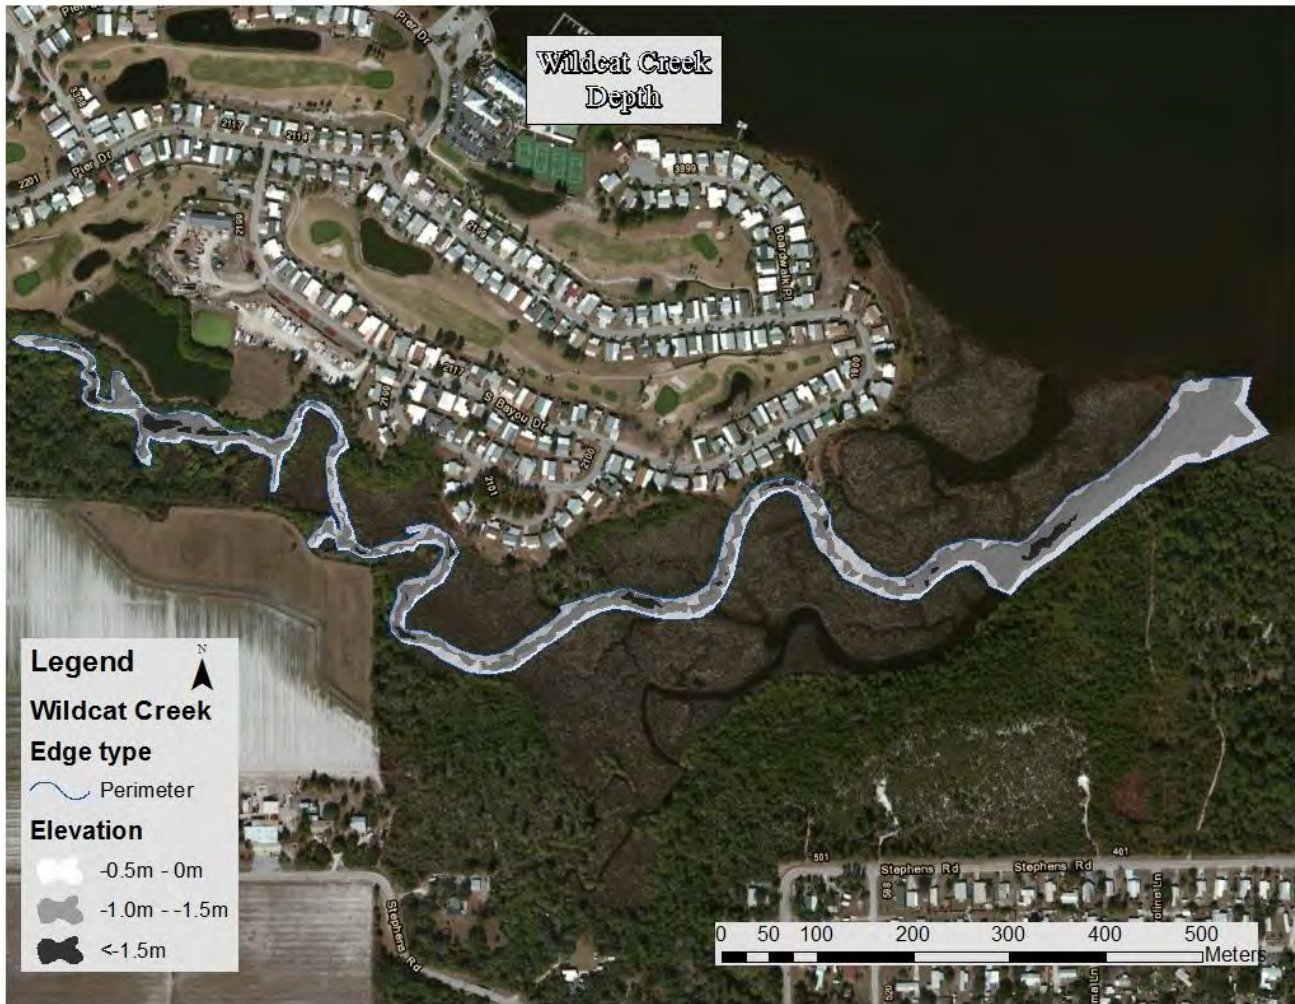
Figure 27. Wildcat Creek Bathymetric Stratum Map

In the study area, Wildcat Creek had a mean depth of 2.37 feet and a maximum depth of 7.72 feet. A total of 12.06 acres of creek was mapped during the assessment. At the time of assessment, Wildcat Creek contained an estimated 6,913,642 gallons of water in the study area. Figure 27 details the bathymetric mapping for Wildcat Creek showing the three depth stratum.
