West-Central Florida Tidal Stream Assessment Study

Prepared for the Sarasota Bay Estuary Program by the Florida Center for
Community Design and Research at the University of South Florida

December 10, 2013

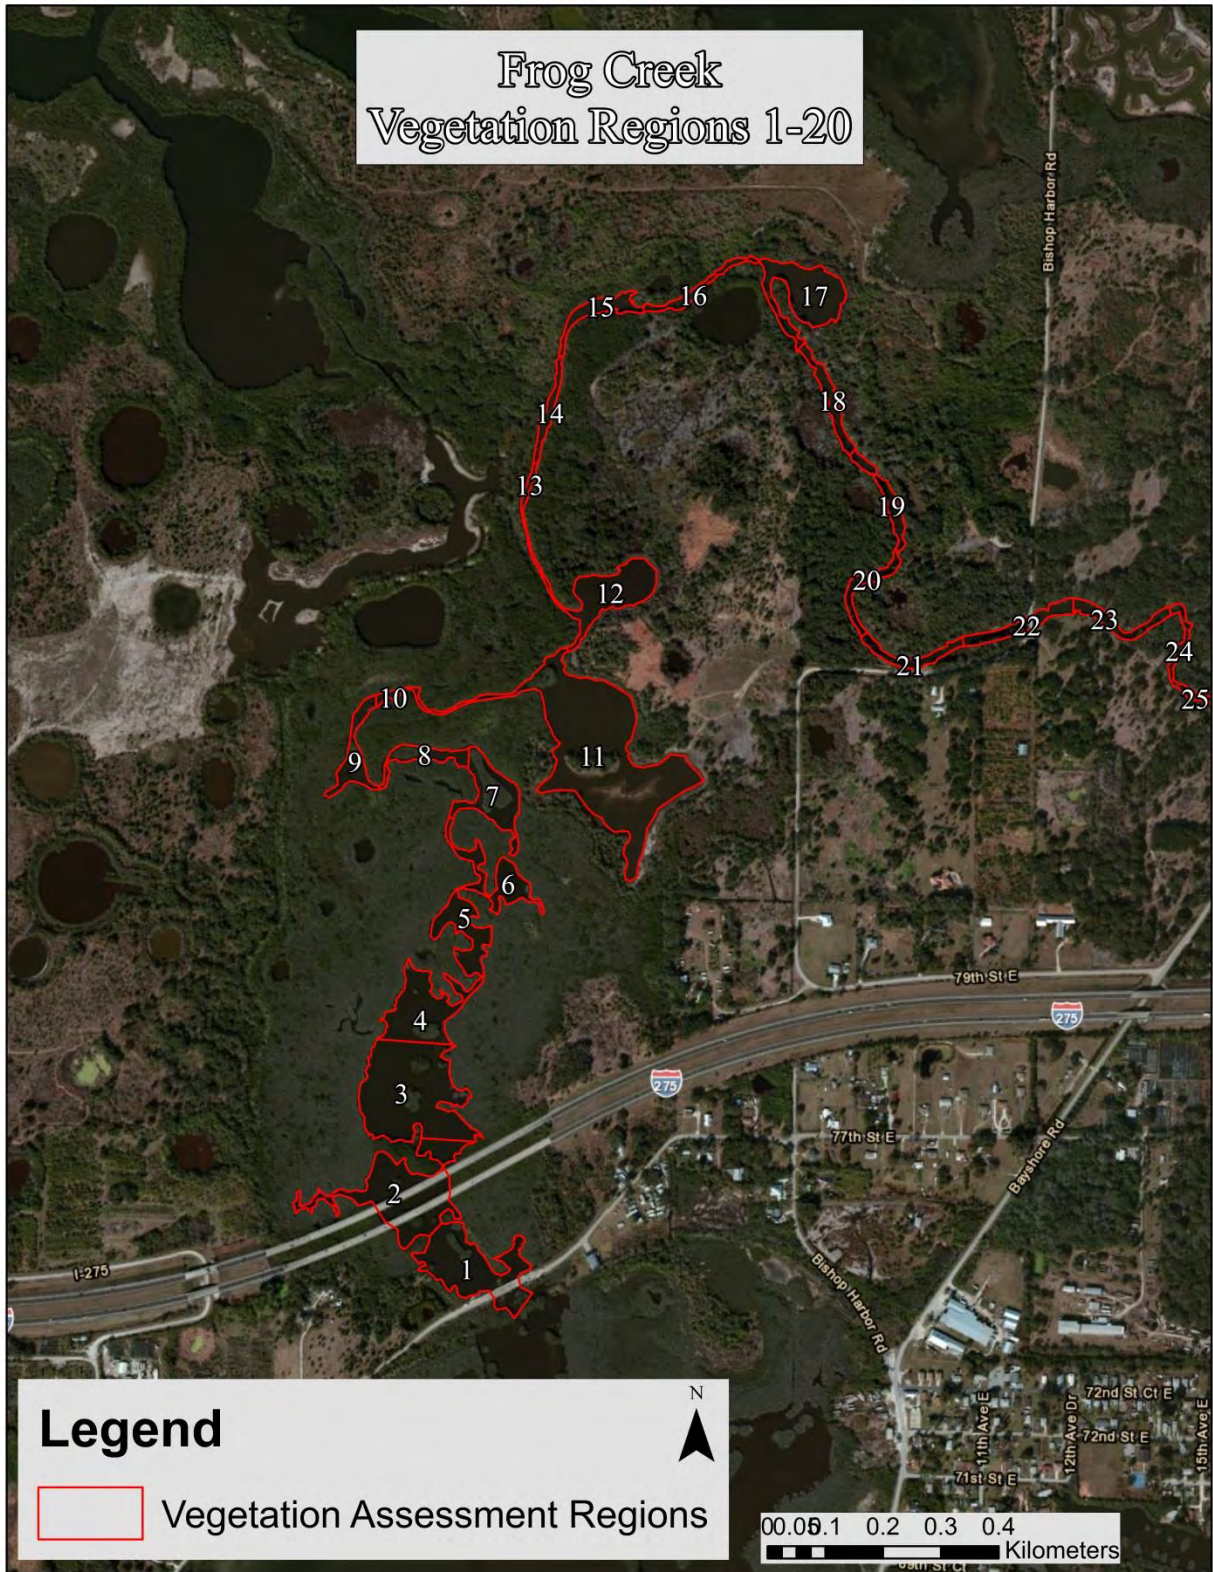
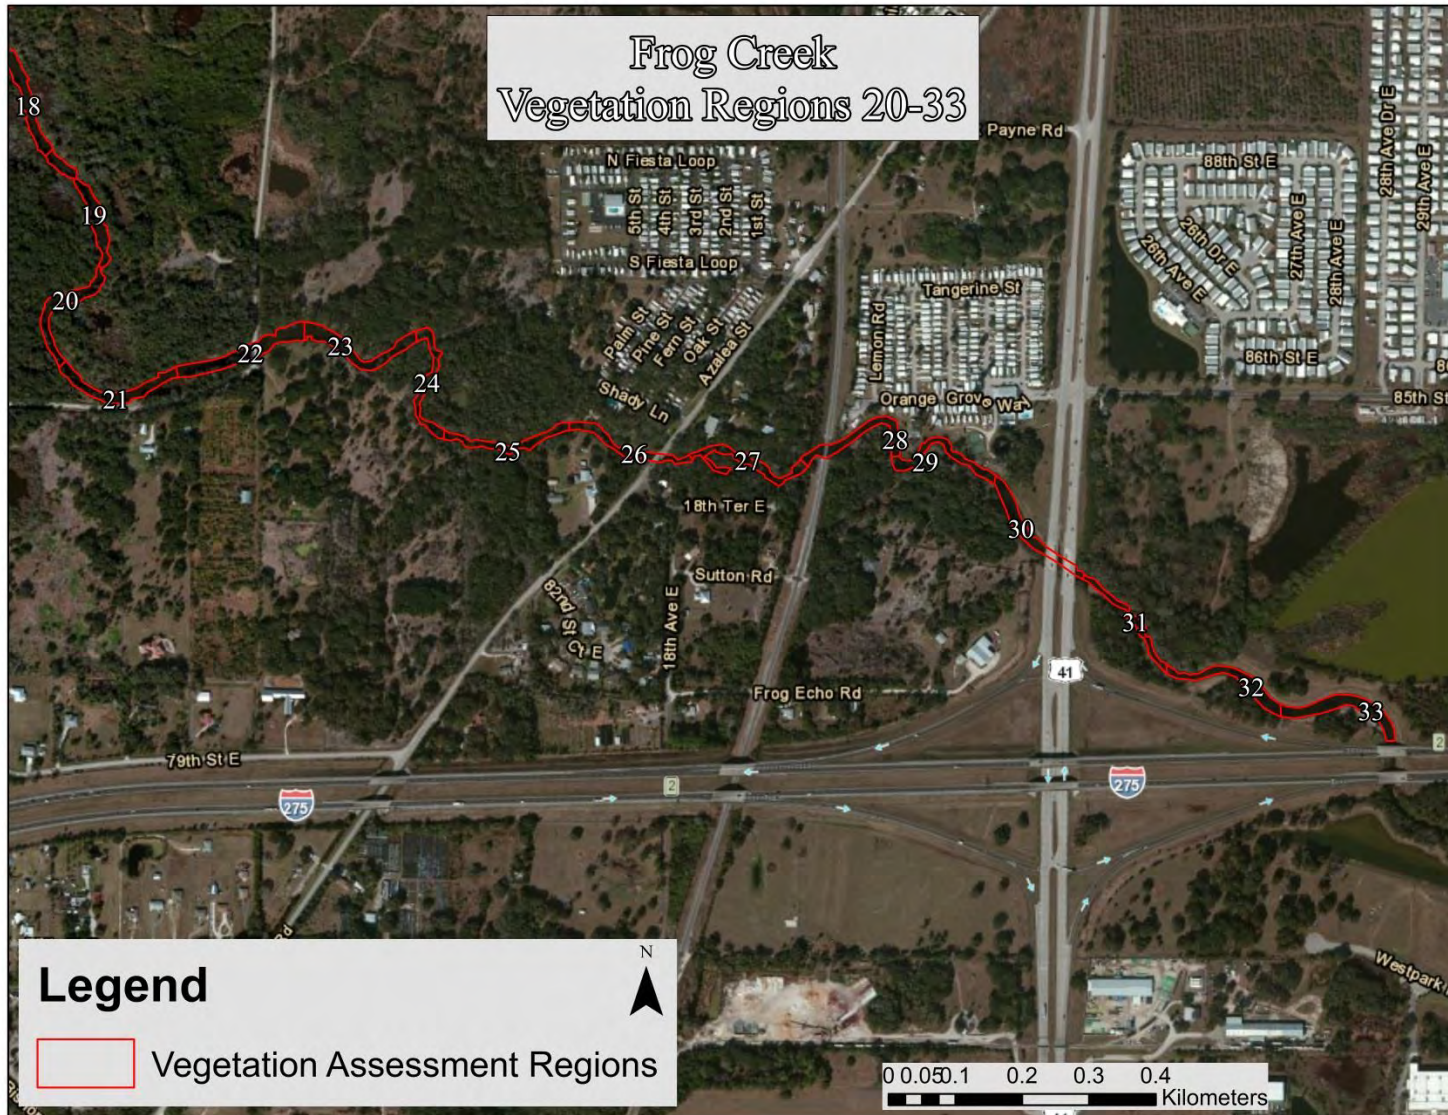
Figure 29. Overview of Frog Creek Vegetation Assessment Regions

The Frog Creek vegetation assessment encompassed 33 vegetation regions from the mouth in Terra Ceia Bay to the overpass at Interstate 275 as shown in Figure 29 through Figure 31. In these regions, 96 species of vegetation were identified. Regions 1 through 18 were dominated by mangroves (*Rhizophora mangle*, *Laguncularia racemosa* and *Avicennia germinans*) with few other salt tolerant species present. The most upstream mangrove was *Avicennia germinans* in Region 19. The first occurrence of Leather Fern (*Acrostichum danaeifolium*) was in Region 15, becoming dominant in regions 17-22 and 24. Needle Rush (*Juncus roemerianus*) was first observed in Region 12 with the last occurrence in Region 17. Above Region 19 the vegetation communities are populated by many species indicative of dominating freshwater influence.

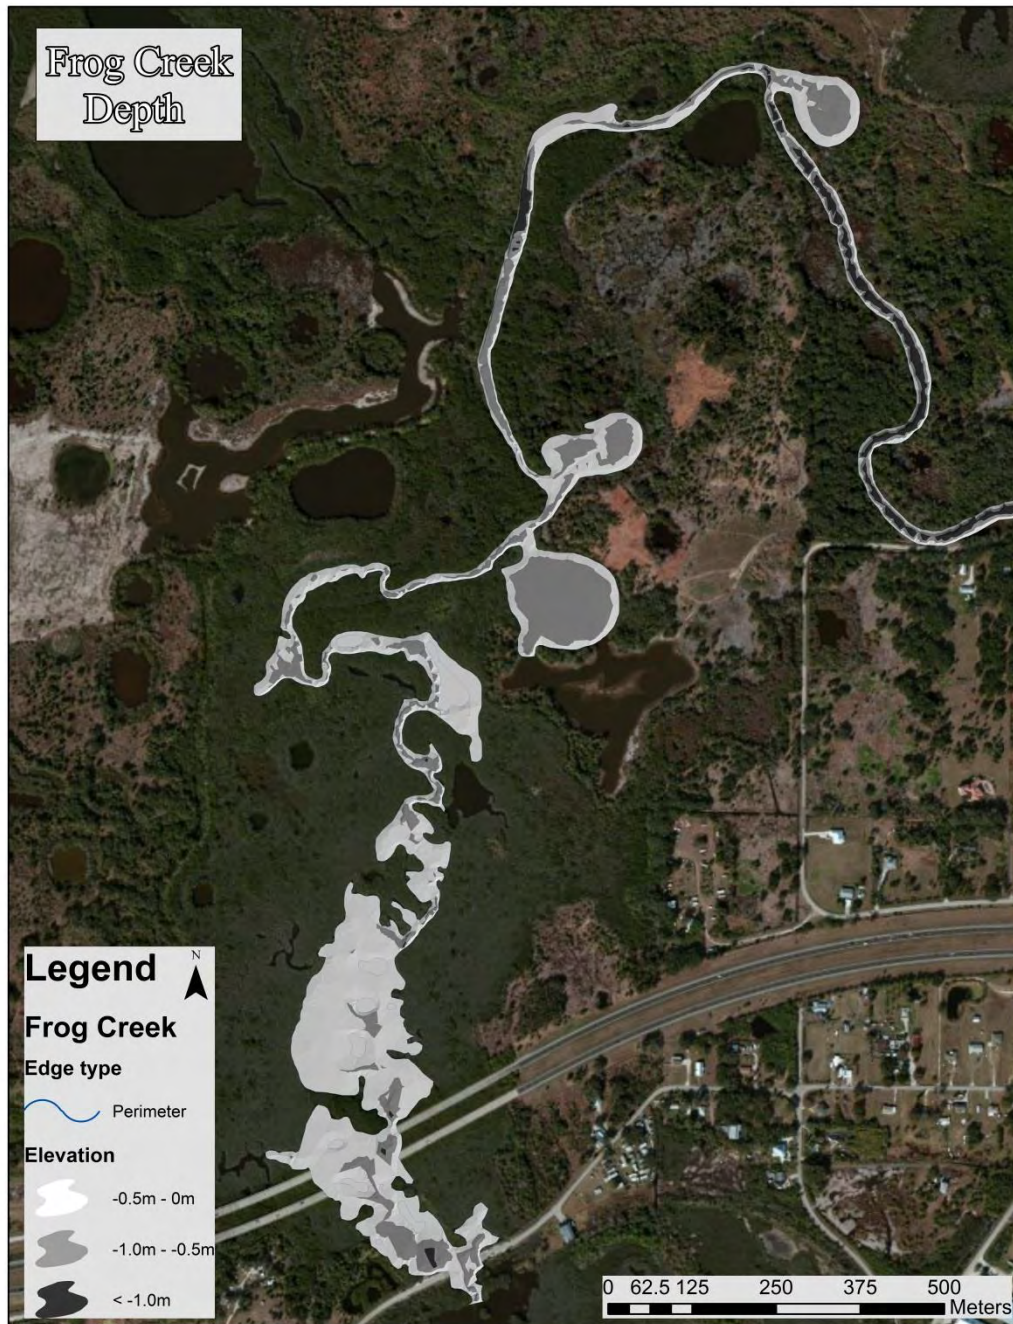
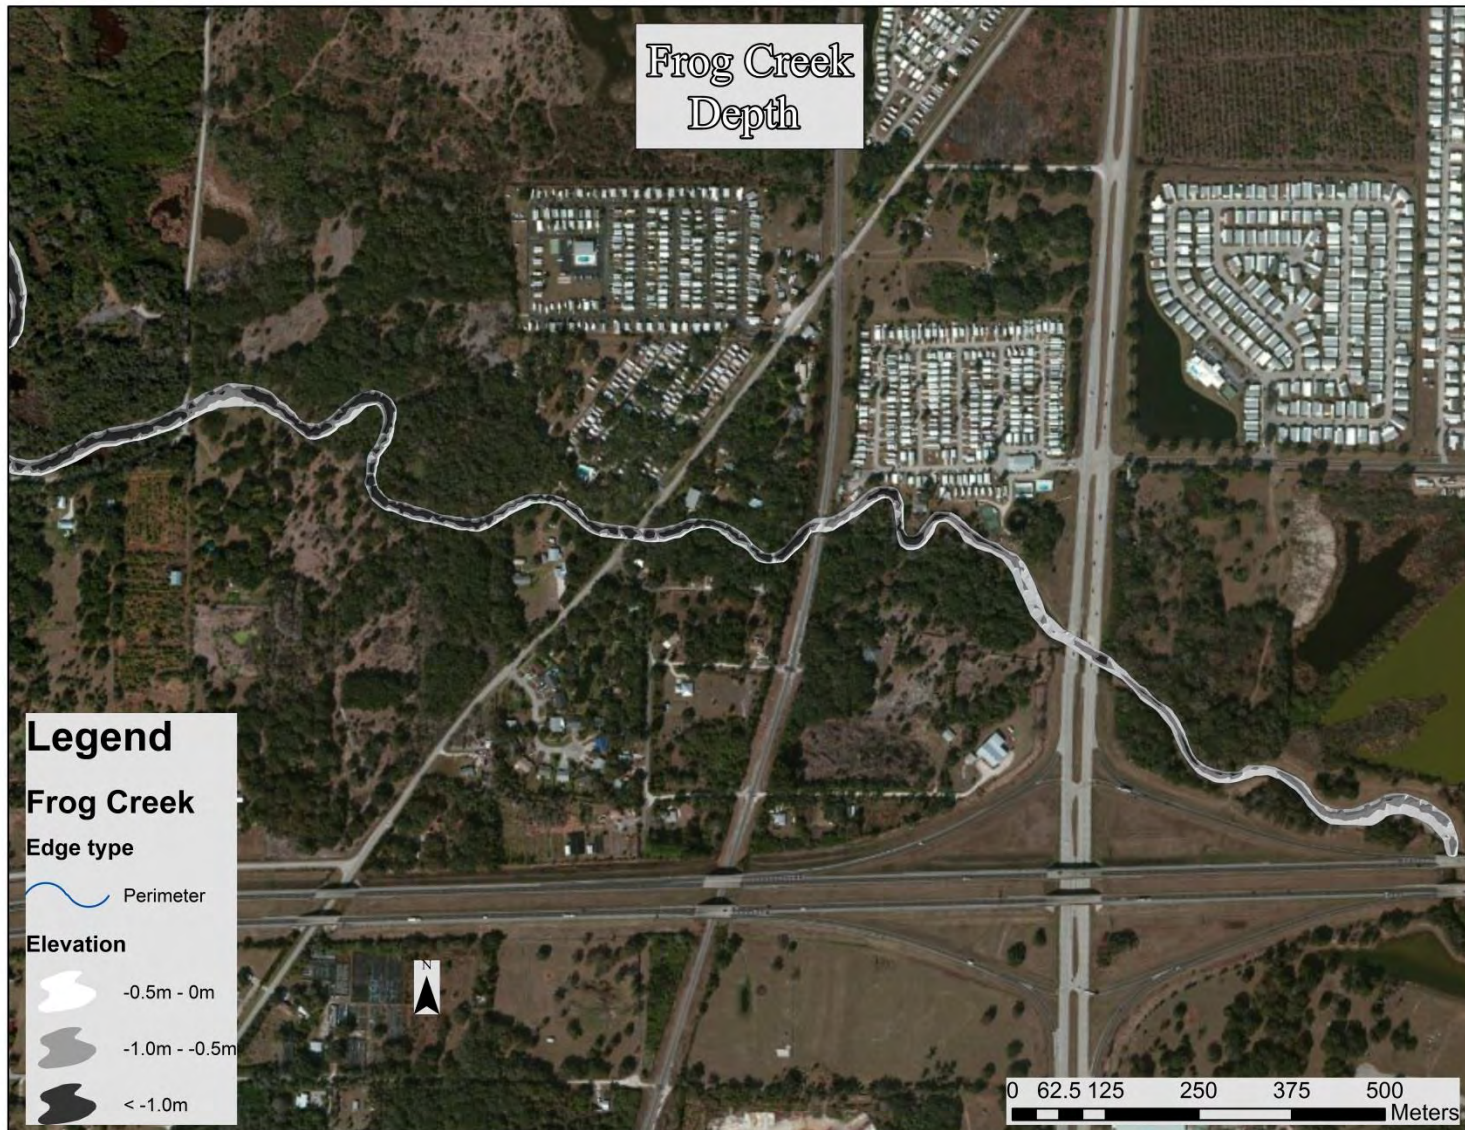
Figure 34. Frog Creek Bathymetric Stratum Map (1 of 2)

In the study area, Frog Creek had a mean depth of 2.71 feet and a maximum depth of 8.60 feet. A total of 57.5 acres of creek was mapped during the assessment. At the time of assessment, Frog Creek contained an estimated 27,860,668 gallons of water in the study area. Figure 34 and Figure 35 detail the bathymetric mapping for Frog Creek showing the three depth stratum.

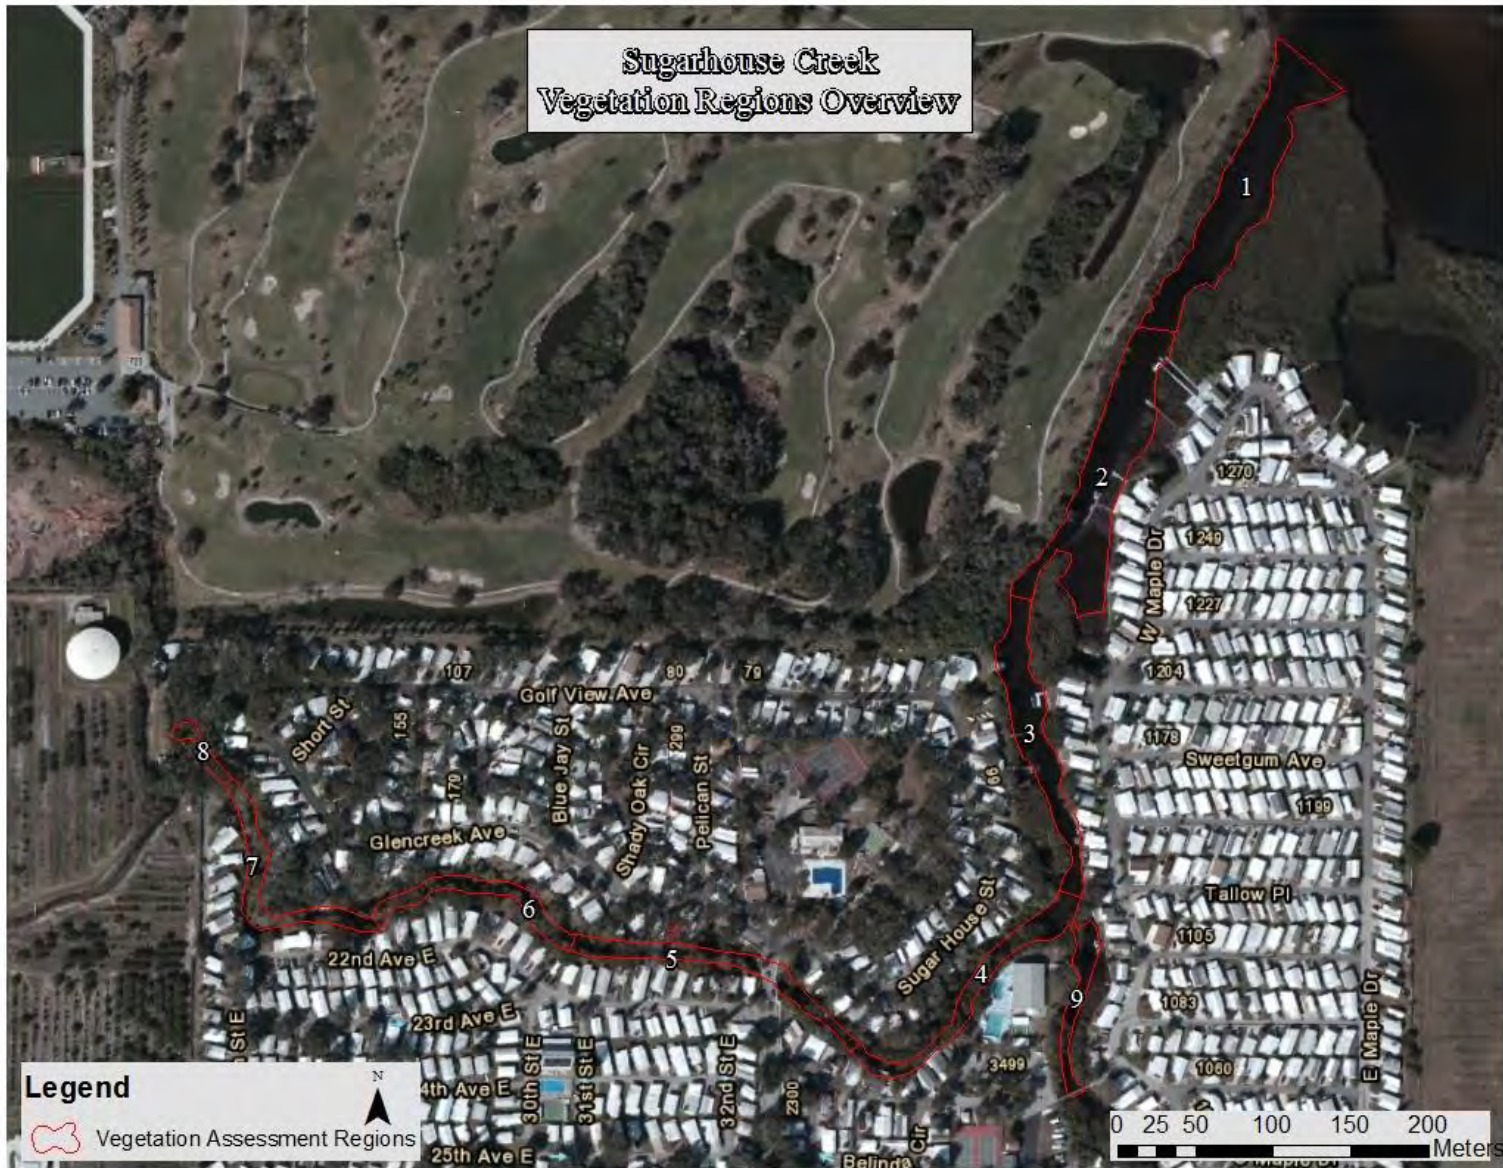
Figure 37. Overview of Sugarhouse Creek Vegetation Assessment Regions

The Sugarhouse Creek vegetation assessment encompassed 9 vegetation regions from the mouth in the Braden River to the footbridge on the south branch and the agricultural field on the west branch as shown in Figure 37. In these regions, 46 species of vegetation were identified. Regions 1 through 5 and Region 9 were dominated by mangroves (*Rhizophora mangle*, *Laguncularia racemosa* and *Avicennia germinans*) with few other salt tolerant species present. The most upstream mangrove was *Laguncularia racemosa* in Region 6. The first occurrence of Leather Fern (*Acrostichum danaeifolium*) was in Region 3, becoming dominant in regions 5 through 7. Needle Rush (*Juncus roemerianus*) was first observed in Region 2 with the last occurrence in regions 3 and 9. Above Region 6 the vegetation communities are populated by many species indicative of dominating freshwater influence.

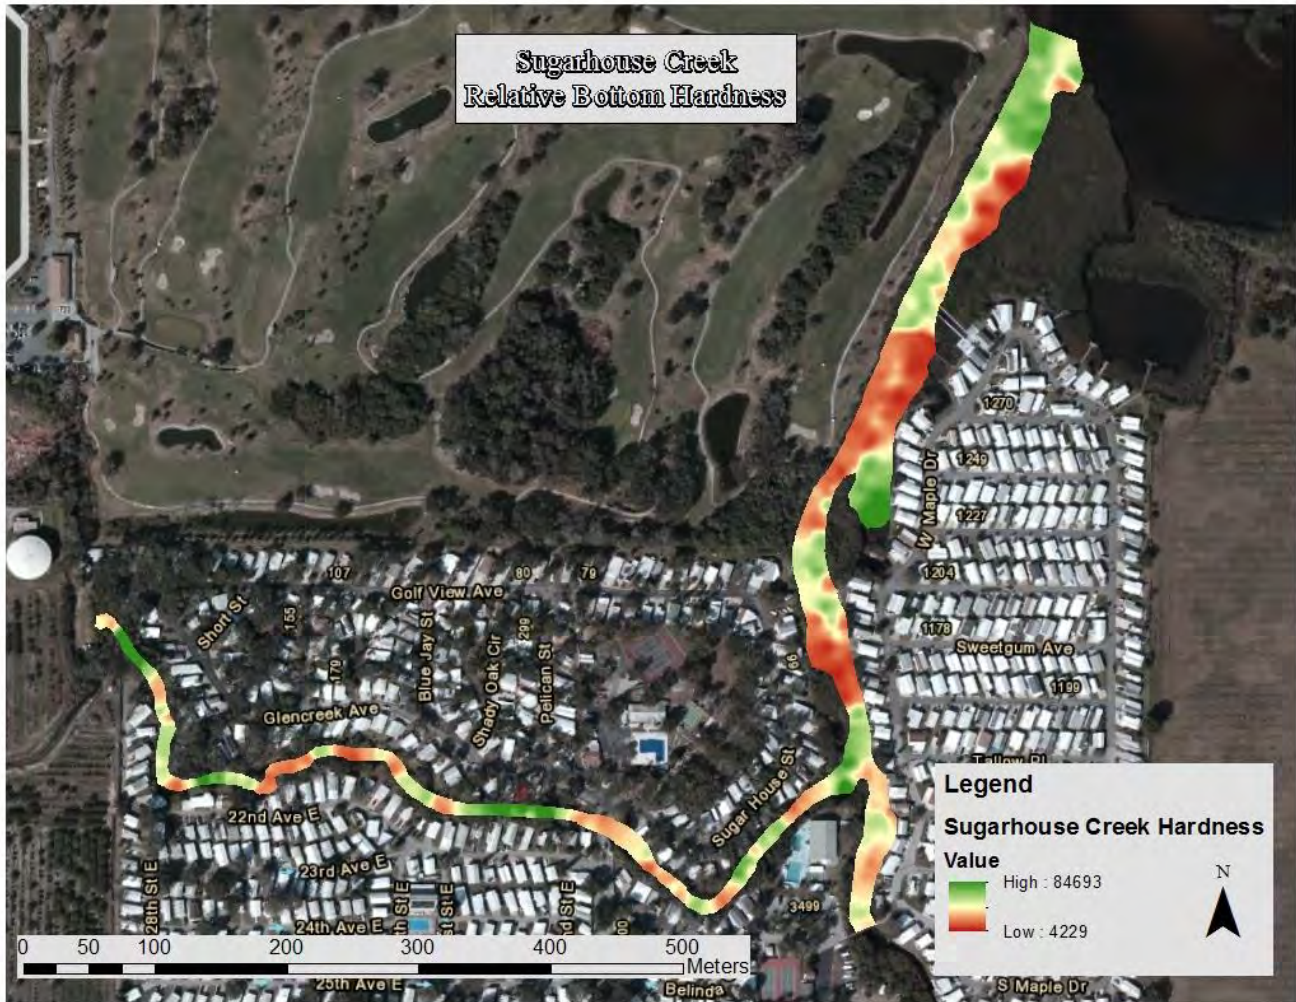
Figure 39. Sugarhouse Creek Relative Bottom Hardness Map

Collected sonar data was processed through Dr. Depth software to analyze the strength of the return signal from the bottom to get an estimate of the relative bottom hardness for Sugarhouse Creek. Figure 39 shows the bottom hardness raster for Sugarhouse Creek. This map is meant to help identify locations of harder and softer bottoms for benthic invertebrate sampling, fish sampling and benthic chlorophyll sampling.

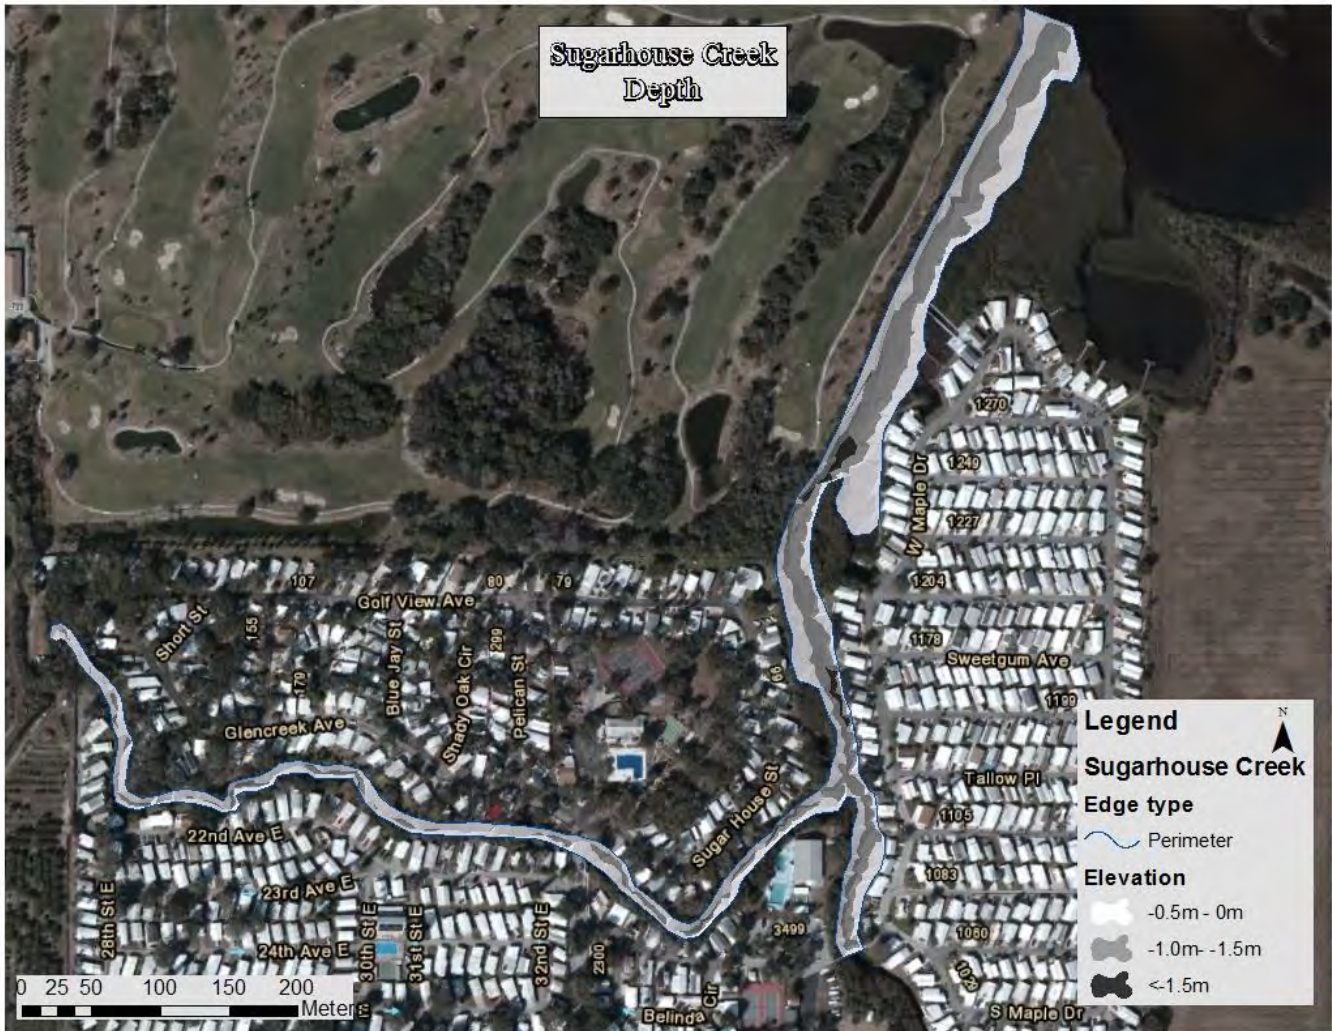
Figure 40. Sugarhouse Creek Bathymetric Stratum Map

In the study area, Sugarhouse Creek had a mean depth of 2.06 feet and a maximum depth of 4.71 feet. A total of 7.26 acres of creek was mapped during the assessment. At the time of assessment, Sugarhouse Creek contained an estimated 3,302,061 gallons of water in the study area. Figure 40 details the bathymetric mapping for Sugarhouse Creek showing the three depth stratum.

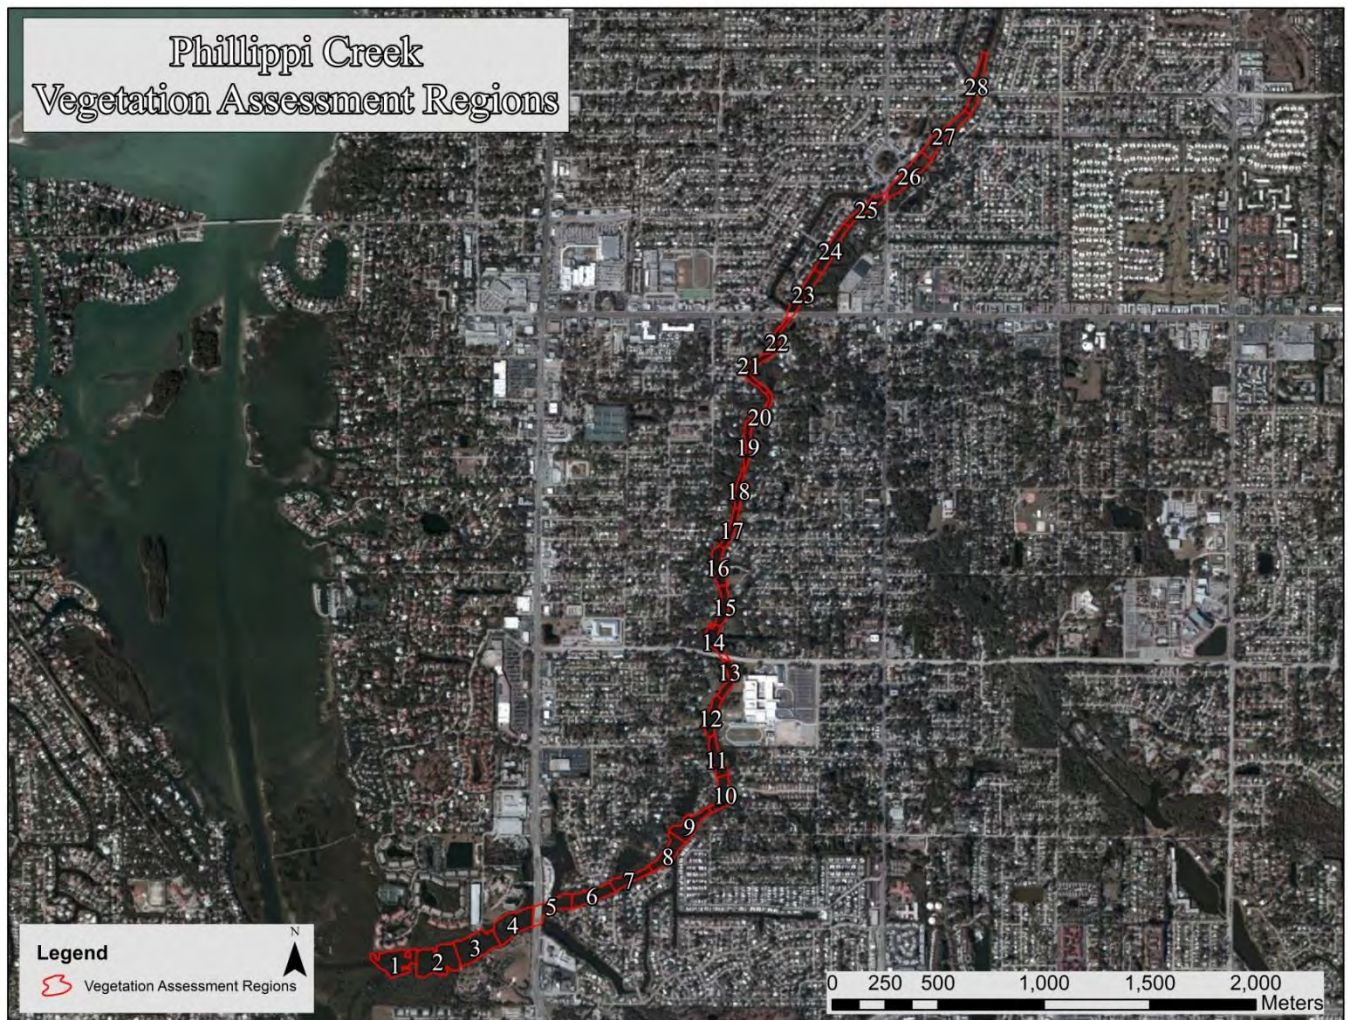
Figure 42. Overview of Phillippi Creek Vegetation Assessment Regions

The Phillippi Creek vegetation assessment encompassed 28 vegetation regions from the mouth in Roberts Bay to above Webber Street as shown in Figure 42. In these regions, 82 species of vegetation were identified. Regions 1 through 20 were dominated by mangroves (*Rhizophora mangle*, *Laguncularia racemosa* and *Avicennia germinans*) with few other salt tolerant species present. The most upstream mangrove was *Laguncularia racemosa* in Region 26. The first occurrence of Leather Fern (*Acrostichum danaeifolium*) was in Region 11, becoming co-dominant in regions 24 and 26. Needle Rush (*Juncus roemerianus*) was first observed in Region 7 with the last occurrence in Region 17. Above Region 21 the vegetation communities are populated by many species indicative of dominating freshwater influence.

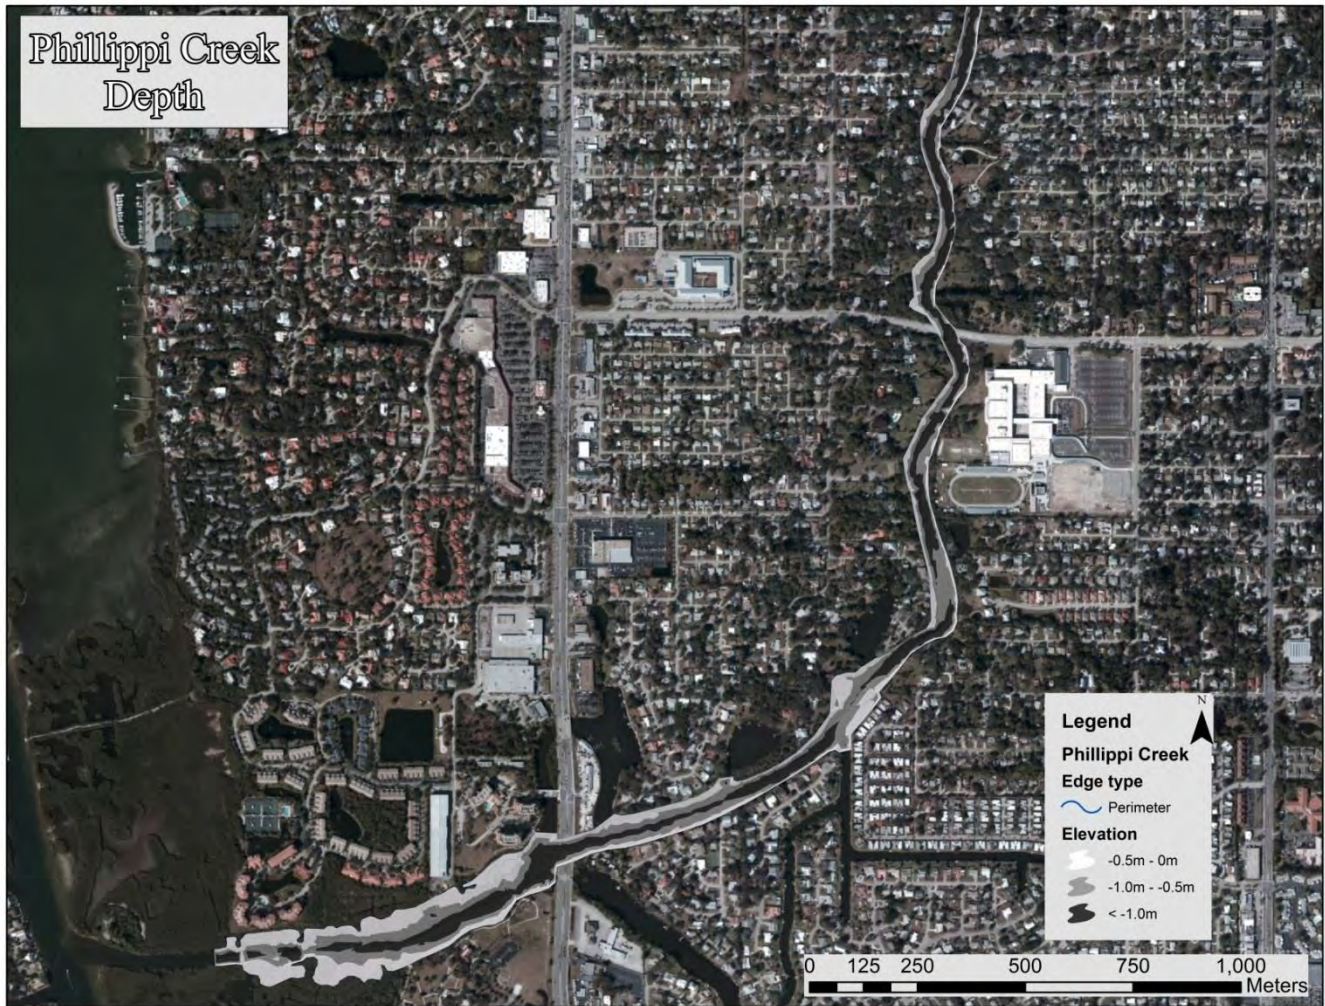
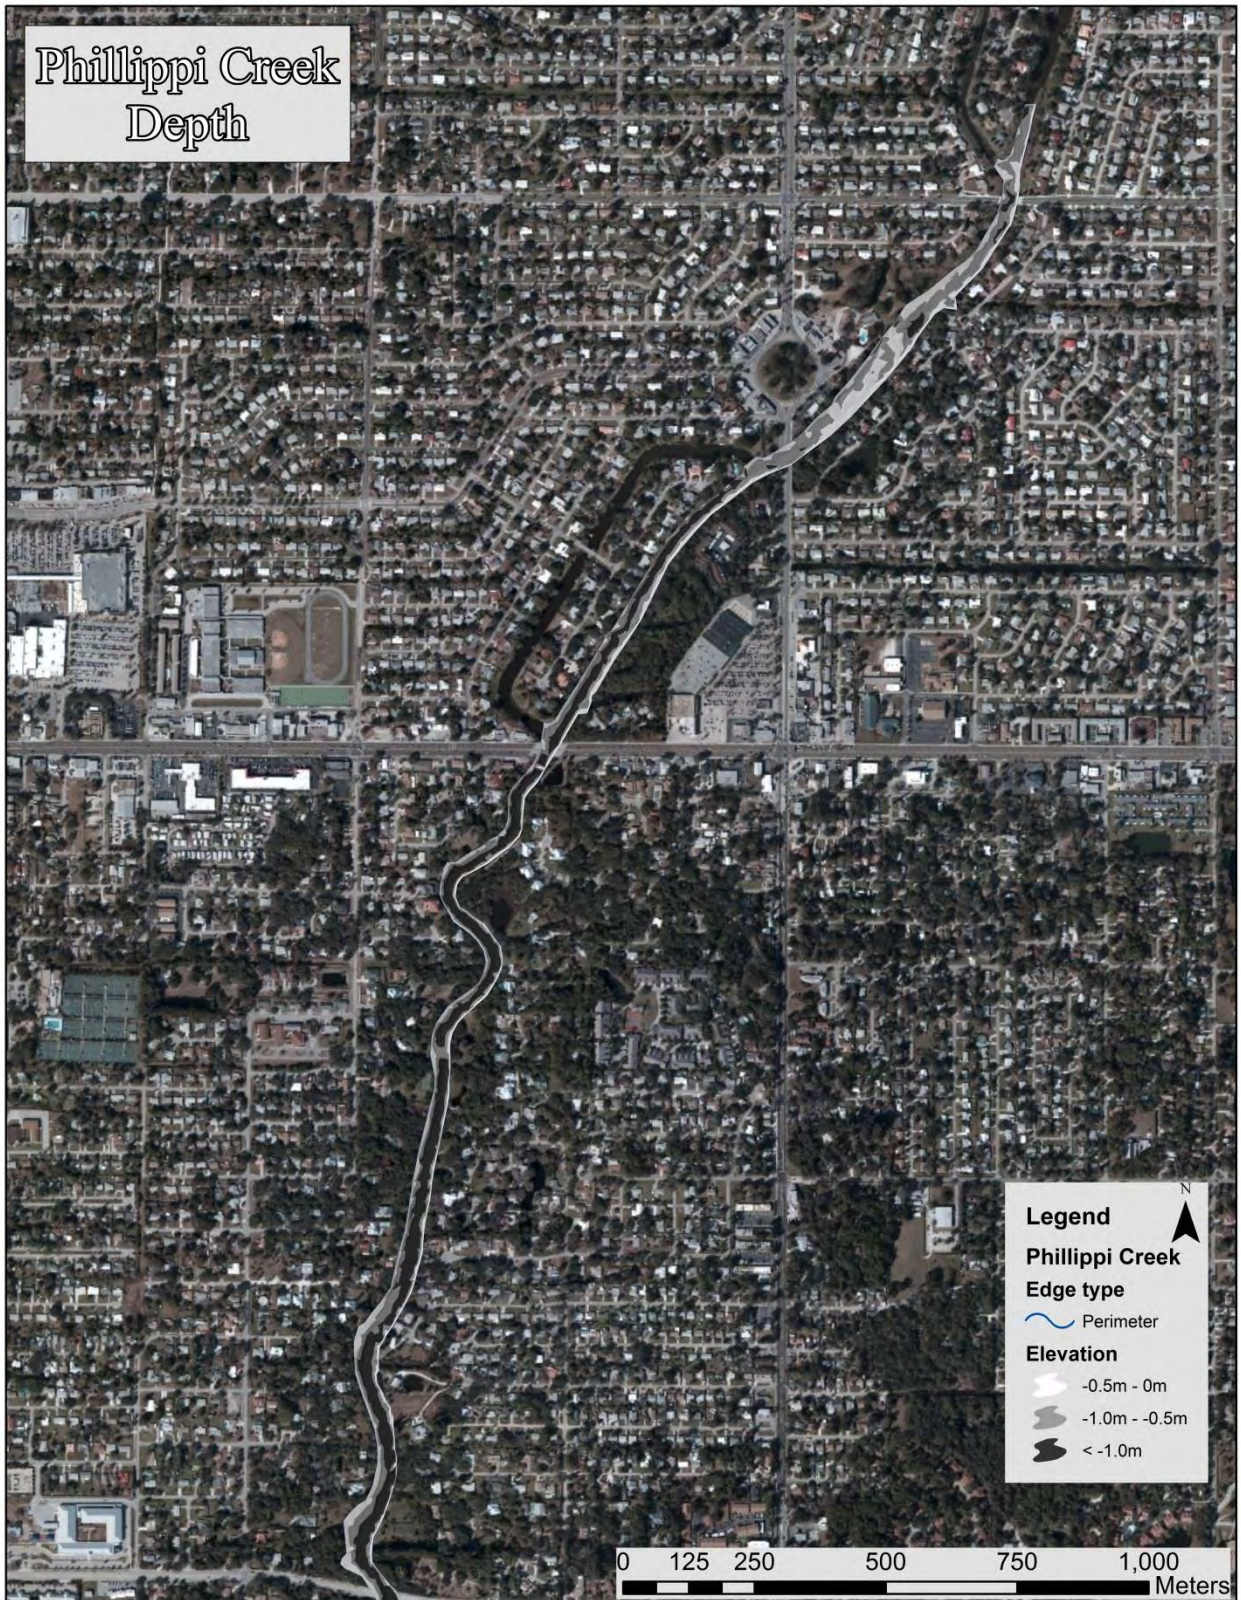
Figure 45. Phillippi Creek Bathymetric Stratum Map (1 of 2)

In the study area, Phillippi Creek had a mean depth of 3.50 feet and a maximum depth of 11.75 feet. A total of 78.62 acres of creek was mapped during the assessment. At the time of assessment, Phillippi Creek contained an estimated 62,075,018 gallons of water in the study area. Figure 45 and Figure 46 detail the bathymetric mapping for Phillippi Creek showing the three depth stratum.

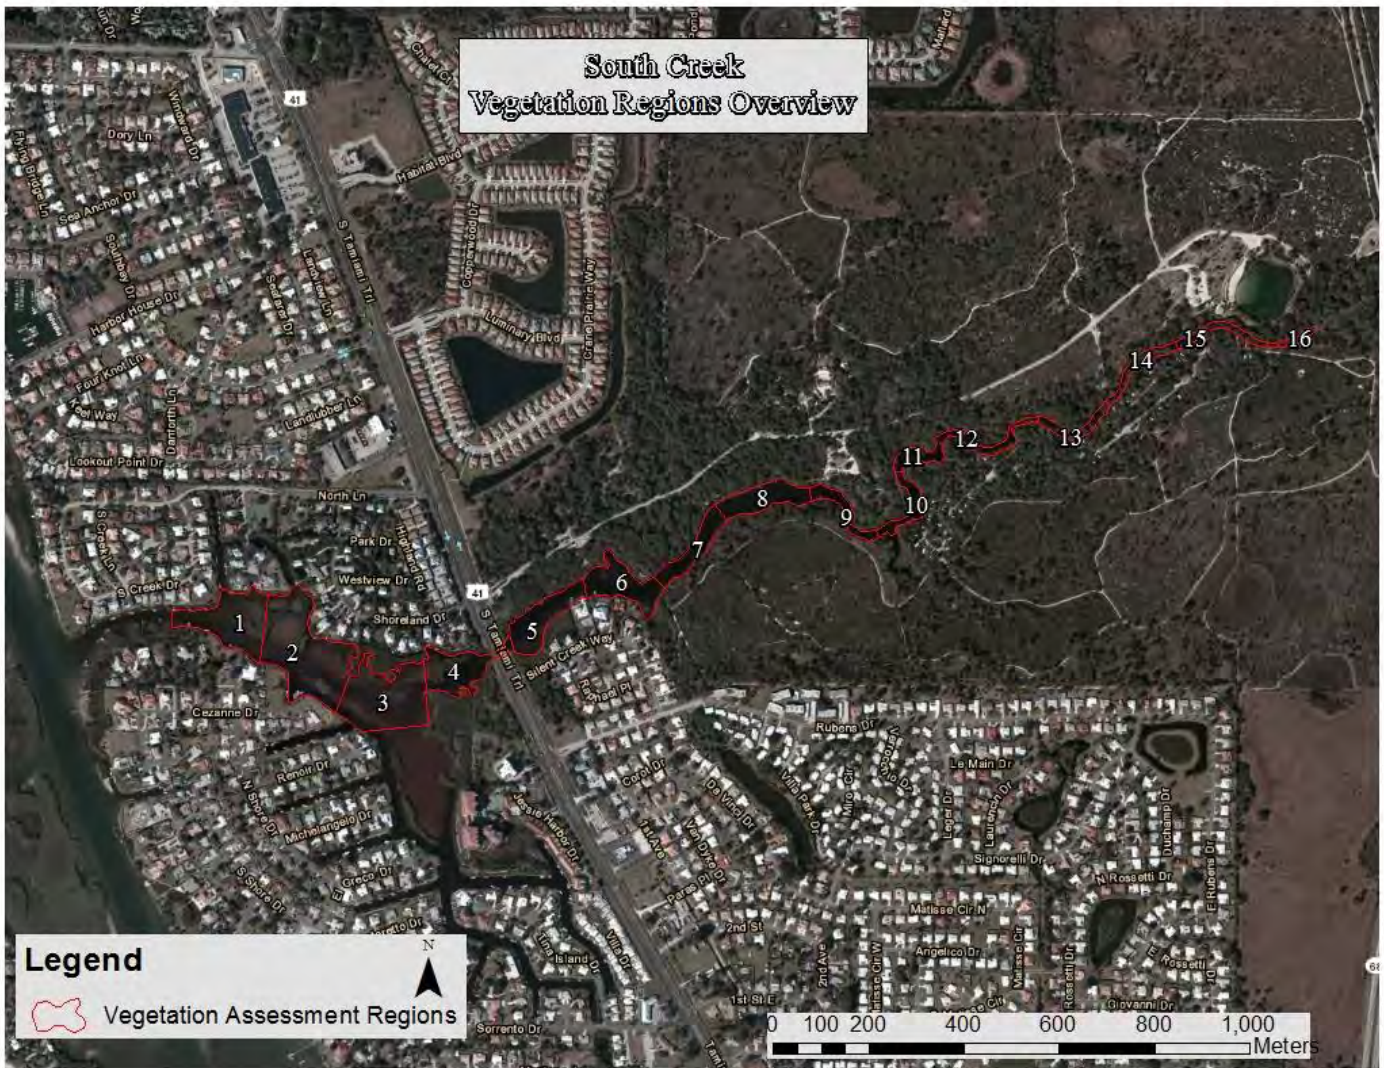
Figure 48. Overview of South Creek Vegetation Assessment Regions

The South Creek vegetation assessment encompassed 16 vegetation regions from the mouth in Blackburn Bay to upstream in Oscar Scherer State Park as shown in Figure 48. In these regions, 46 species of vegetation were identified. Regions 1 through 12 were dominated by mangroves (*Rhizophora mangle*, *Laguncularia racemosa* and *Avicennia geminans*) with few other salt tolerant species present. The most upstream mangrove was *Avicennia geminans* in Region 15. The first occurrence of Leather Fern (*Acrostichum danaeifolium*) was in Region 6. Needle Rush (*Juncus roemerianus*) was first observed in Region 6 with the last occurrence in Region 14. Above Region 13 the vegetation communities are populated by many species indicative of dominating freshwater influence.

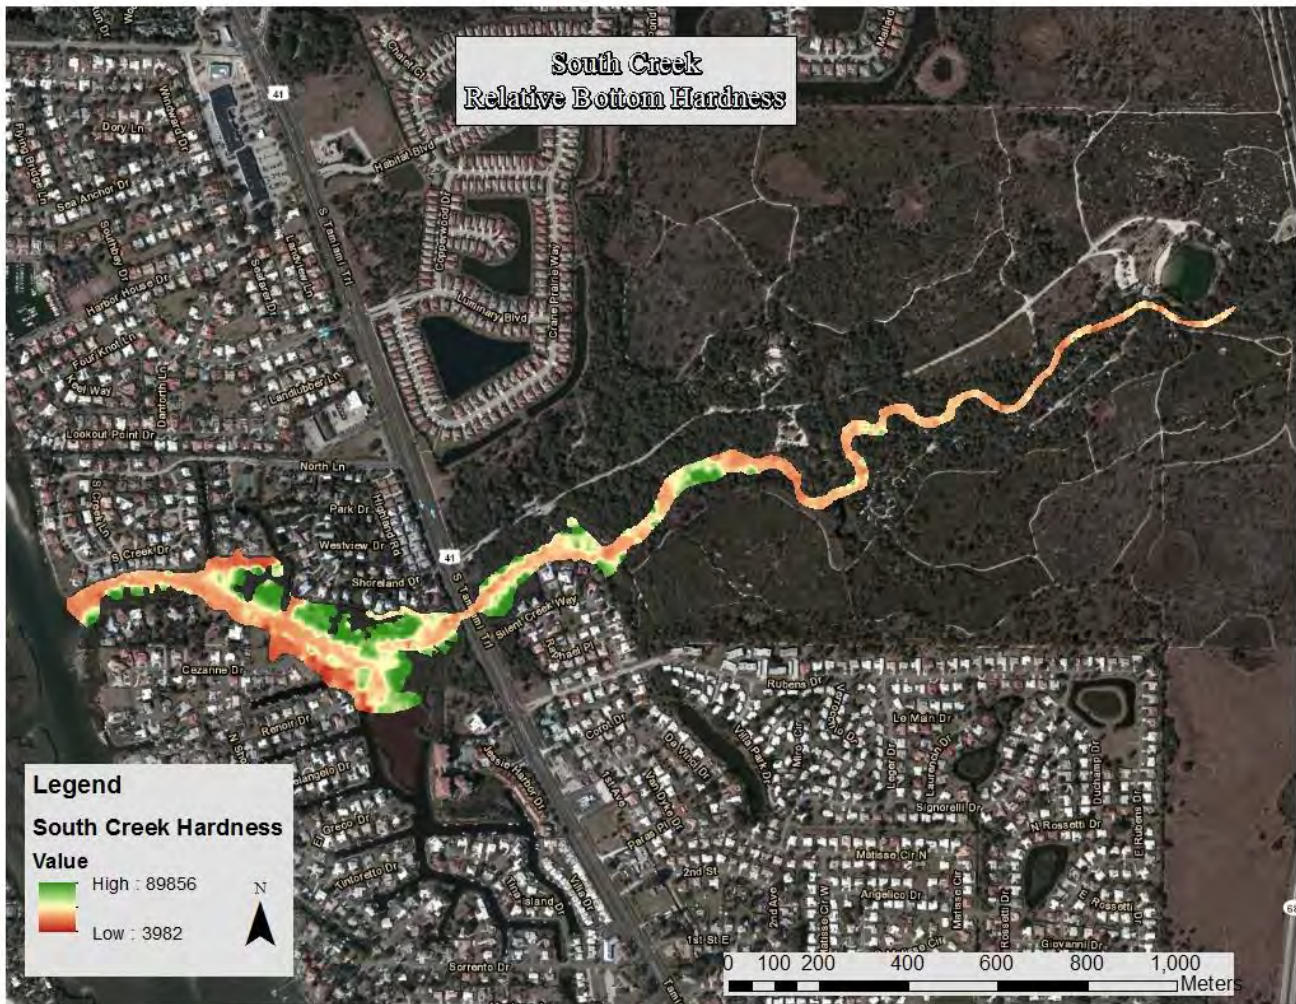
Figure 50. South Creek Relative Bottom Hardness Map

Collected sonar data was processed through Dr. Depth software to analyze the strength of the return signal from the bottom to get an estimate of the relative bottom hardness for South Creek. Figure 50 shows the bottom hardness raster for South Creek. This map is meant to help identify locations of harder and softer bottoms for benthic invertebrate sampling, fish sampling and benthic chlorophyll sampling.

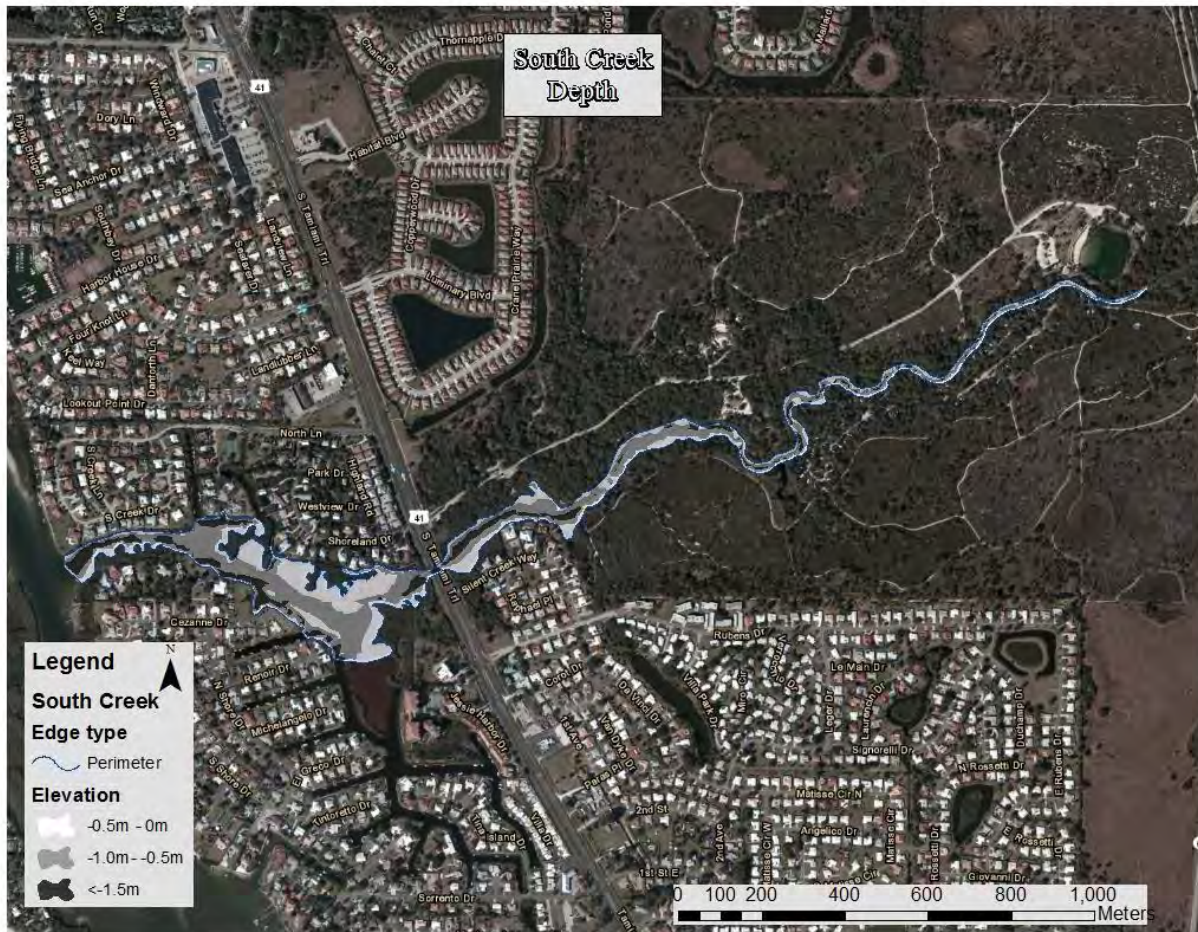
Figure 51. South Creek Bathymetric Stratum Map

In the study area, South Creek had a mean depth of 2.7 feet and a maximum depth of 8.4 feet. A total of 39.5 acres of creek was mapped during the assessment. At the time of assessment, South Creek contained an estimated 25,269,730 gallons of water in the study area. Figure 51 details the bathymetric mapping for South Creek showing the three depth stratum.

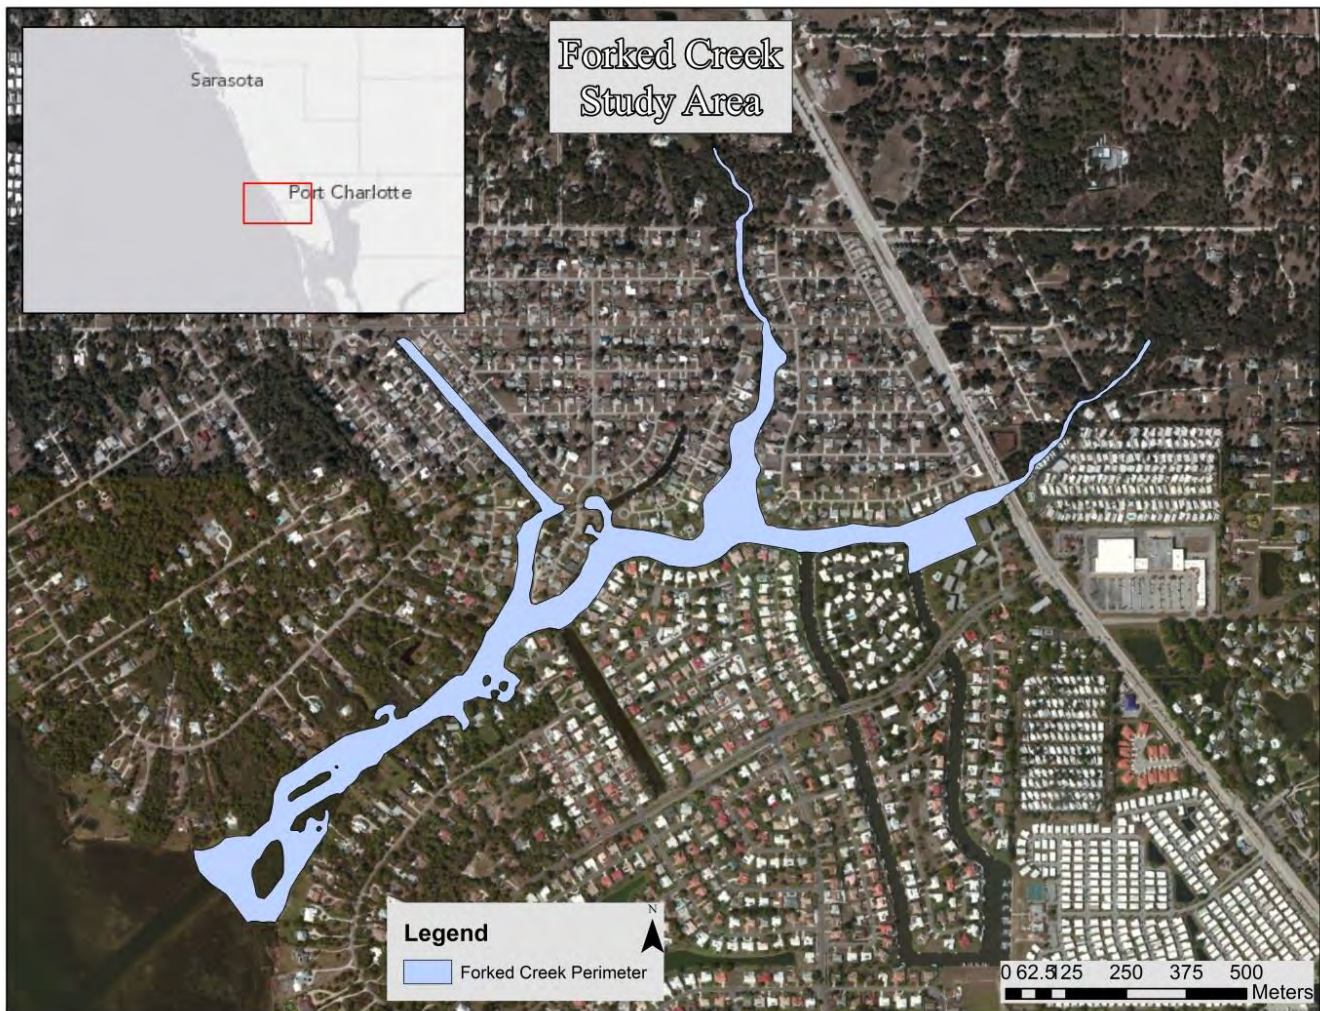
Figure 52. Overview of the Forked Creek Study Area

Forked Creek has a mostly urban watershed. The watershed becomes less urban above US-41 where there is a mix of agriculture and natural lands which results in a watershed LDI value of 3.6. The majority of Forked Creek is channelized and navigable via boat. Forked Creek's banks have been either developed to have rip-rap or to seawalls. There are some areas of mangroves on downstream portion of the creek where there are also some shallower areas which have not been dredged. The urbanized and non-natural areas immediately surrounding Forked Creek gives it a buffer LDI value of 6.0.
