West-Central Florida Tidal Stream Assessment Study

Prepared for the Sarasota Bay Estuary Program by the Florida Center for
Community Design and Research at the University of South Florida

December 10, 2013

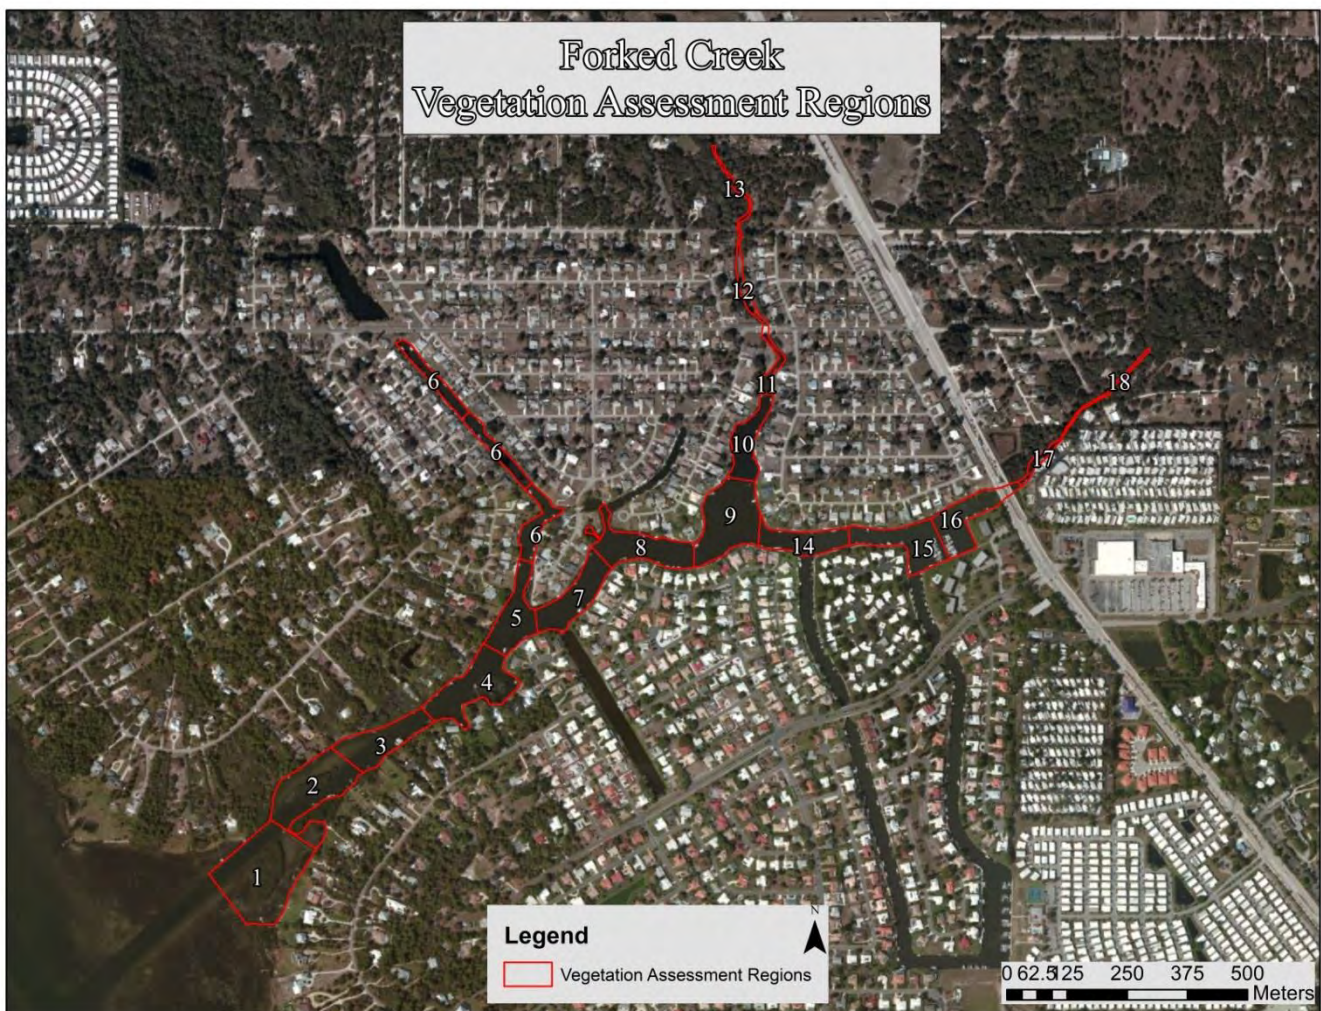
Figure 53. Overview of Forked Creek Vegetation Assessment Regions

The Forked Creek vegetation assessment encompassed 18 vegetation regions from the mouth in Lemon Bay to the near Keyway Road as shown in Figure 53. In these regions, 36 species of vegetation were identified. Most of the regions were dominated by mangroves (*Rhizophora mangle*, *Laguncularia racemosa* and *Avicennia germinans*) with few other salt tolerant species present until Region 18 which was dominated by a variety of freshwater and upland species. The majority of the Forked Creek study area was lined by seawall which is reflected in the lack of a dominant species in Regions 5, 6, 9, 10, 14 and 15. The first occurrence of Leather Fern (*Acrostichum danaeifolium*) was in Region 17. Needle Rush (*Juncus roemerianus*) was first observed in Region 1 with the last occurrence in Region 10. Above region 17 the vegetation communities are populated by many species indicative of dominating freshwater influence.

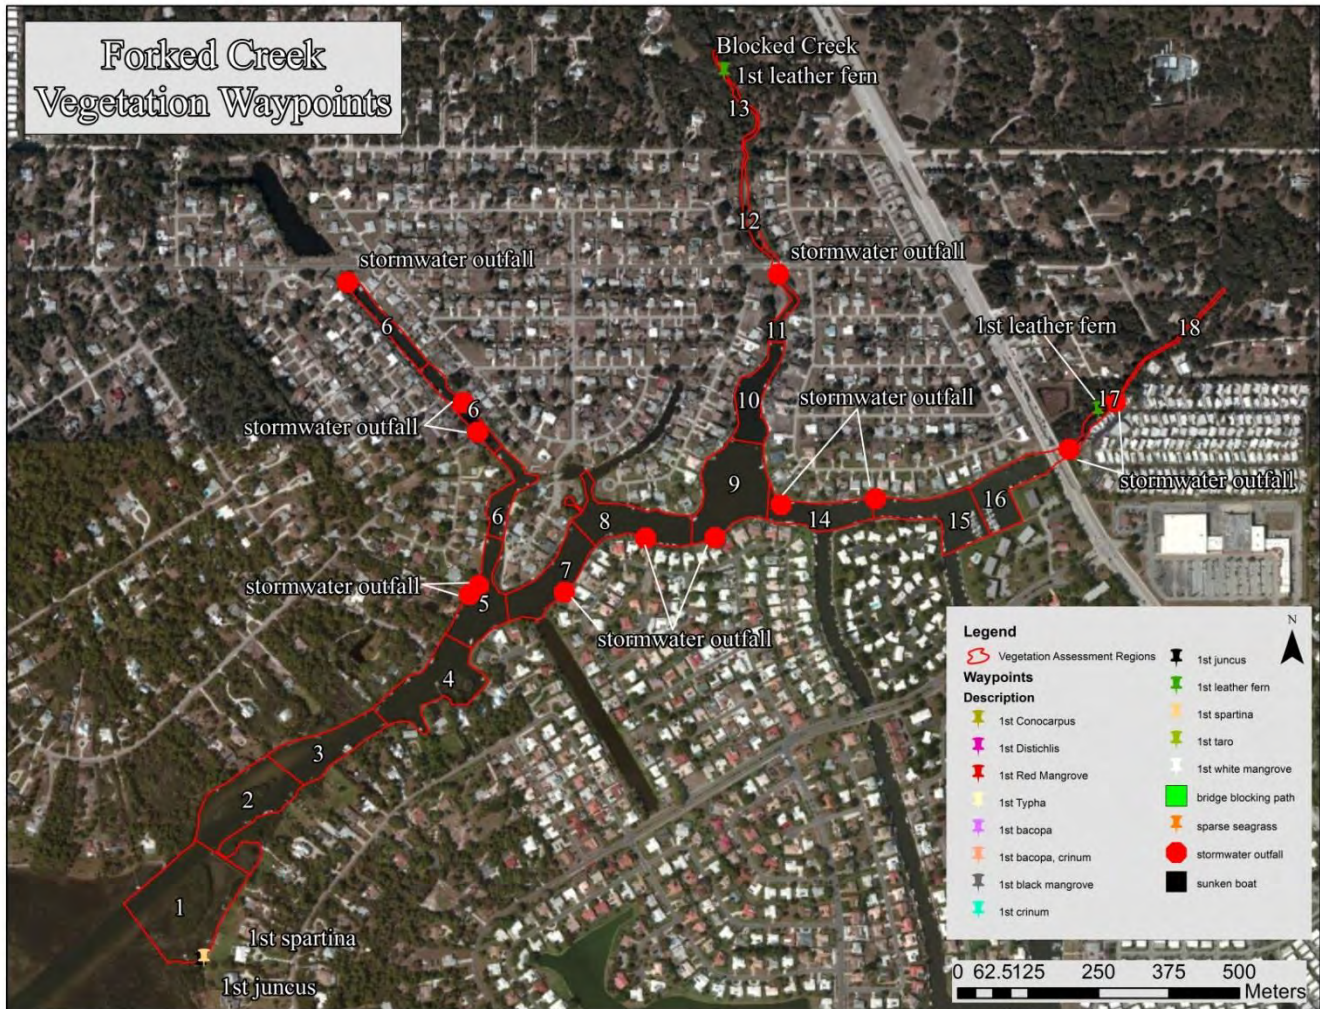
Figure 54. Forked Creek Vegetation Waypoints

Figure 54 shows the vegetation transition zone of Forked Creek indicating the first occurrence of *Juncus* and *Spartina* in Region 1 as well as the first occurrences of Leather Fern in Regions 13 and 17. Based on the available vegetation assessment data Regions 1 through 9 would comprise the highest salinity and tidal influence zone, Regions 10 through 12 and Regions 14 through 16 would comprise the “mixing” zone and Regions 13 and 17 through 18 would comprise the freshwater dominant zone. The vegetation assessment species lists are shown in Table 14.

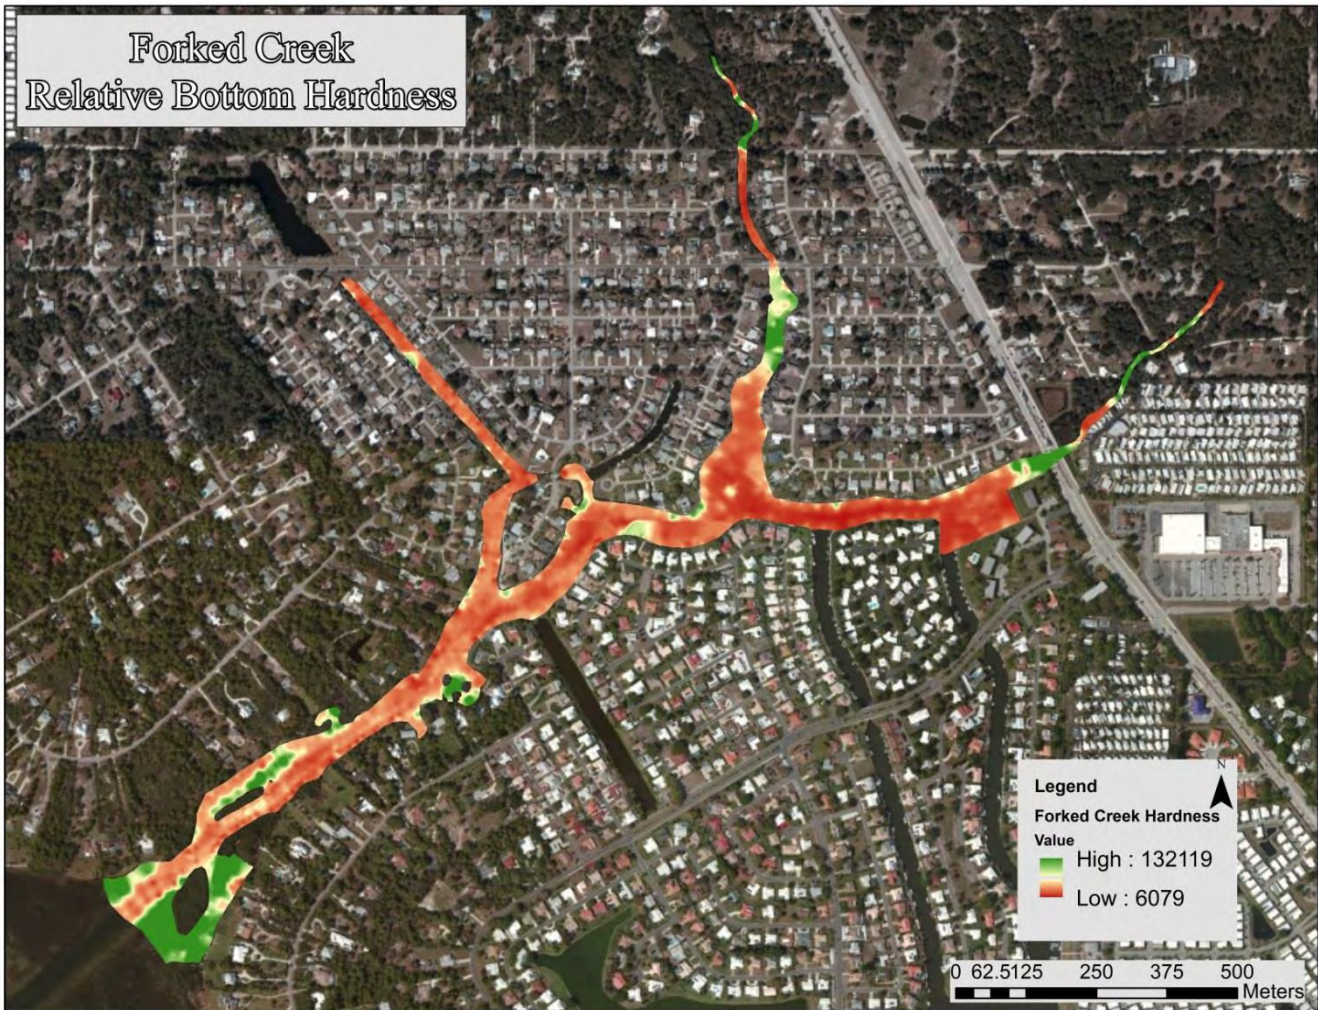
Figure 55. Forked Creek Relative Bottom Hardness Map

Collected sonar data was processed through Dr. Depth software to analyze the strength of the return signal from the bottom to get an estimate of the relative bottom hardness for Forked Creek. Figure 55 shows the bottom hardness raster for Forked Creek. In this raster, the higher the hardness value, the harder the bottom substrate. This map is meant to help identify locations of harder and softer bottoms for benthic invertebrate sampling, fish sampling and benthic chlorophyll sampling.

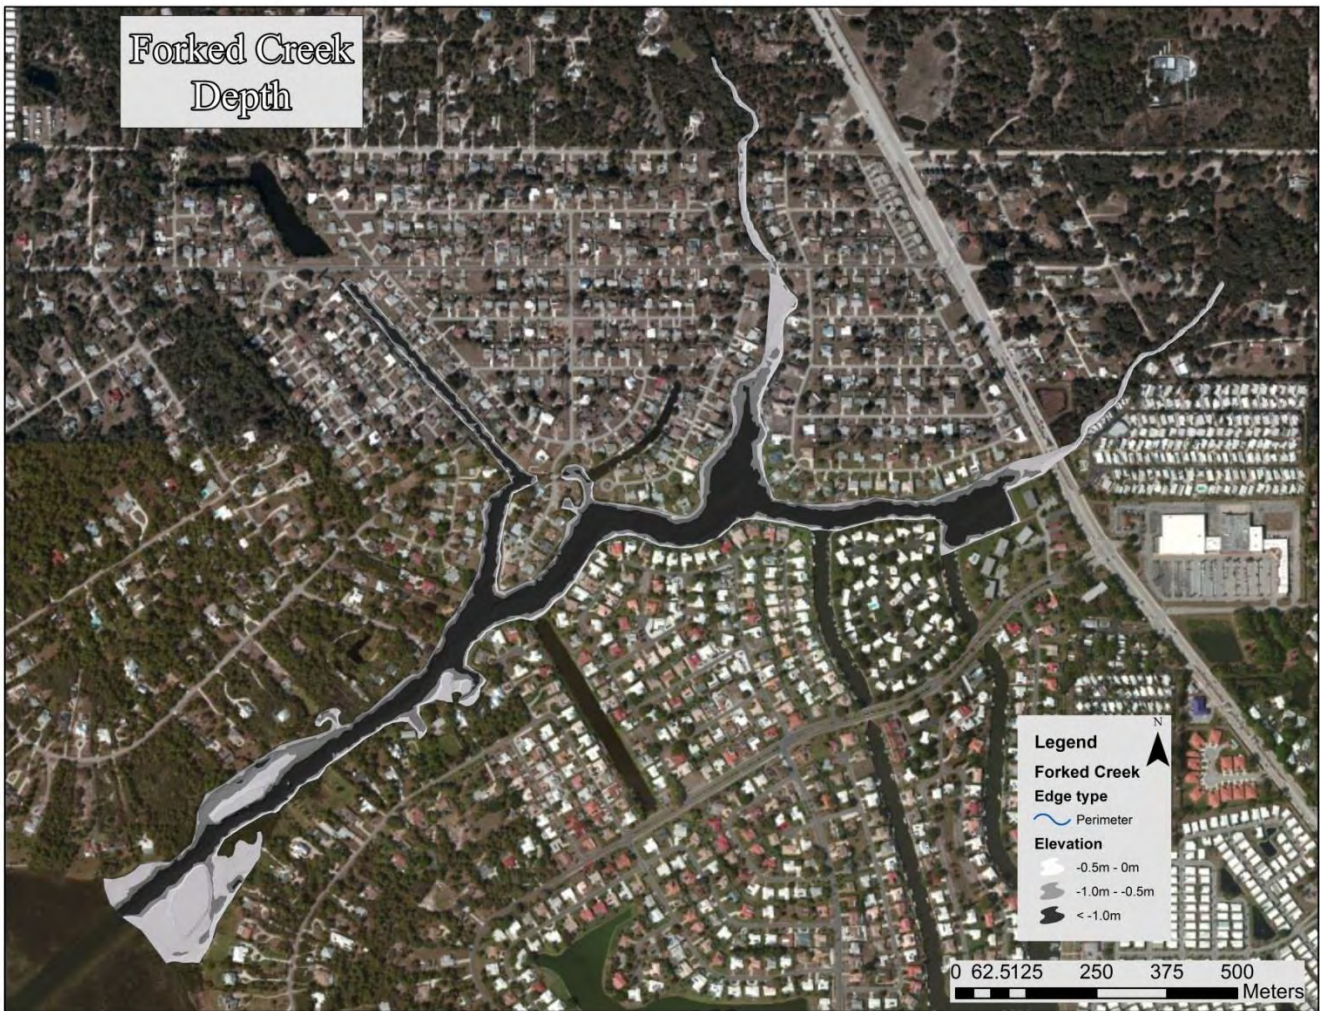
Figure 56. Forked Creek Bathymetric Stratum Map

In the study area, Forked Creek had a mean depth of 3.33 feet and a maximum depth of 8.37 feet. A total of 47.8 acres of creek was mapped during the assessment. At the time of assessment, Forked Creek contained an estimated 45,924,792 gallons of water in the study area. Figure 56 details the bathymetric mapping for Forked Creek showing the three depth stratum.

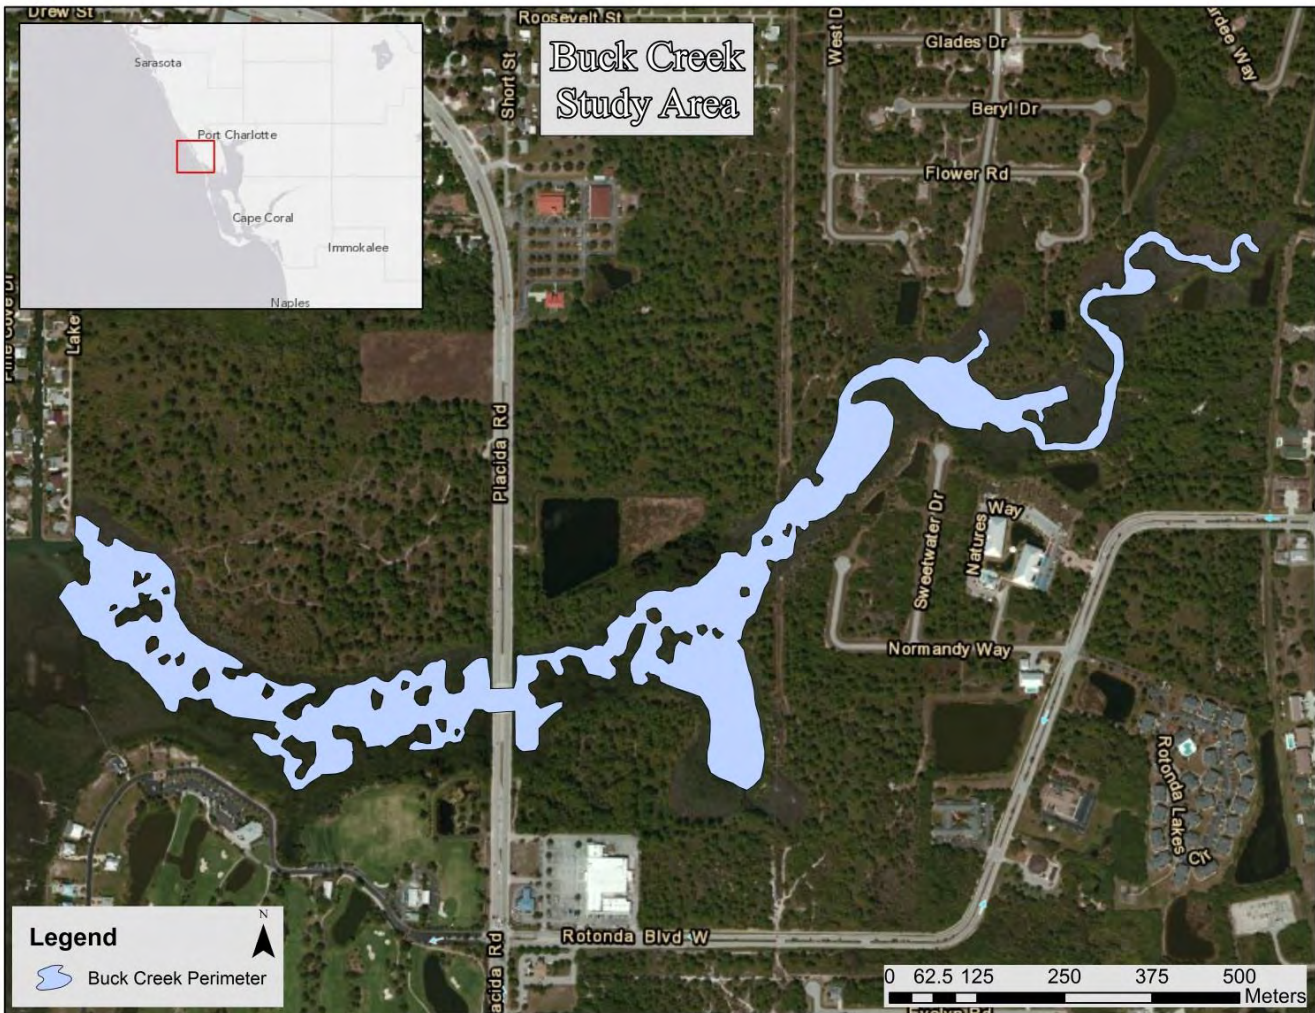
Figure 57. Overview of the Buck Creek Study Area

Buck Creek is located in a relatively unimpaired watershed. Most of the creek is bordered by mangroves. A small area of medium density residential property borders a portion of the downstream area of Buck Creek. A golf course that is buffered by mangroves is located within the downstream portion of the creek. Buck Creek’s watershed has a LDI value of 3.8 and the area immediately surrounding the creek with a buffer LDI value of 1.2.

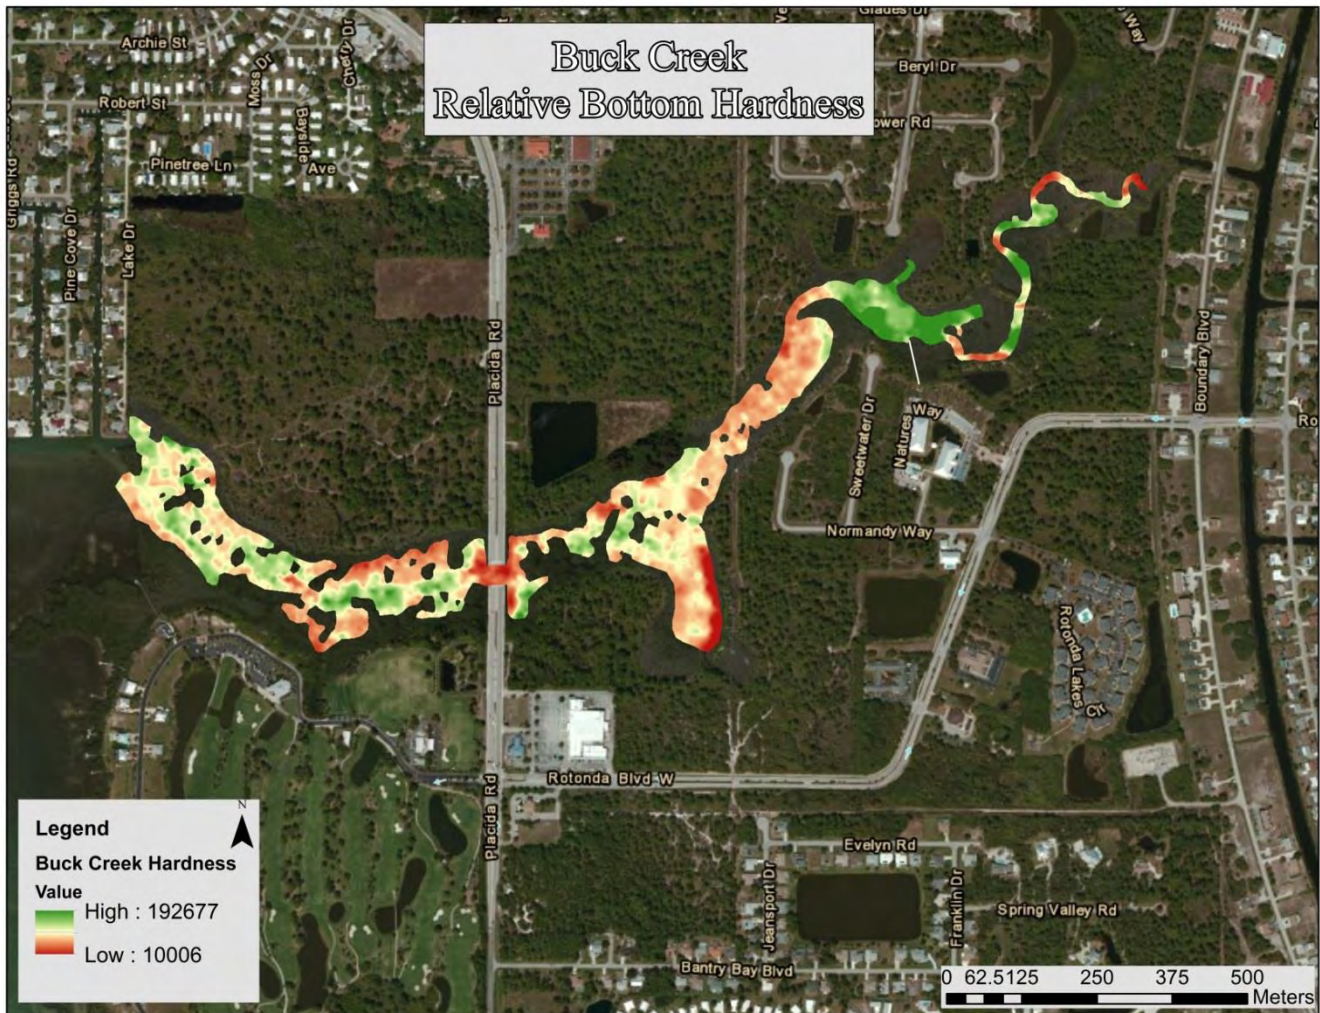
Figure 60. Buck Creek Relative Bottom Hardness Map

Collected sonar data was processed through Dr. Depth software to analyze the strength of the return signal from the bottom to get an estimate of the relative bottom hardness for Buck Creek. Figure 60 shows the bottom hardness raster for Buck Creek. In this raster, the higher the hardness value, the harder the bottom substrate. This map is meant to help identify locations of harder and softer bottoms for benthic invertebrate sampling, fish sampling and benthic chlorophyll sampling.

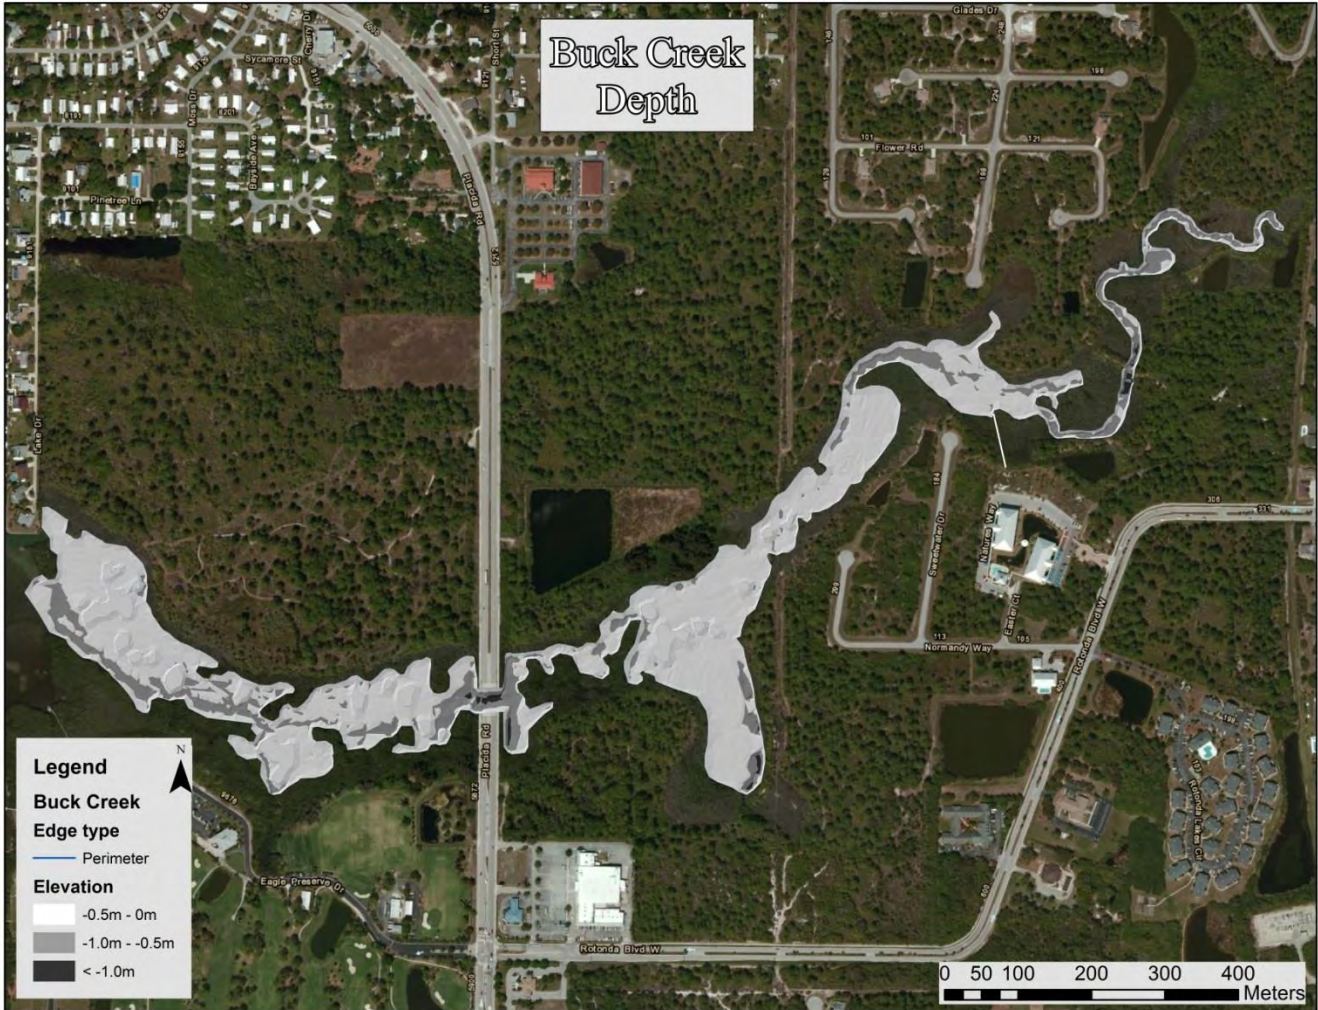
Figure 61. Buck Creek Bathymetric Stratum Map

In the study area, Buck Creek had a mean depth of 1.73 feet and a maximum depth of 5.35 feet. A total of 36.94 acres of creek was mapped during the assessment. At the time of assessment, Buck Creek contained an estimated 14,652,632 gallons of water in the study area. Figure 61 details the bathymetric mapping for Buck Creek showing the three depth stratum.

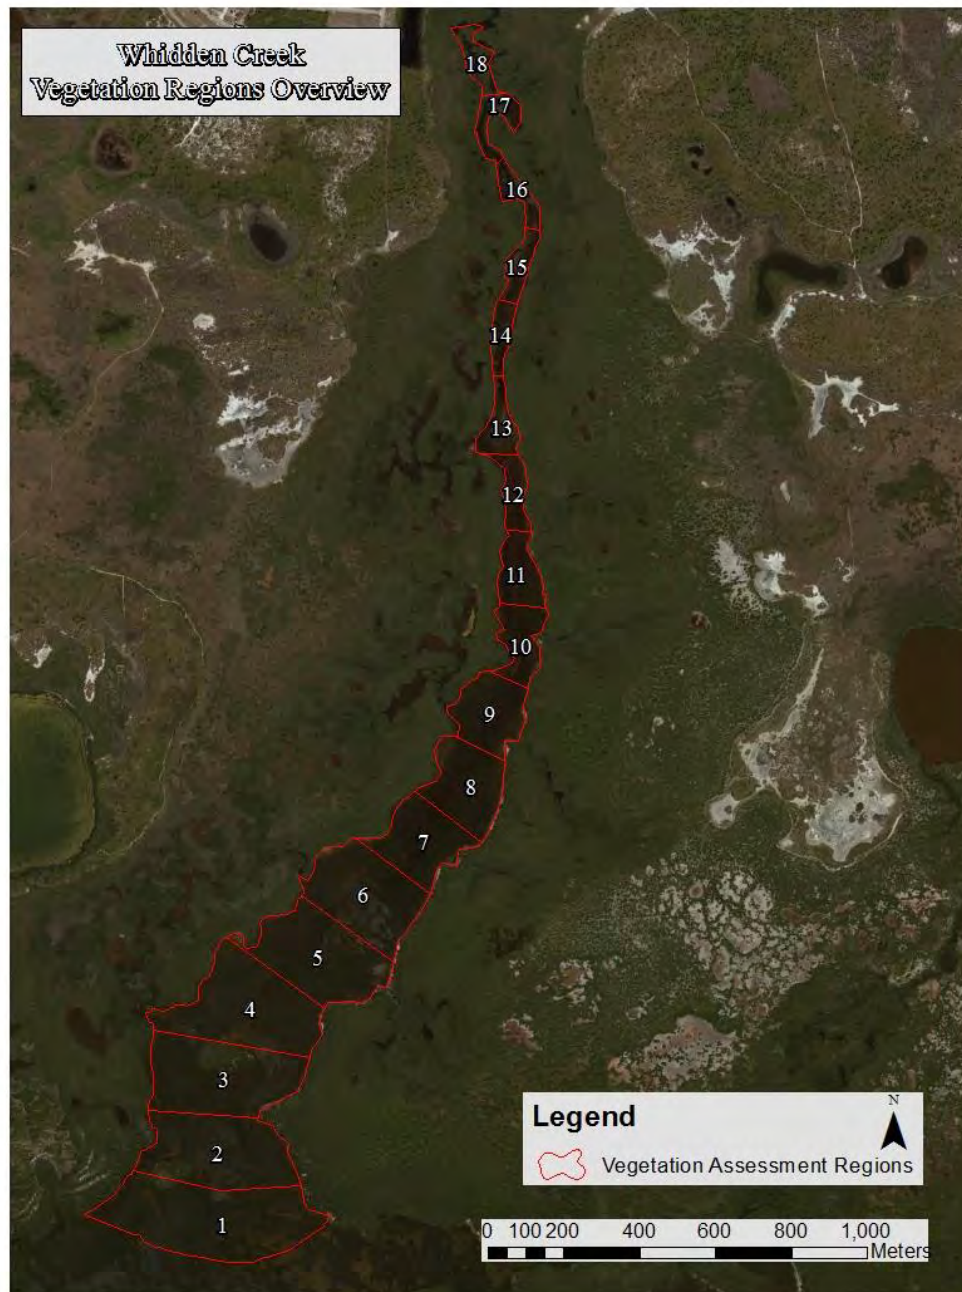
Figure 63. Overview of Whidden Creek Vegetation Assessment Regions

The Whidden Creek vegetation assessment encompassed 18 vegetation regions from the mouth in Cape Haze as shown in Figure 63. In these regions, 5 species of vegetation were identified. Regions 1 through 18 were dominated by mangroves (*Rhizophora mangle*, *Laguncularia racemosa* and *Avicennia germinans*). The only observed vegetation gradient in the study area was a change in species of seagrasses. Turtle Grass (*Thalassia testudinum*) was present in regions 1 through 3. Widgeon Grass (*Ruppia maritima*) was present in regions 1 through 14. Above Region 14 there was no more submerged vegetation observed.

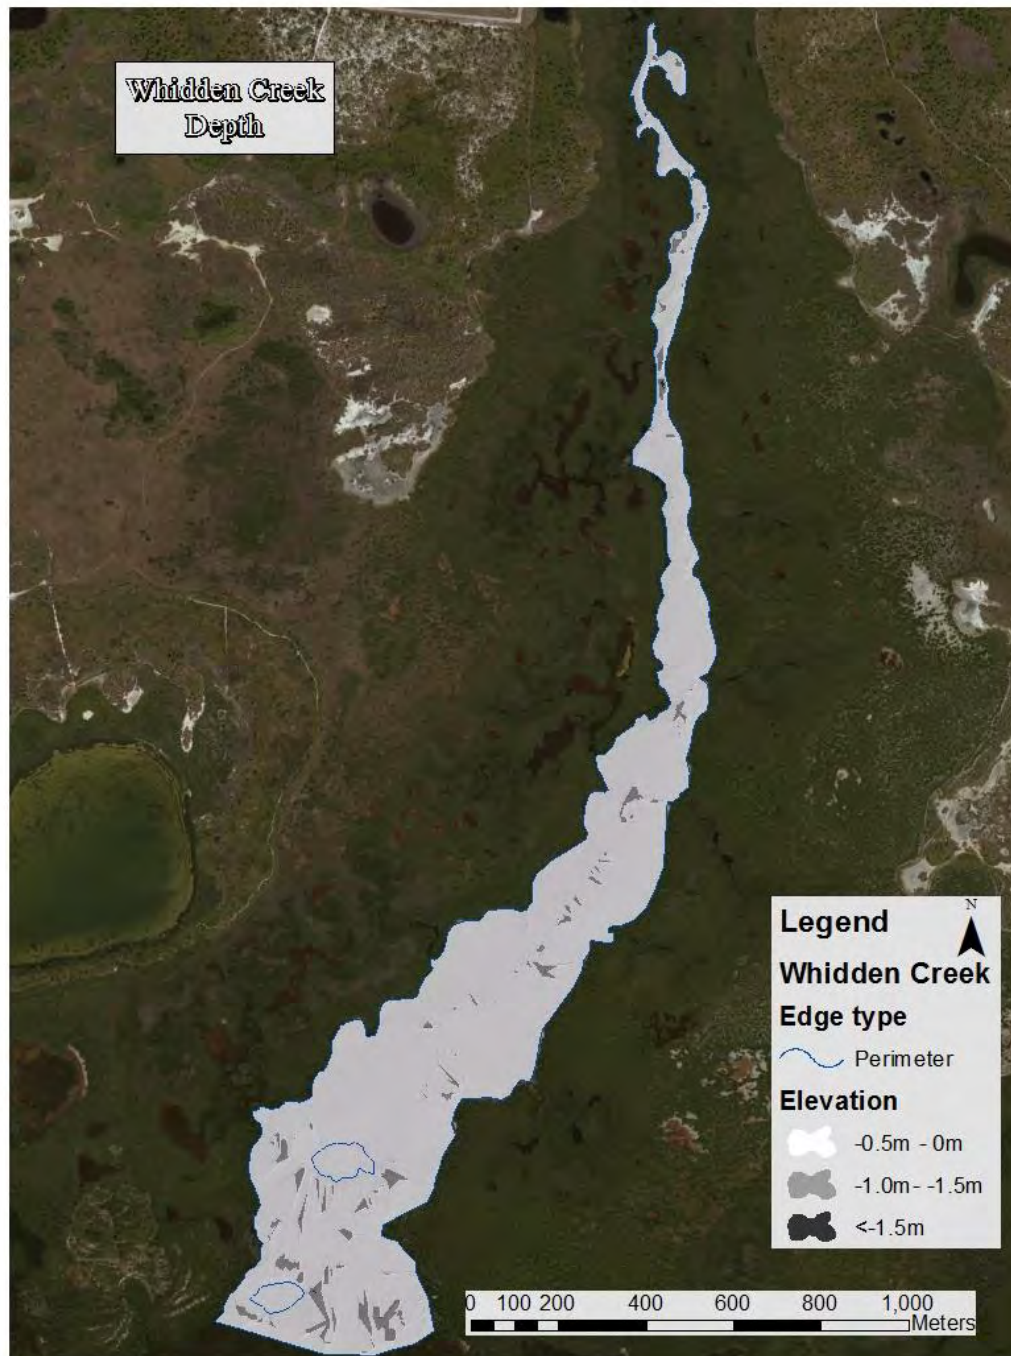
Figure 66. Whidden Creek Bathymetric Stratum Map

In the study area, Whidden Creek had a mean depth of 1.35 feet and a maximum depth of 5.19 feet. A total of 144.95 acres of creek was mapped during the assessment. At the time of assessment, Whidden Creek contained an estimated 39,793,034 gallons of water in the study area. Figure 66 details the bathymetric mapping for Whidden Creek showing the three depth stratum.

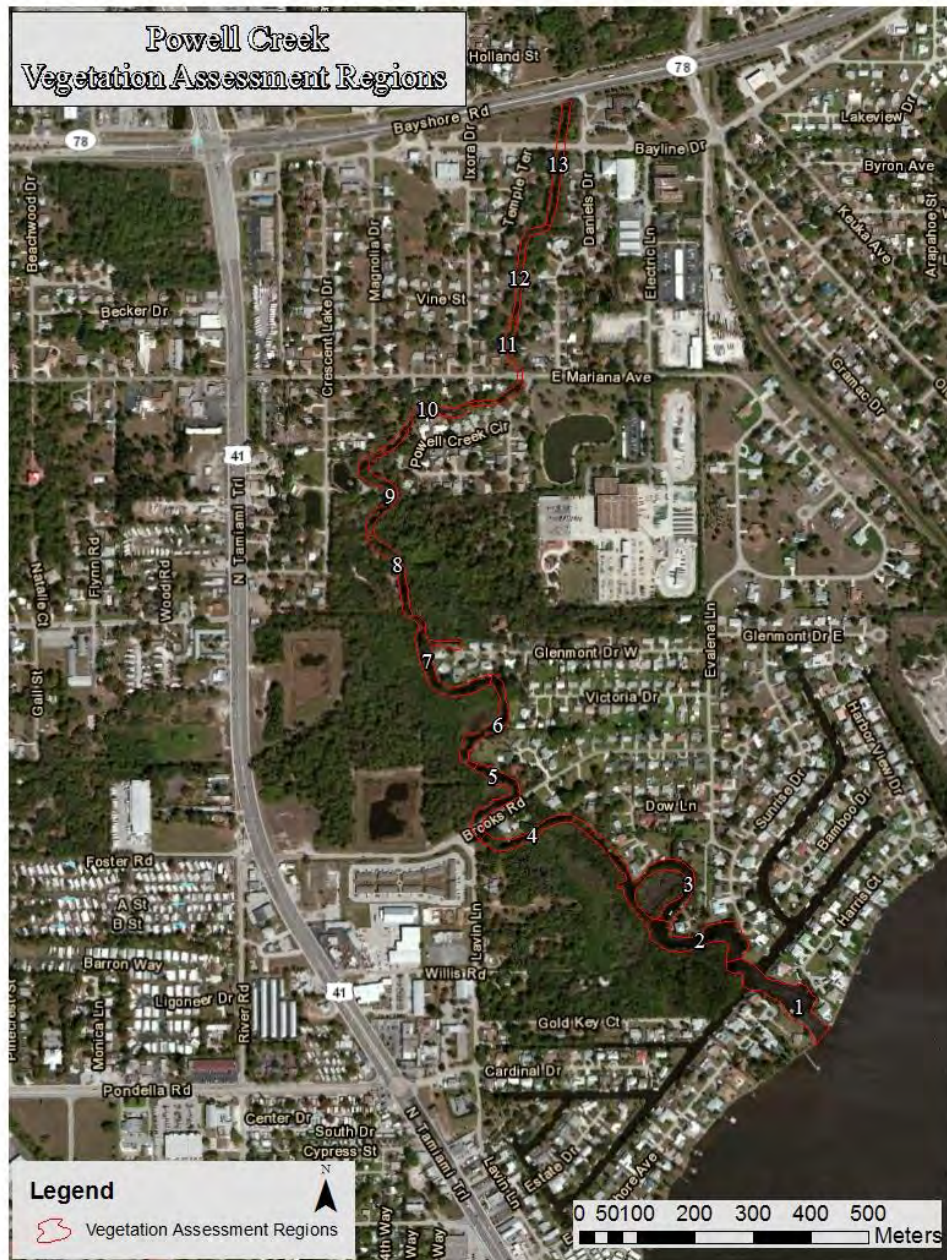
Figure 73. Overview of Powell Creek Vegetation Assessment Regions

The Powell Creek vegetation assessment encompassed 13 vegetation regions from the mouth in the tidal Caloosahatchee River to the overpass at Bayshore Road as shown in Figure 73. In these regions, 60 species of vegetation were identified. Regions 1 through 7 were dominated by mangroves (*Rhizophora mangle* and *Laguncularia racemosa*) with few other salt tolerant species present. The most upstream mangrove was *Rhizophora mangle* in Region 9. The first occurrence of Leather Fern (*Acrostichum danaeifolium*) was in Region 2, becoming dominant in regions 2 through 8.. Above Region 9 the vegetation communities are populated by many species indicative of dominating freshwater influence.

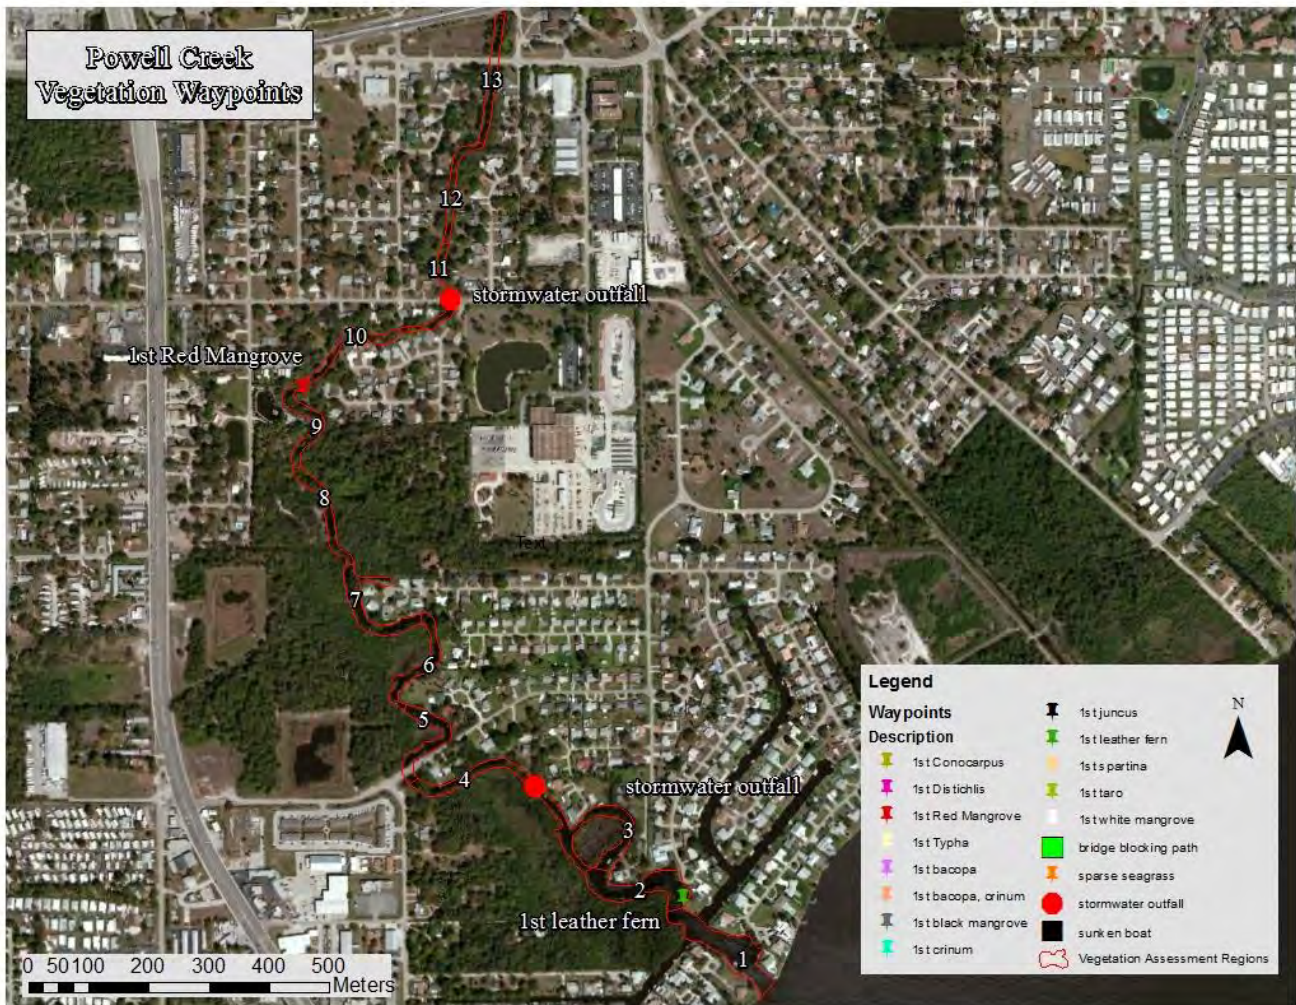
Figure 74. Powell Creek Vegetation Waypoints

Figure 74 shows the vegetation transition zone of Powell Creek indicating the most upstream Red Mangrove as well as the most downstream Leather Fern. Based on the vegetation assessment data for Powell Creek, regions 1 through 4 would comprise the highest salinity and tidal influence zone, regions 5 through 9 would comprise the “mixing” zone and regions 10 through 13 would comprise the freshwater dominant zone. The vegetation assessment species list is shown in Table 18.

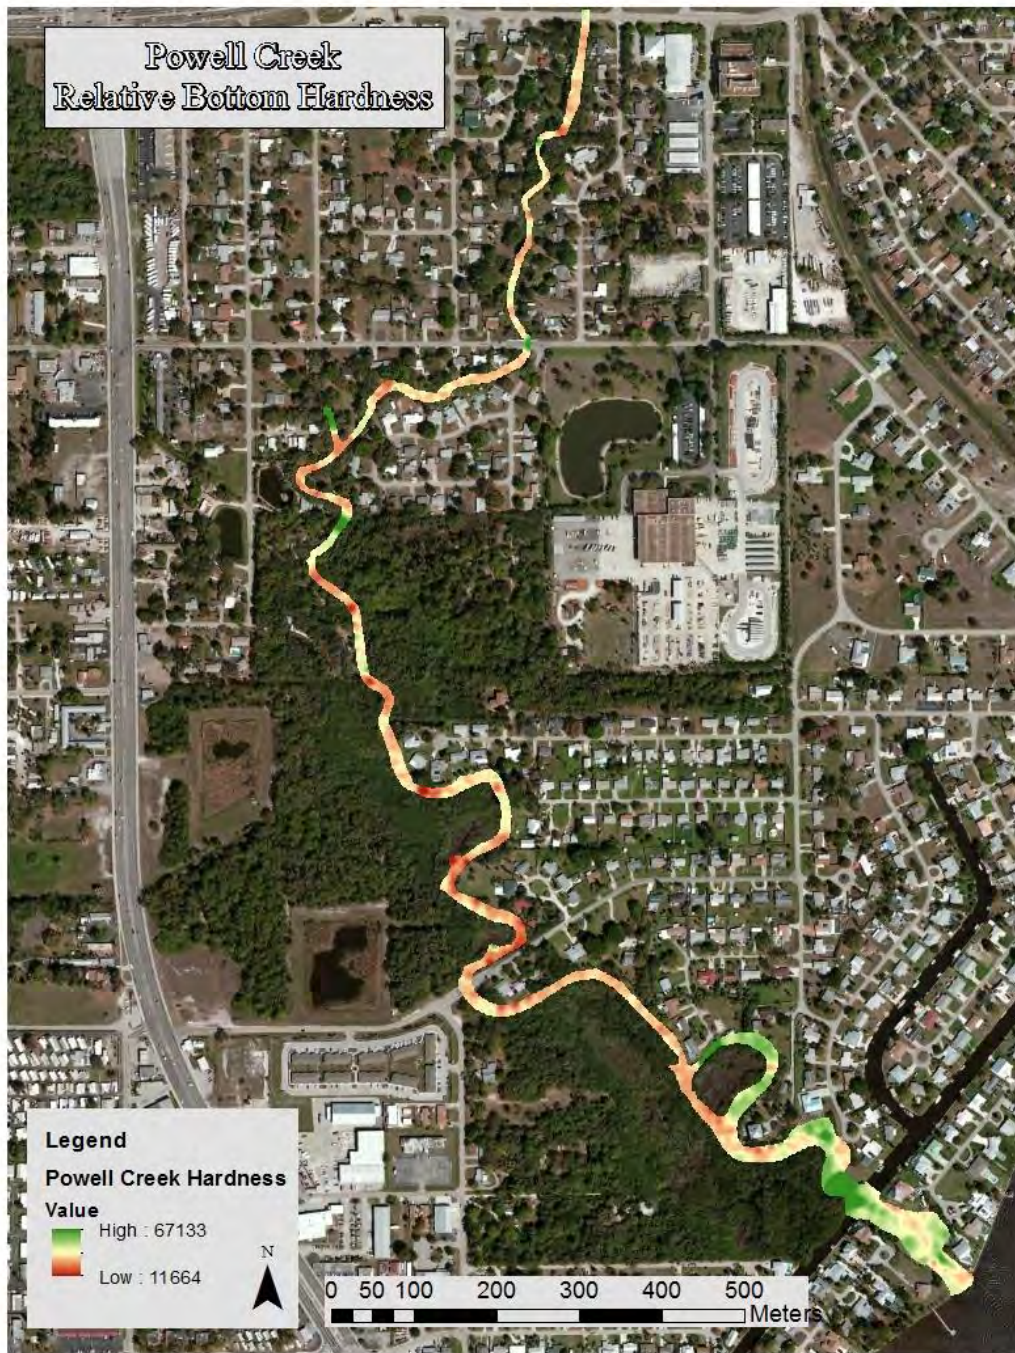
Figure 75. Powell Creek Relative Bottom Hardness Map

Collected sonar data was processed through Dr. Depth software to analyze the strength of the return signal from the bottom to get an estimate of the relative bottom hardness for Powell Creek. Figure 75 shows the bottom hardness raster for Powell Creek. This map is meant to help identify locations of harder and softer bottoms for benthic invertebrate sampling, fish sampling and benthic chlorophyll sampling.

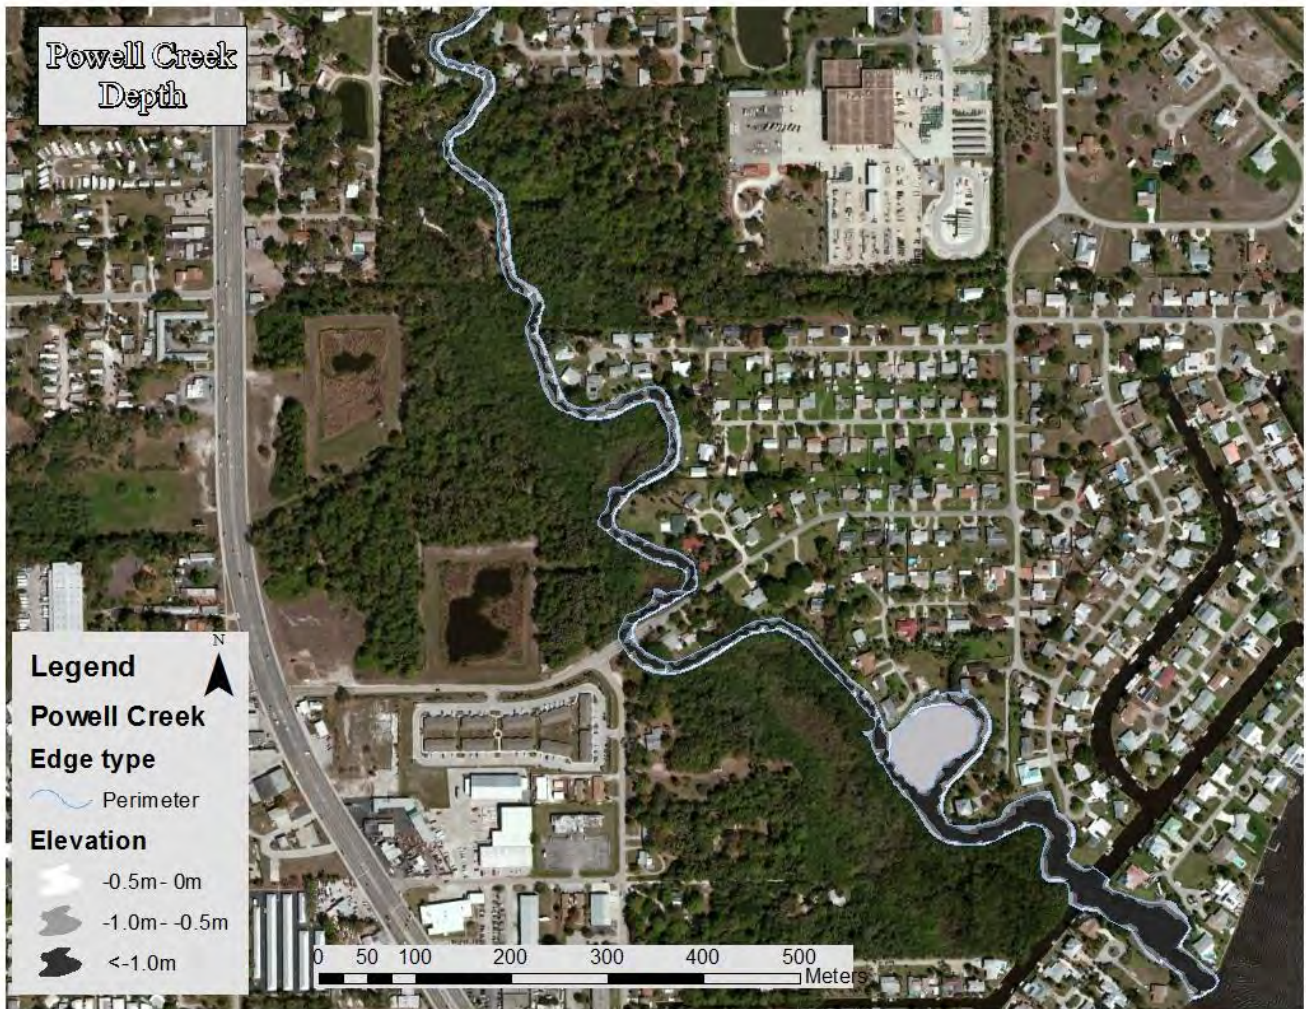
Figure 76. Powell Creek Bathymetric Stratum Map

In the study area, Powell Creek had a mean depth of 3.66 feet and a maximum depth of 7.92 feet. A total of 10.16 acres of creek was mapped during the assessment. At the time of assessment, Powell Creek contained an estimated 8,606,125 gallons of water in the study area. Figure 76 and Figure 77 detail the bathymetric mapping for Powell Creek showing the three depth stratum.

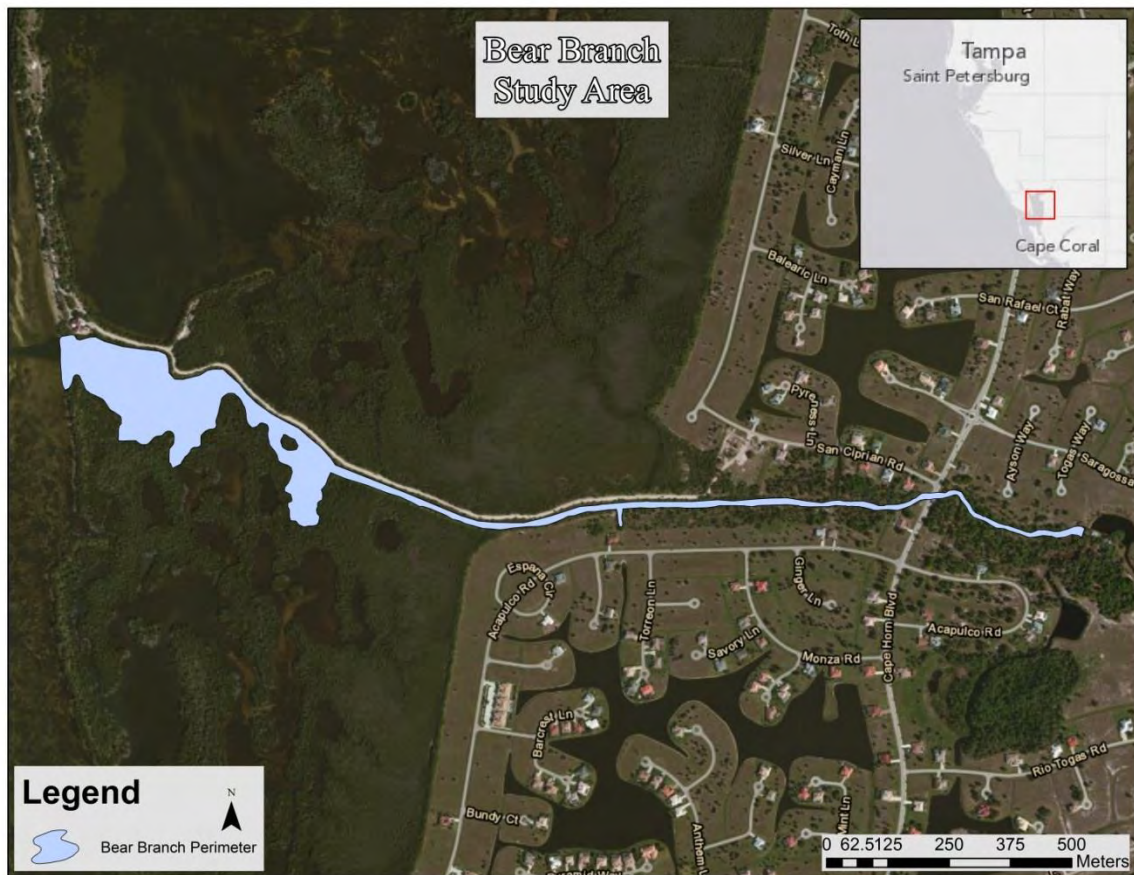
Figure 78. Overview of the Bear Branch Study Area

Bear Branch is located in the Charlotte Harbor Watershed in southern Charlotte County with its head waters in and unnamed canal at the end of Harborside Blvd and its mouth in Charlotte Harbor as shown in Figure 78. Bear Branch is also known as Key Point Canal which is located within a relatively unimpaired watershed. The downstream portion of Bear Branch is surrounded by mangroves. The upstream portion of Bear Branch is surrounded by a combination of open land and low density residential property. Bear Branch’s watershed has a LDI value of 2.7 and the area immediately surrounding the creek with a buffer LDI value of 2.1.

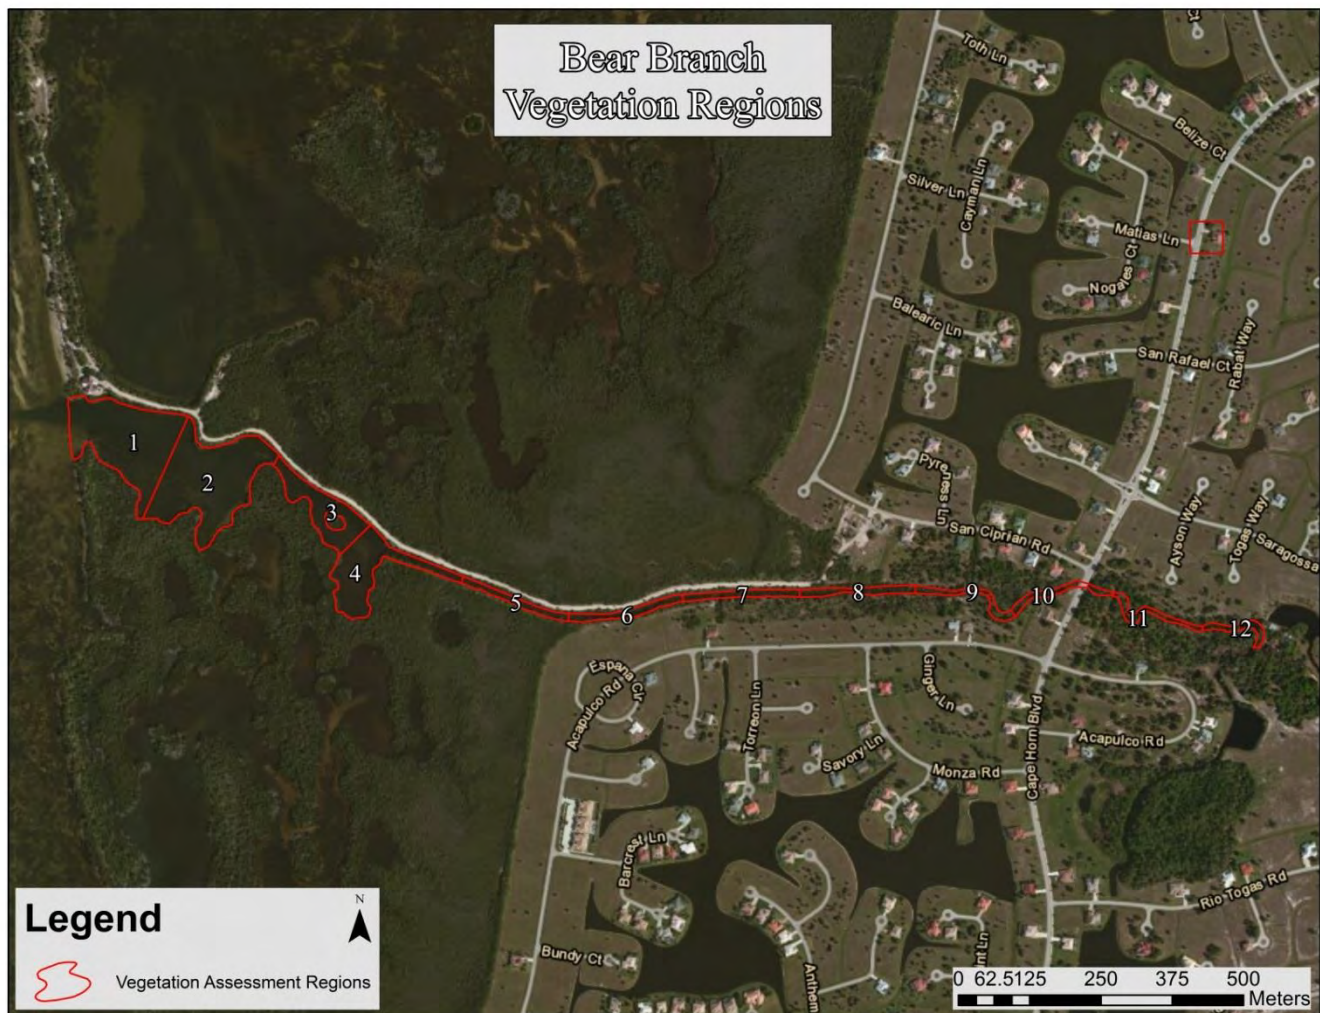
Figure 79. Overview of Bear Branch Vegetation Assessment Regions

The Bear Branch vegetation assessment encompassed 12 vegetation regions from the mouth in Charlotte Harbor to the culvert above Cape Horn Road as shown in Figure 79. In these regions, 48 species of vegetation were identified. Regions 1 through 10 were dominated by mangroves (*Rhizophora mangle*, *Laguncularia racemosa* and *Avicennia germinans*) with few other salt tolerant species present. The most upstream mangrove was *Laguncularia racemosa* in Region 10. The first occurrence of Leather Fern (*Acrostichum danaeifolium*) was in Region 7, becoming co-dominant in regions 10 and 11. Needle Rush (*Juncus roemerianus*) was first observed in Region 9. Above the Cape Horn Road bridge in Region 10 the vegetation communities are populated by many species indicative of dominating freshwater influence.
