West-Central Florida Tidal Stream Assessment Study

Prepared for the Sarasota Bay Estuary Program by the Florida Center for
Community Design and Research at the University of South Florida

December 10, 2013

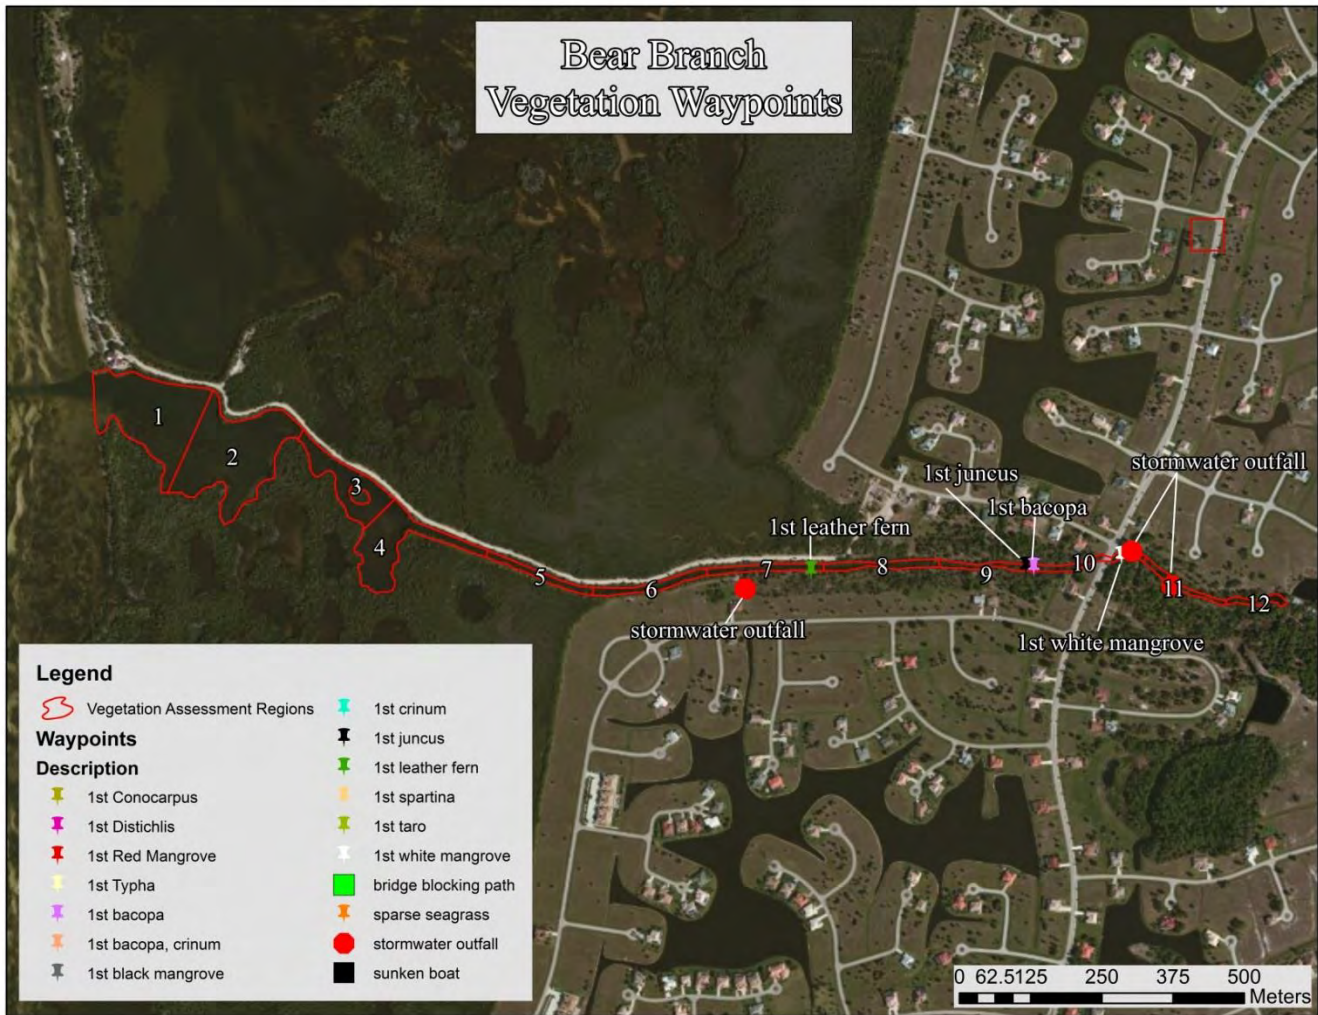
Figure 80. Bear Branch Vegetation Waypoints

Figure 80 shows the vegetation transition zone of Bear Branch indicating the most upstream White Mangrove (*Laguncularia racemosa*) as well as the most downstream Leather Fern (*Acrostichum danaeifolium*), Waterhyssop (*Bacopa monnieri*), and Needle Rush (*Juncus roemerianus*). The locations of stormwater outfalls are also indicated on the map. Based on the vegetation assessment data for Bear Branch, regions 1 through 7 would comprise the highest salinity and tidal influence zone, regions 8 through 10 would comprise the “mixing” zone and regions 11 and 12 would comprise the freshwater dominant zone. The vegetation assessment species list is shown in Table 19.

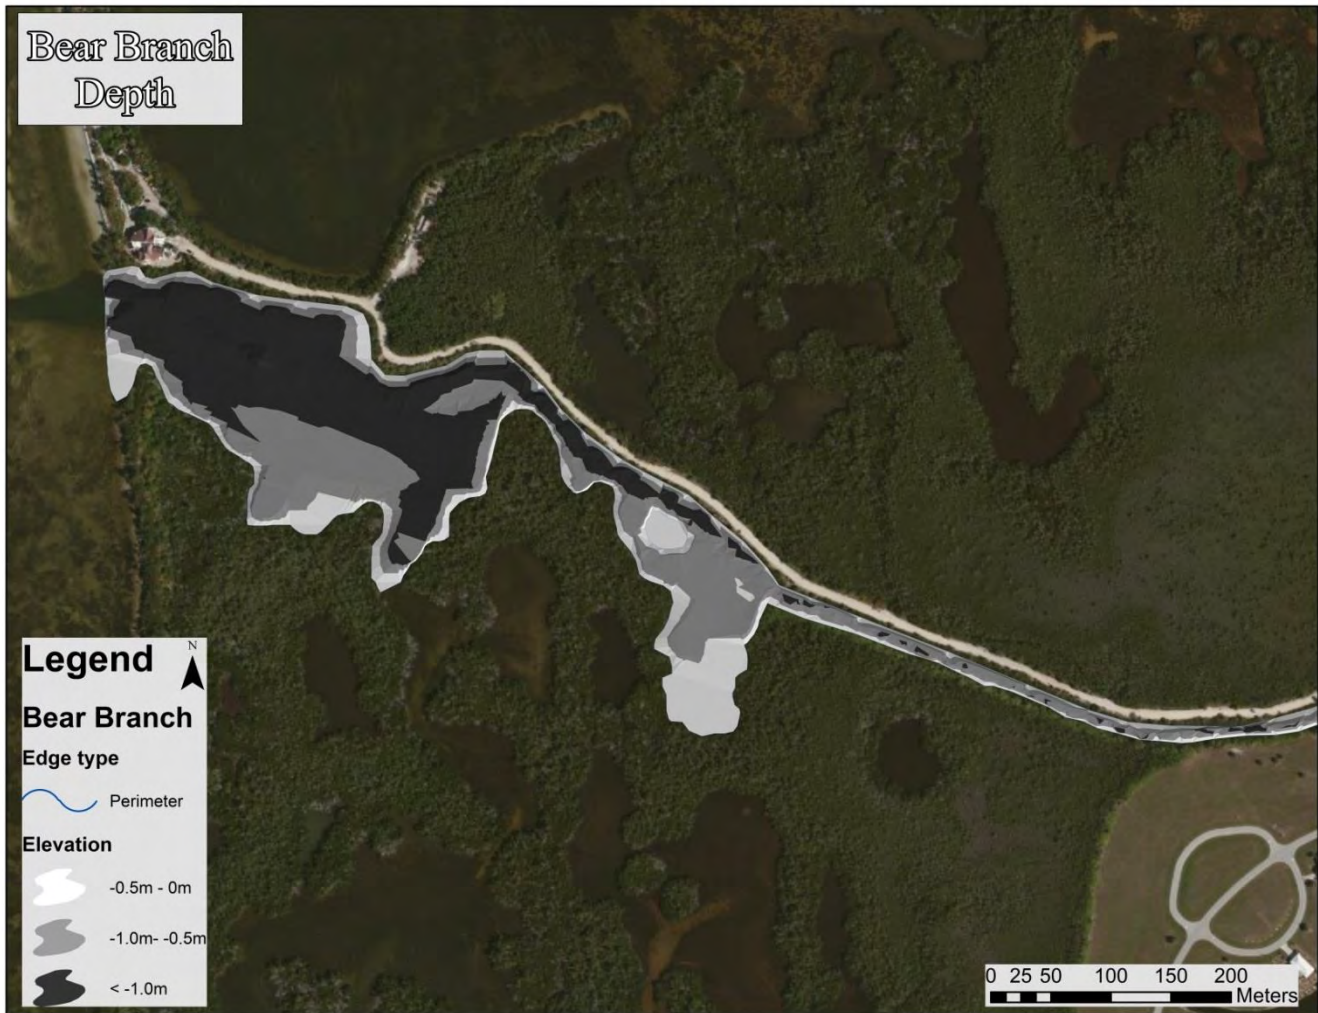
Figure 82. Bear Branch Bathymetric Stratum Map (1 of 2)

In the study area, Bear Branch had a mean depth of 3.28 feet and a maximum depth of 10.22 feet. A total of 21.19 acres of creek was mapped during the assessment. At the time of assessment, Bear Branch contained an estimated 18,600,604 gallons of water in the study area. Figure 82 and Figure 83 detail the bathymetric mapping for Bear Branch showing the three depth stratum.

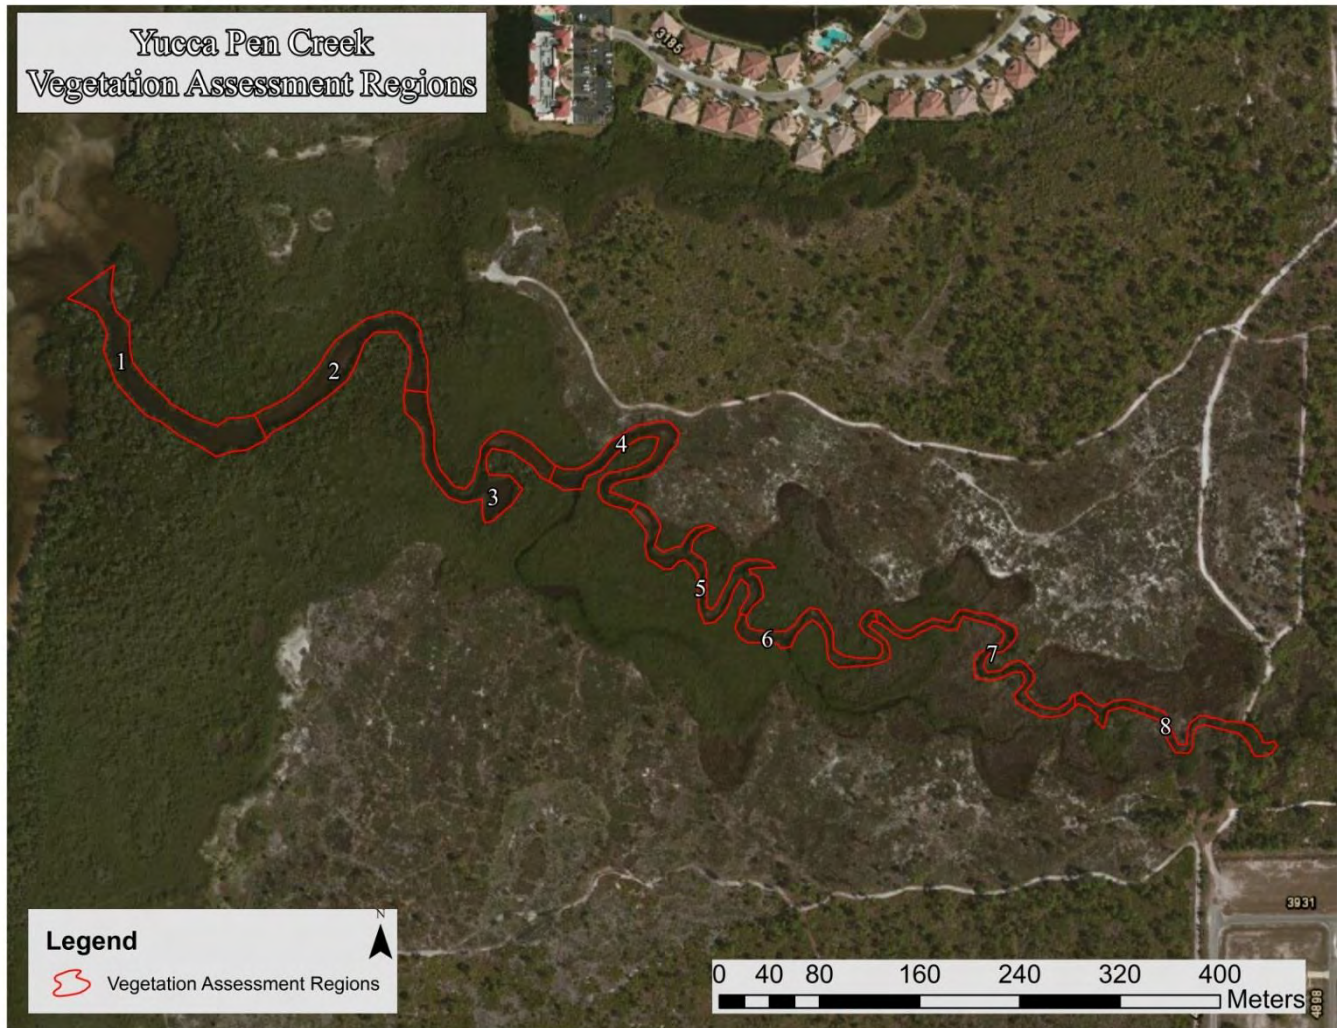
Figure 85. Overview of Yucca Pen Creek Vegetation Assessment Regions

The Yucca Pen Creek vegetation assessment encompassed 8 vegetation regions from the mouth in Charlotte Harbor to Old Burnt Store Road as shown in Figure 85. In these regions, 20 species of vegetation were identified. Regions 1 through 8 were dominated by mangroves (*Rhizophora mangle*, *Laguncularia racemosa* and *Avicennia germinans*) with few other salt tolerant species present. The first occurrence of Leather Fern (*Acrostichum danaeifolium*) was in Region 6, becoming dominant in Region 7. Needle Rush (*Juncus roemerianus*) was first observed in Region 4. Throughout the study area they vegetation indicated influence of salinity.

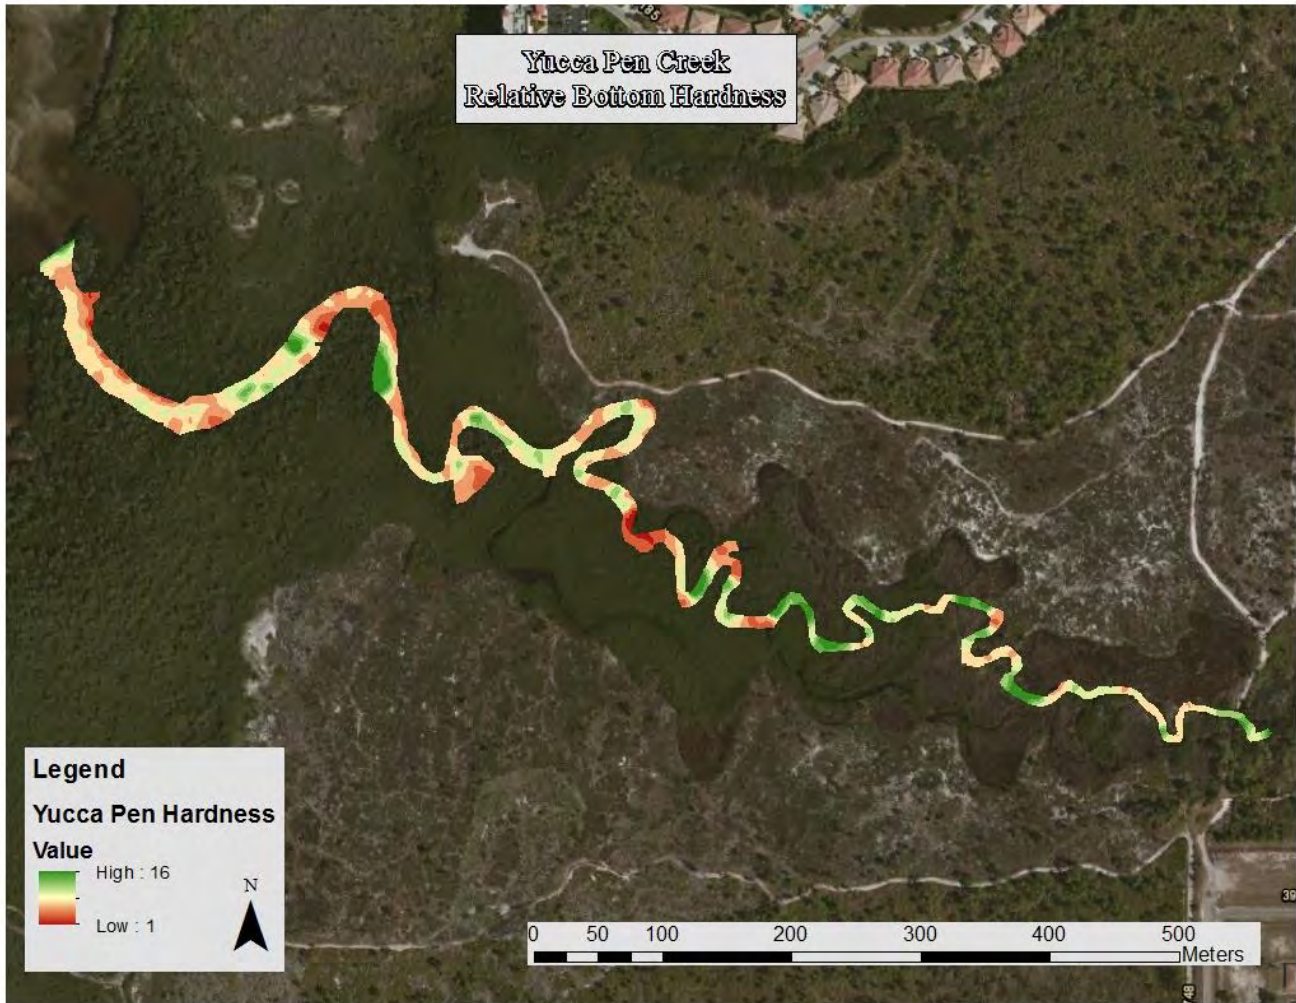
Figure 87. Yucca Pen Creek Relative Bottom Hardness Map

Collected sonar data was processed through Dr. Depth software to analyze the strength of the return signal from the bottom to get an estimate of the relative bottom hardness for Yucca Pen Creek. Figure 87 shows the bottom hardness raster for Yucca Pen Creek. This map is meant to help identify locations of harder and softer bottoms for benthic invertebrate sampling, fish sampling and benthic chlorophyll sampling.

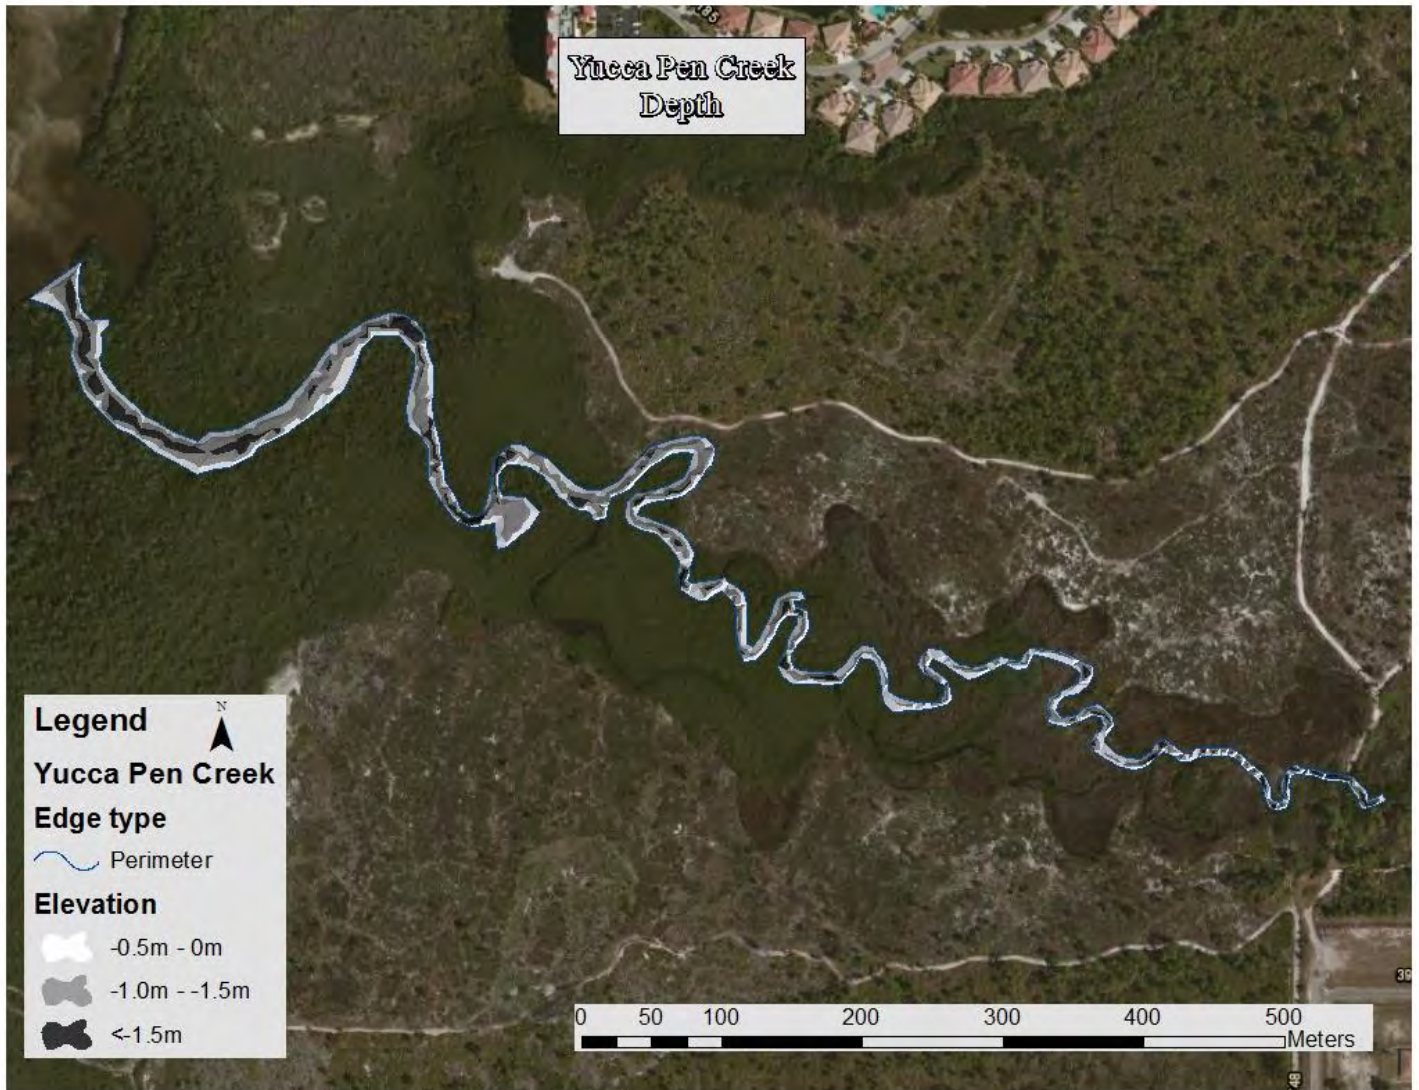
Figure 88. Yucca Pen Creek Bathymetric Stratum Map

In the study area, Yucca Pen Creek had a mean depth of 3.49 feet and a maximum depth of 12.87 feet. A total of 5.12 acres of creek was mapped during the assessment. At the time of assessment, Yucca Pen Creek contained an estimated 3,051,932 gallons of water in the study area. Figure 88 details the bathymetric mapping for Yucca Pen Creek showing the three depth stratum.

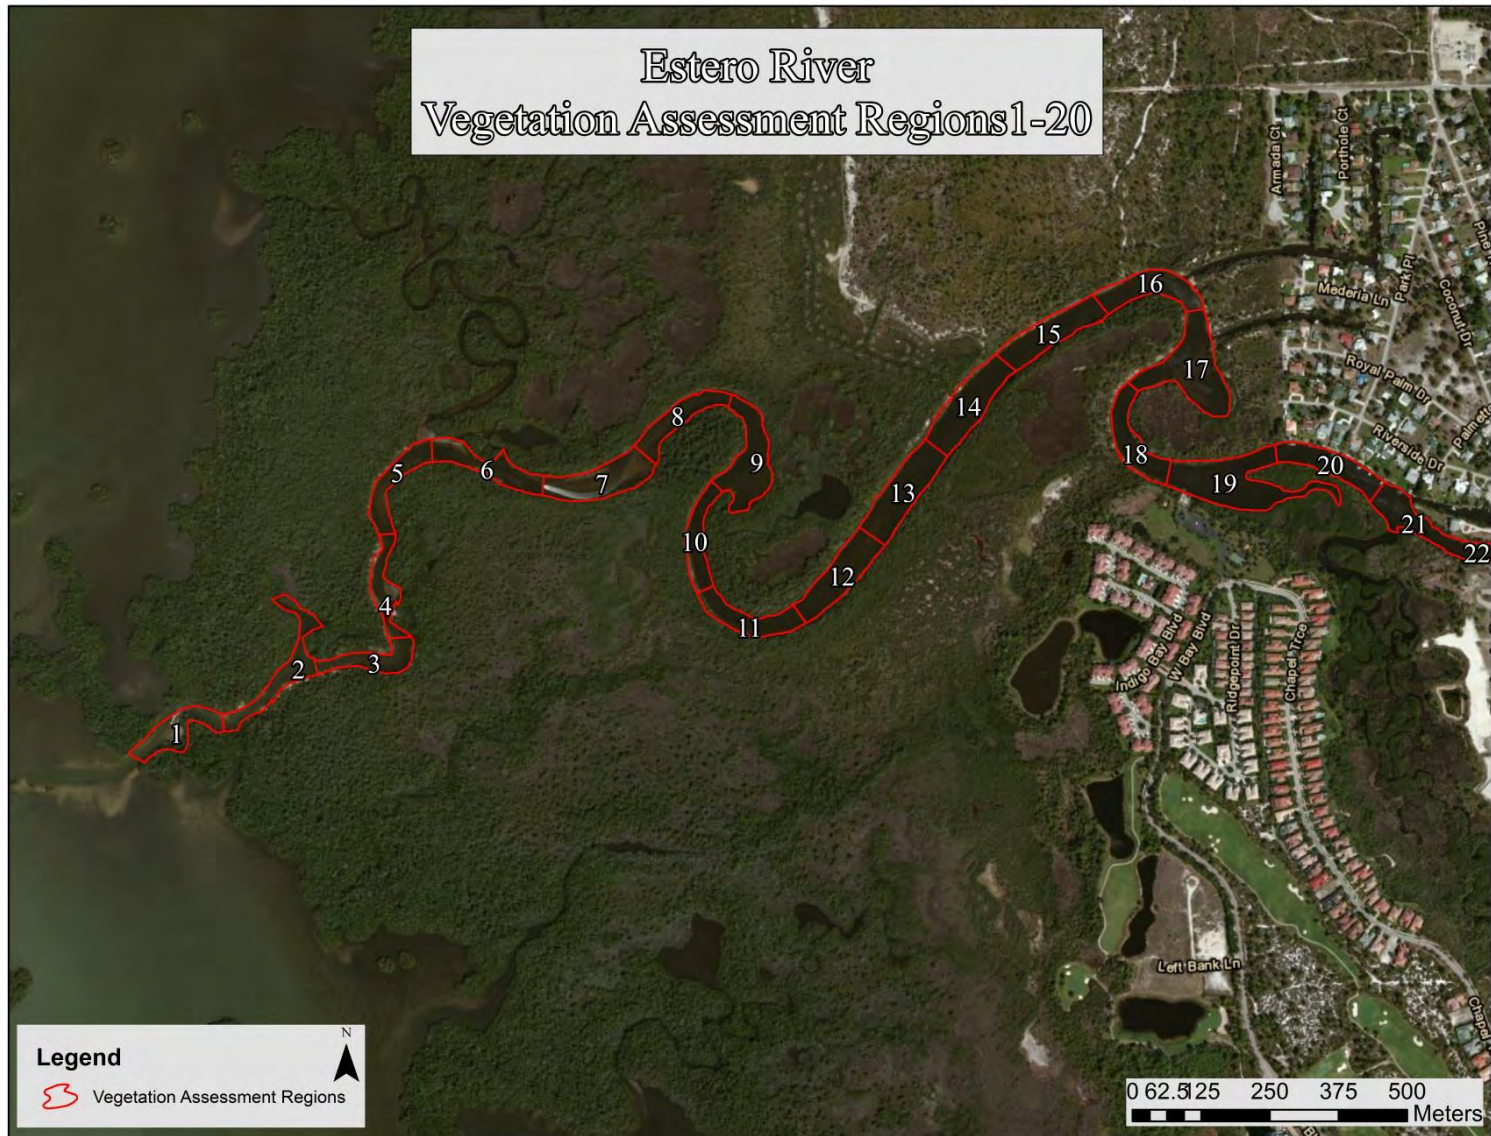
Figure 91. Estero River Vegetation Assessment Regions 1-20

The Estero River vegetation assessment encompassed 40 vegetation regions from the mouth in Estero Bay to above Sandy Lane as shown in Figure 90 through Figure 92. In these regions, 66 species of vegetation were identified. Regions 1 through 27 were dominated by mangroves (*Rhizophora mangle*, *Laguncularia racemosa* and *Avicennia germinans*) with few other salt tolerant species present. Mangroves were present throughout the study area. The first occurrence of Leather Fern (*Acrostichum danaeifolium*) was in Region 15. Needle Rush (*Juncus roemerianus*) was first observed in Region 16 with the last occurrence in Region 30. Above Region 38 the vegetation communities are populated by many species indicative of dominating freshwater influence.

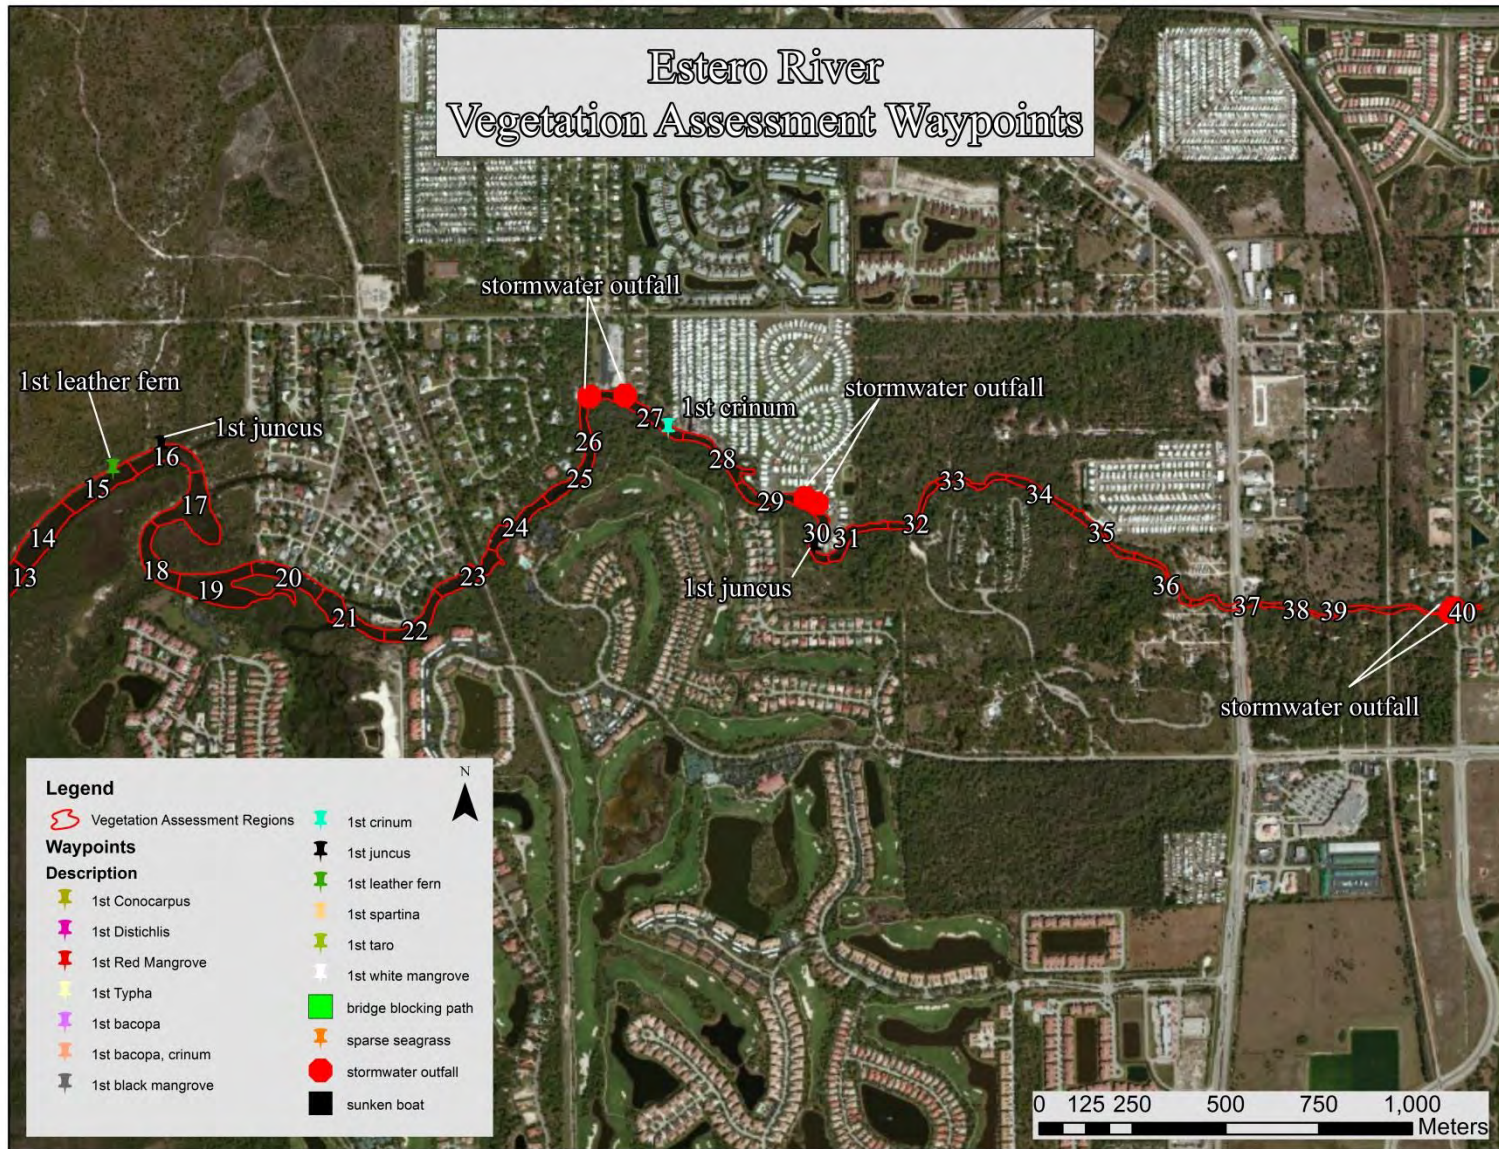
Figure 93. Estero River Vegetation Waypoints

Figure 93 shows the vegetation transition zones of Estero River indicating the most upstream *Juncus* as well as the most downstream Leather Fern, *Juncus* and *Crinum*. Based on the vegetation assessment data for Estero River, regions 1 through 15 would comprise the highest salinity and tidal influence zone, regions 16 through 30 would comprise the “mixing” zone and regions 30 through 40 would comprise the freshwater dominant zone. The vegetation assessment species lists are shown in Table 21 through Table 22.

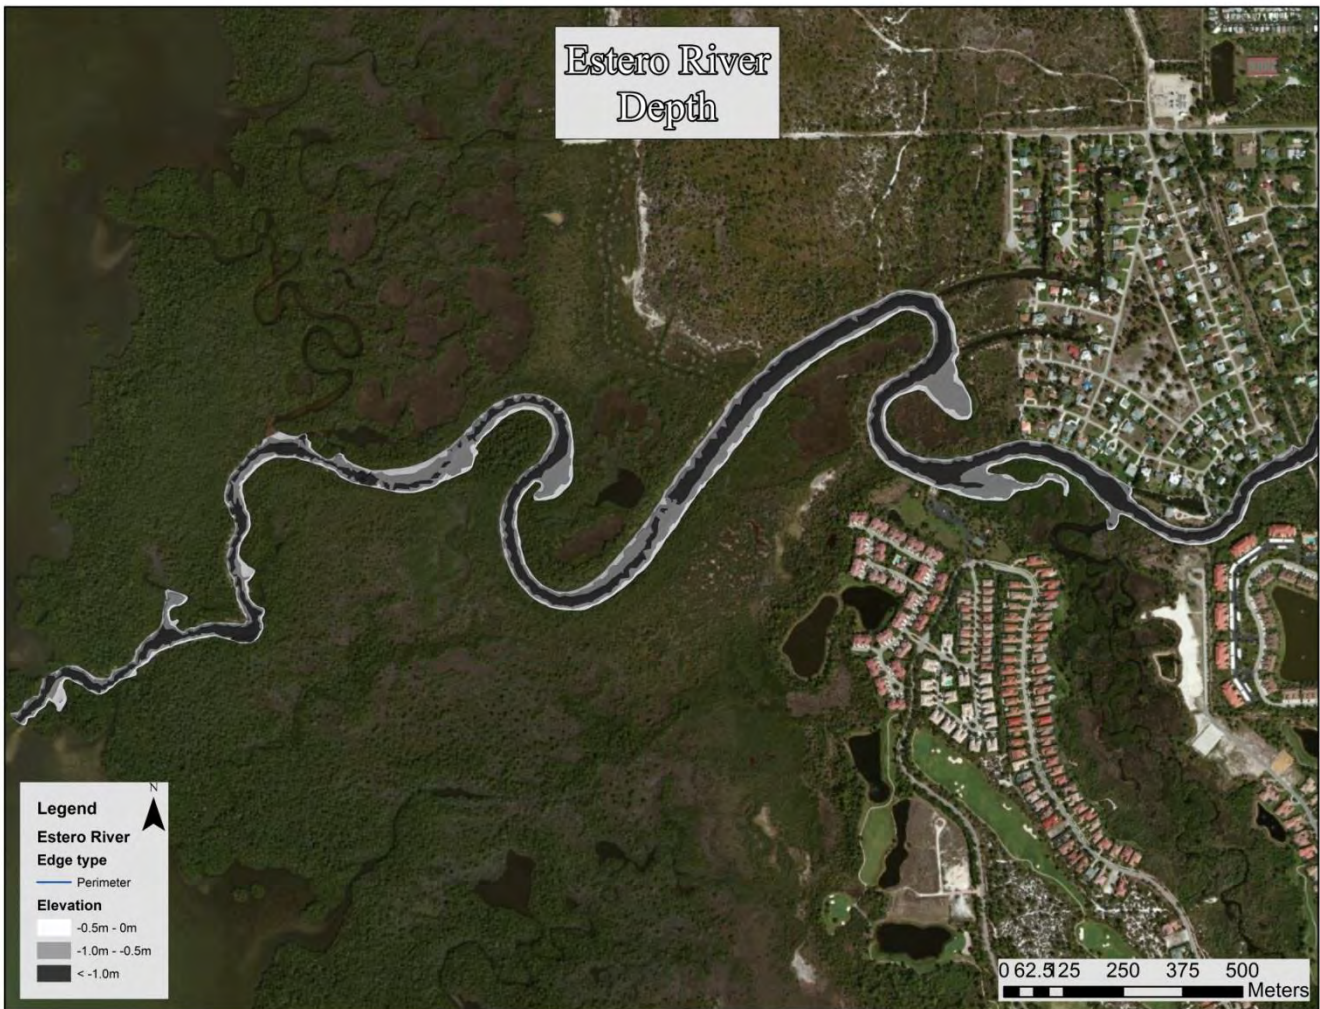
Figure 95. Estero River Bathymetric Stratum Map (1 of 2)

In the study area, Estero River had a mean depth of 3.99 feet and a maximum depth of 12.06 feet. A total of 73.78 acres of creek was mapped during the assessment. At the time of assessment, Estero River contained an estimated 69,288,066 gallons of water in the study area. Figure 95 and Figure 96 detail the bathymetric mapping for Estero River showing the three depth stratum.

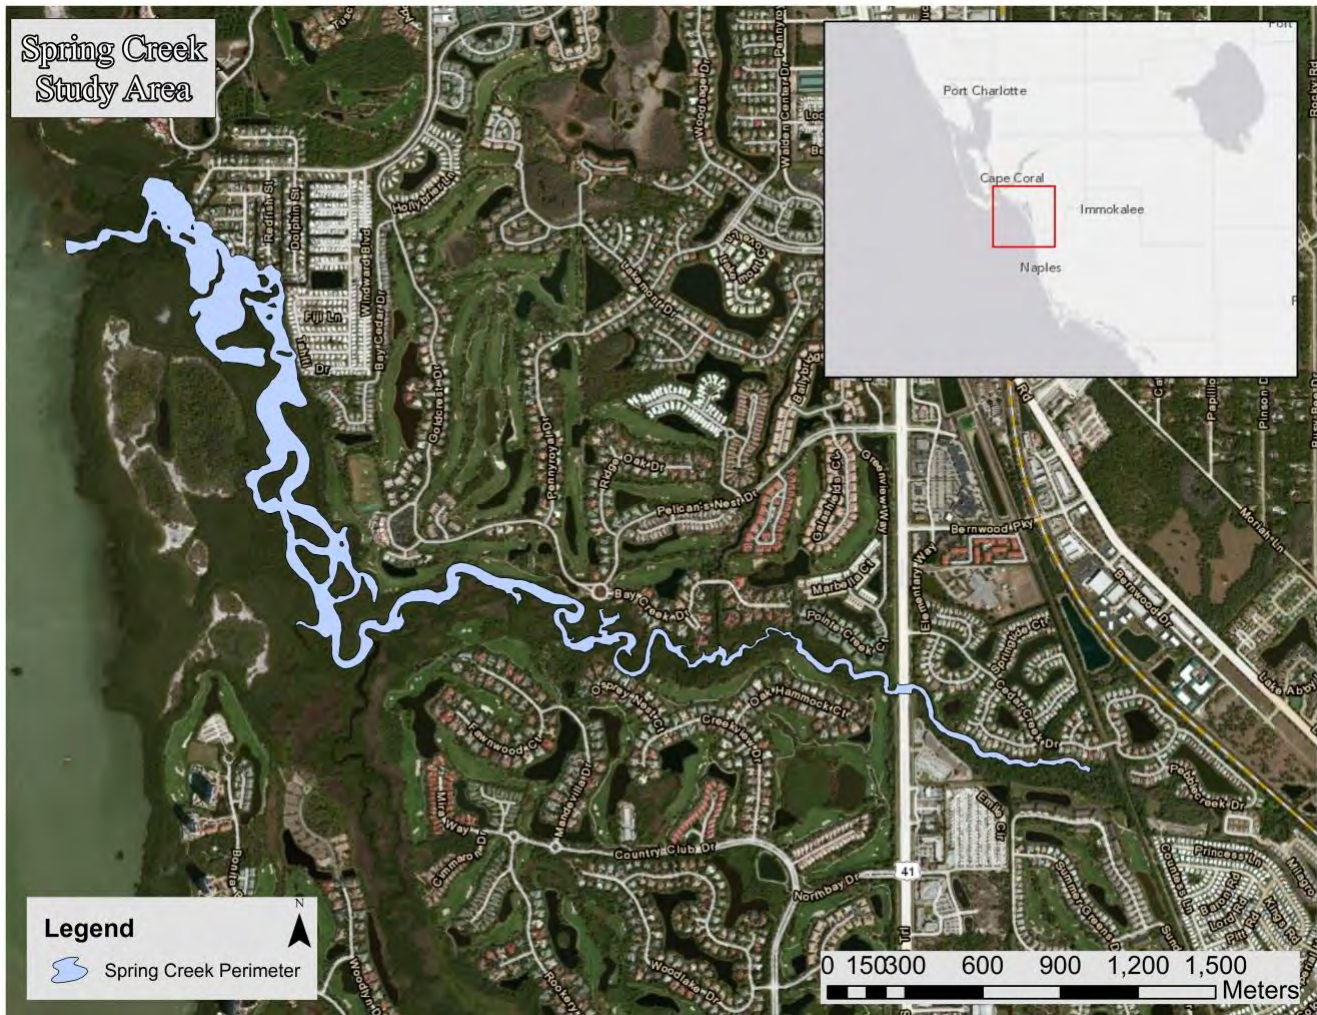
Figure 97. Overview of the Spring Creek Study Area

Spring Creek flows into Estero Bay and is located in the southern portion of Lee County. The watershed is impacted with a LDI value of 5.6 because of the urbanization on the upstream portion. The upstream portion of Spring Creek is also narrower than the downstream portion. Spring Creek widens and becomes more natural with as it moves downstream with mangroves and marsh areas along one of the banks. The creek buffer area is not highly altered with only some channelization at the mouth of the creek and a creek LDI value of 2.8.

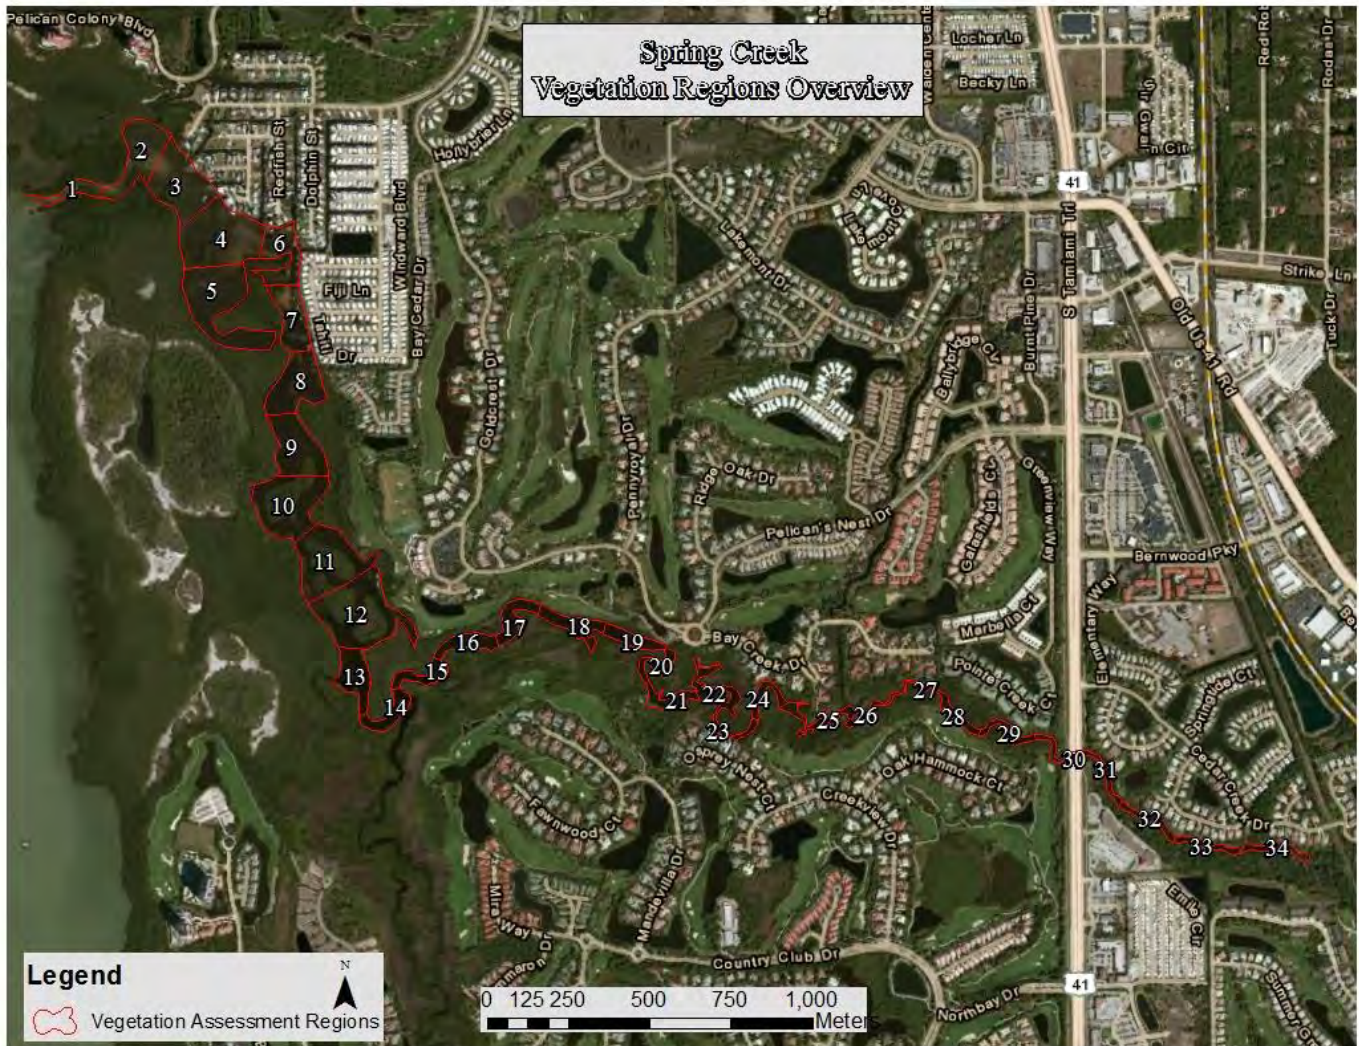
Figure 98. Overview of Spring Creek Vegetation Assessment Regions

The Spring Creek vegetation assessment encompassed 34 vegetation regions from the mouth in Estero Bay to above Highway 41 as shown in Figure 98 through Figure 100. In these regions, 44 species of vegetation were identified. Regions 1 through 32 were dominated by mangroves (*Rhizophora mangle*, *Laguncularia racemosa* and *Avicennia geminans*) with few other salt tolerant species present. The most upstream mangrove was *Rhizophora mangle*, *Laguncularia racemosa* and *Avicennia geminans* in Region 34. The first occurrence of Leather Fern (*Acrostichum danaeifolium*) was in Region 12, becoming dominant in regions 31, 32 and 34. Needle Rush (*Juncus roemerianus*) was first observed in Region 13 with the last occurrence in Region 22. Above Region 32 the vegetation communities are populated by many species indicative of dominating freshwater influence.
