# Photographs

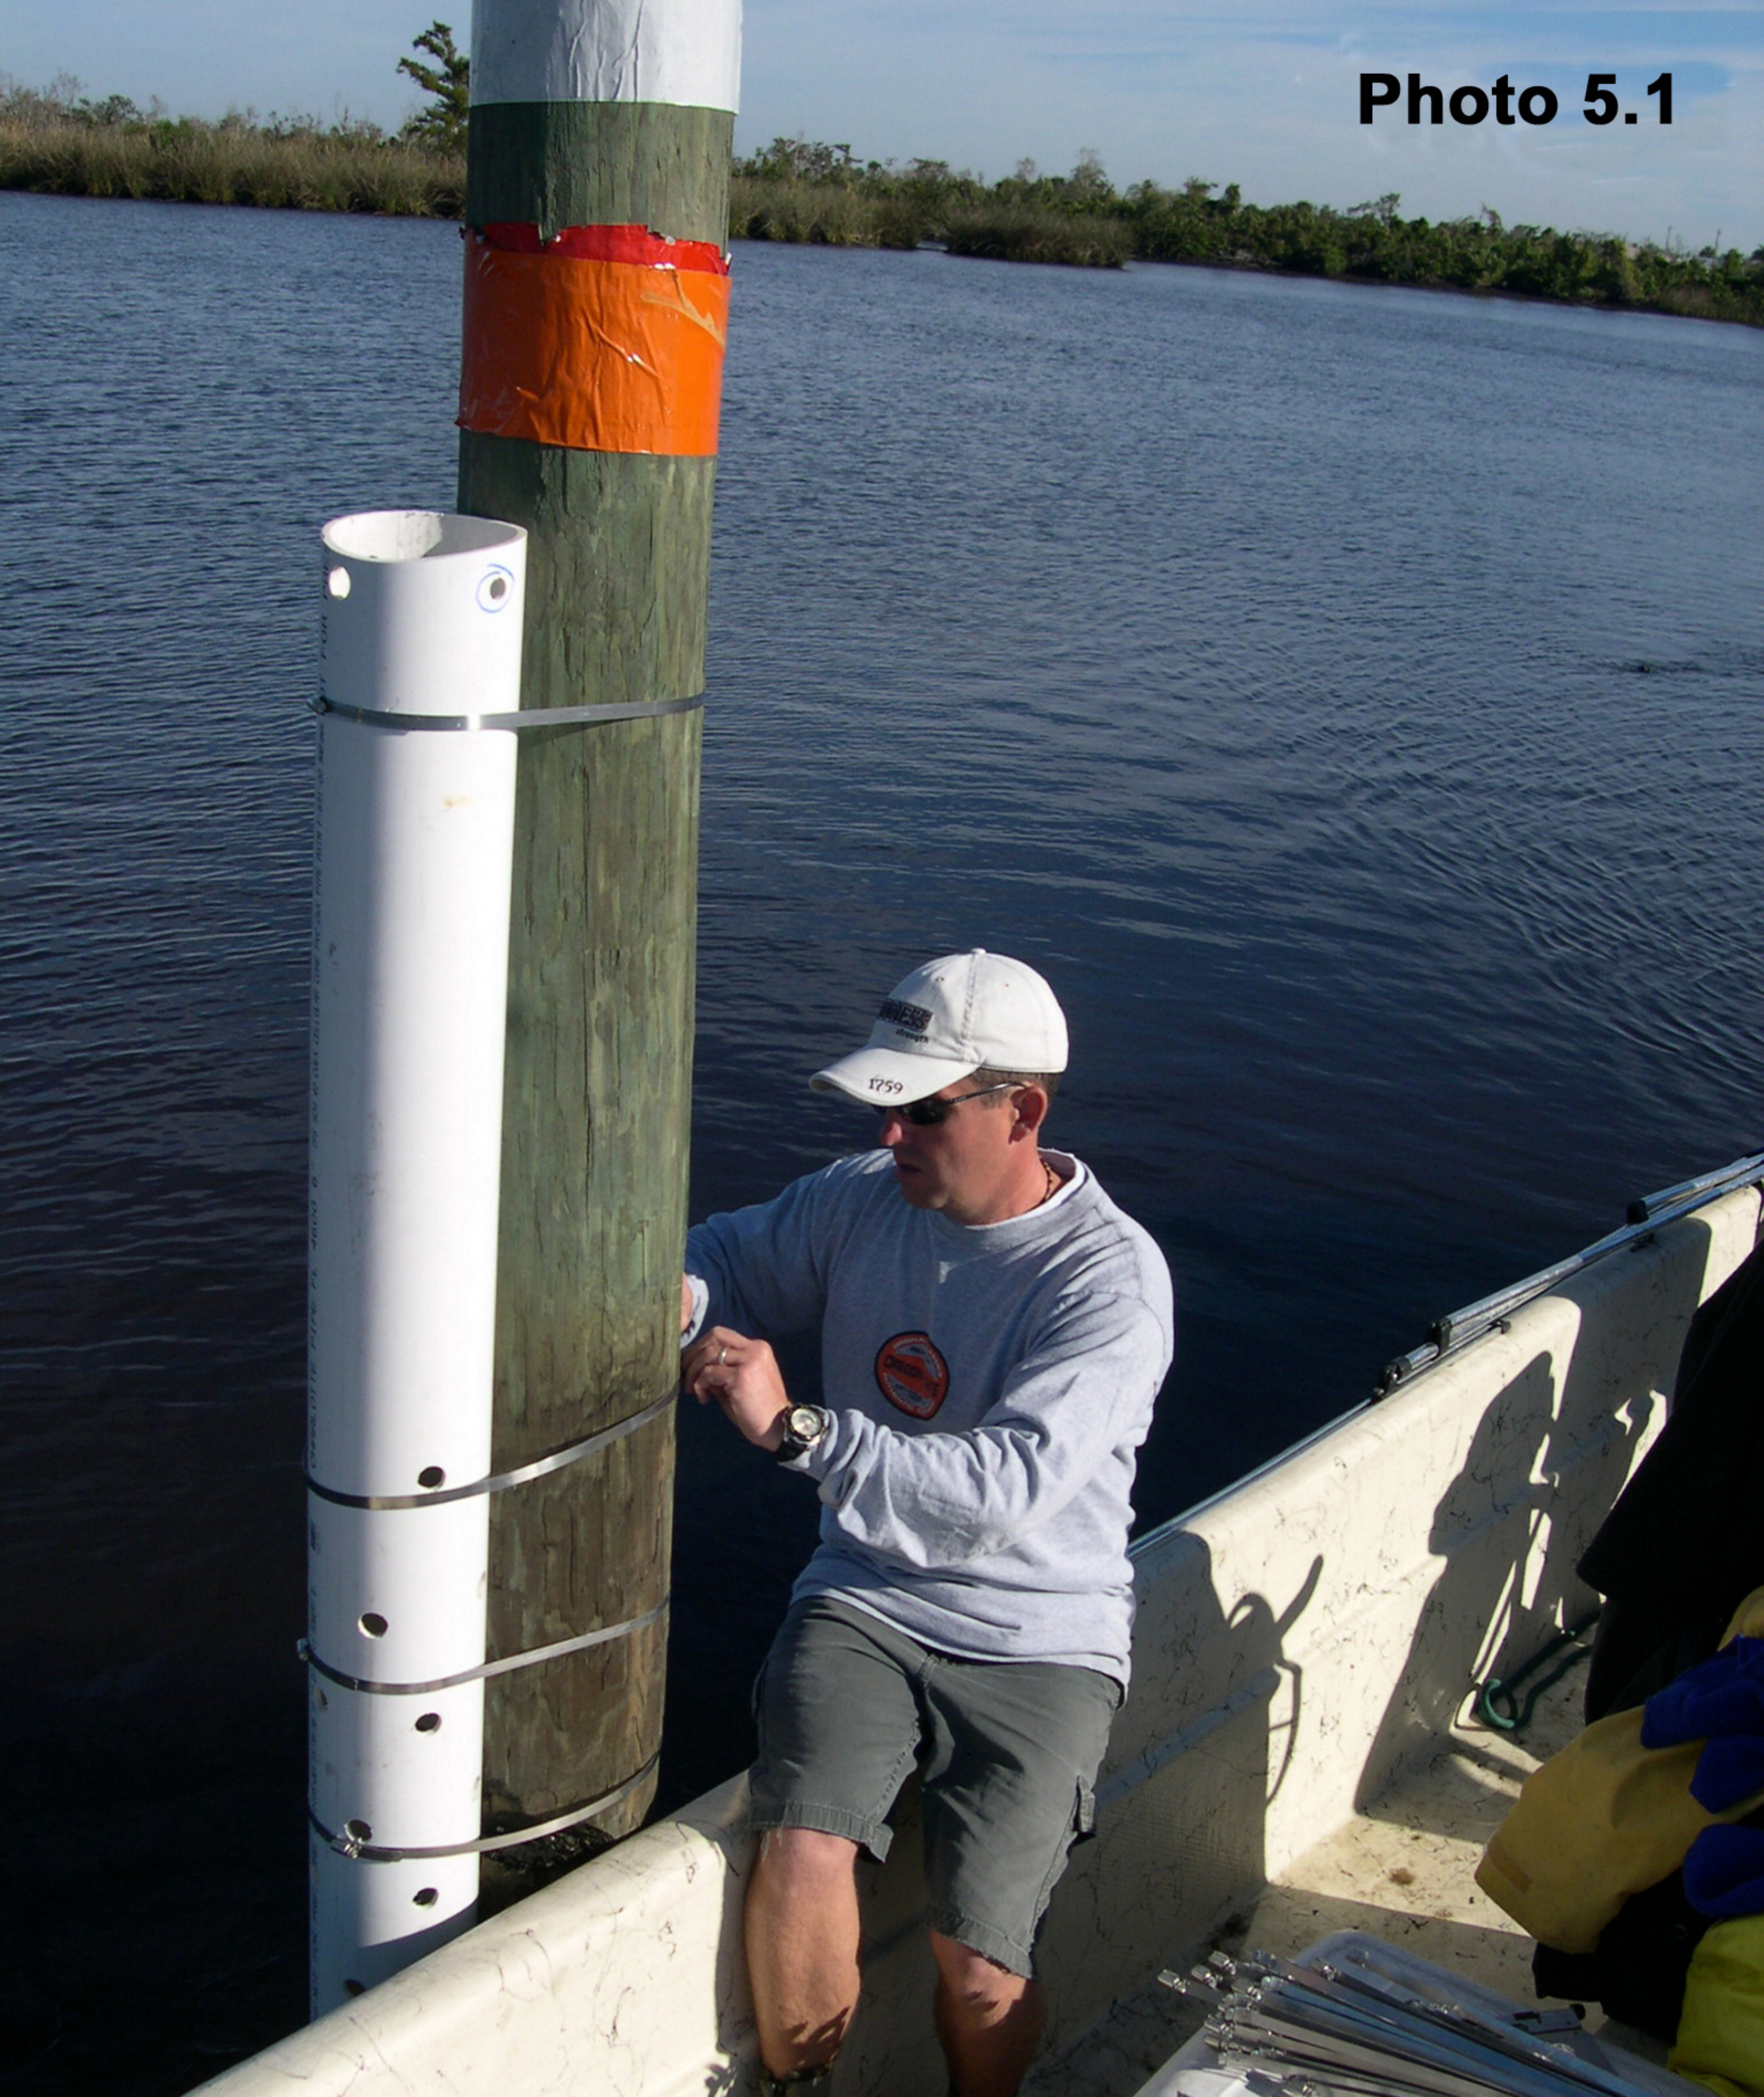
- **Photo 5.1** – shows strapping the PVC stilling well to the inside of one of the Manatee Speed Zone signs.
- **Photo 5.2** – shows the method used to attach the YSI conductivity/temperature sonde to the bullet floats.

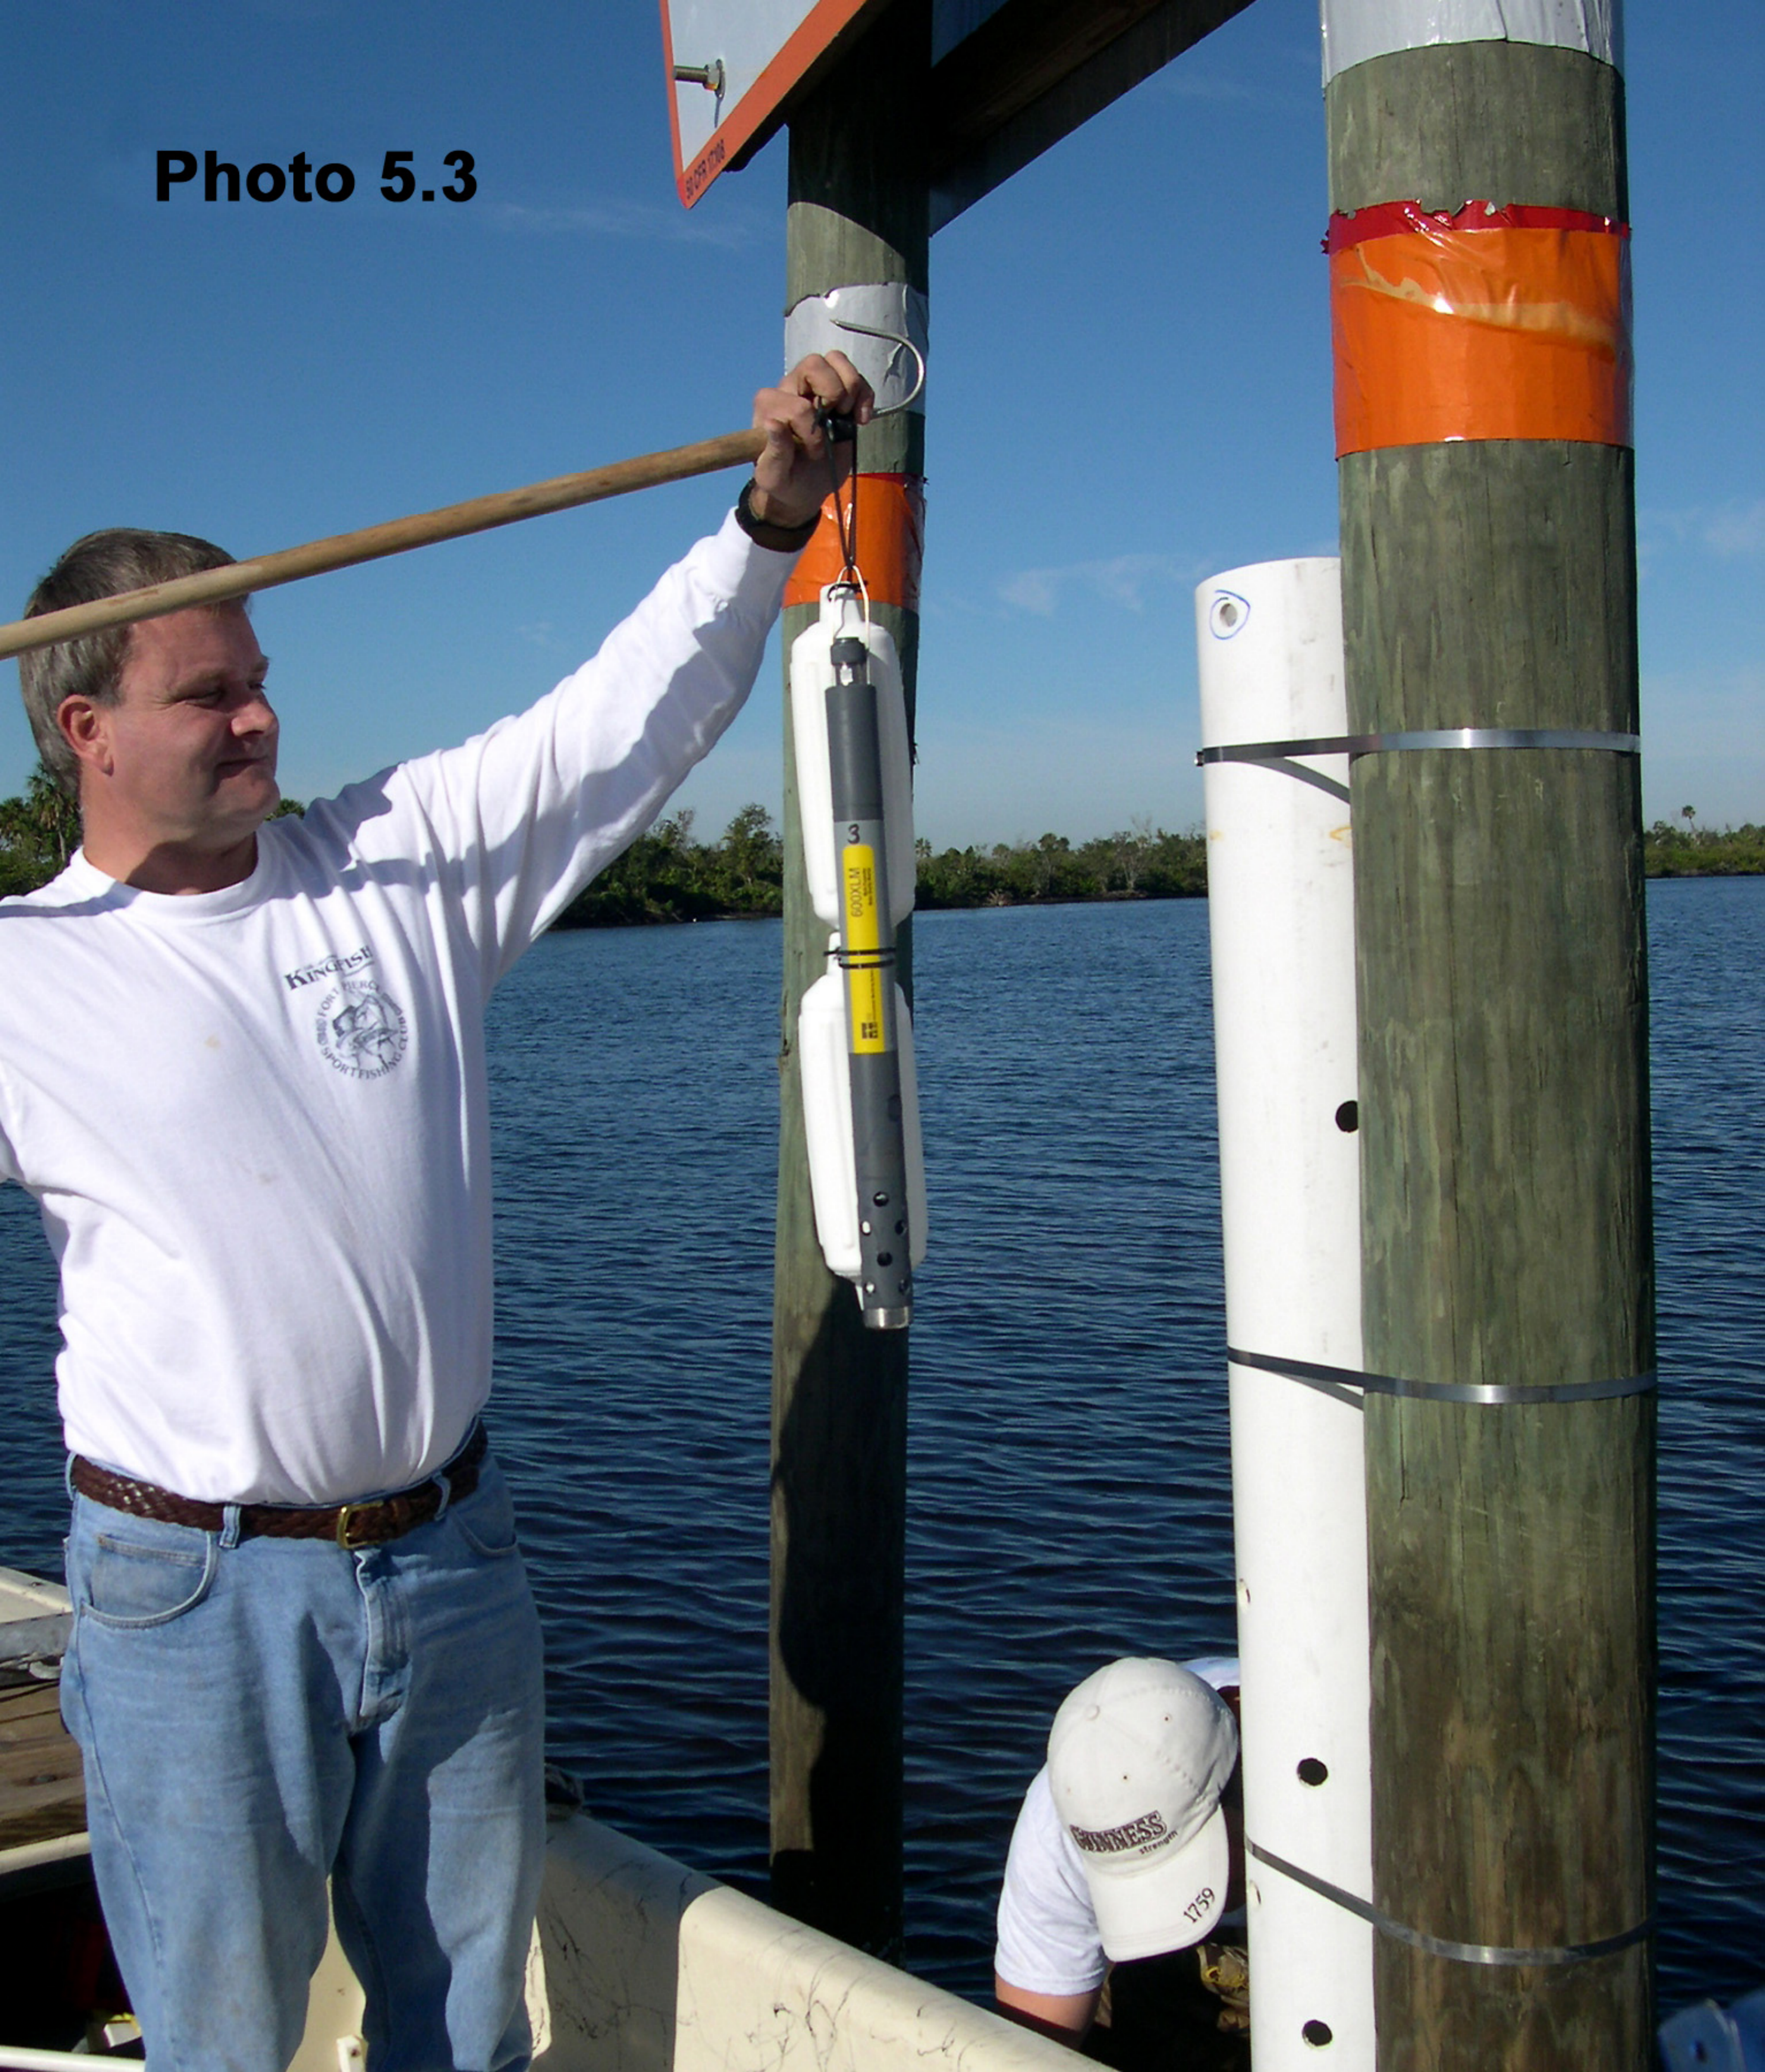
- **Photo 5.3** – the YSI conductivity/temperature sonde attached to two bullet floats is shown being readied for placement in the stilling well.
- **Photo 5.4** – shows the stilling well (with the locking cap) as seen from the river.

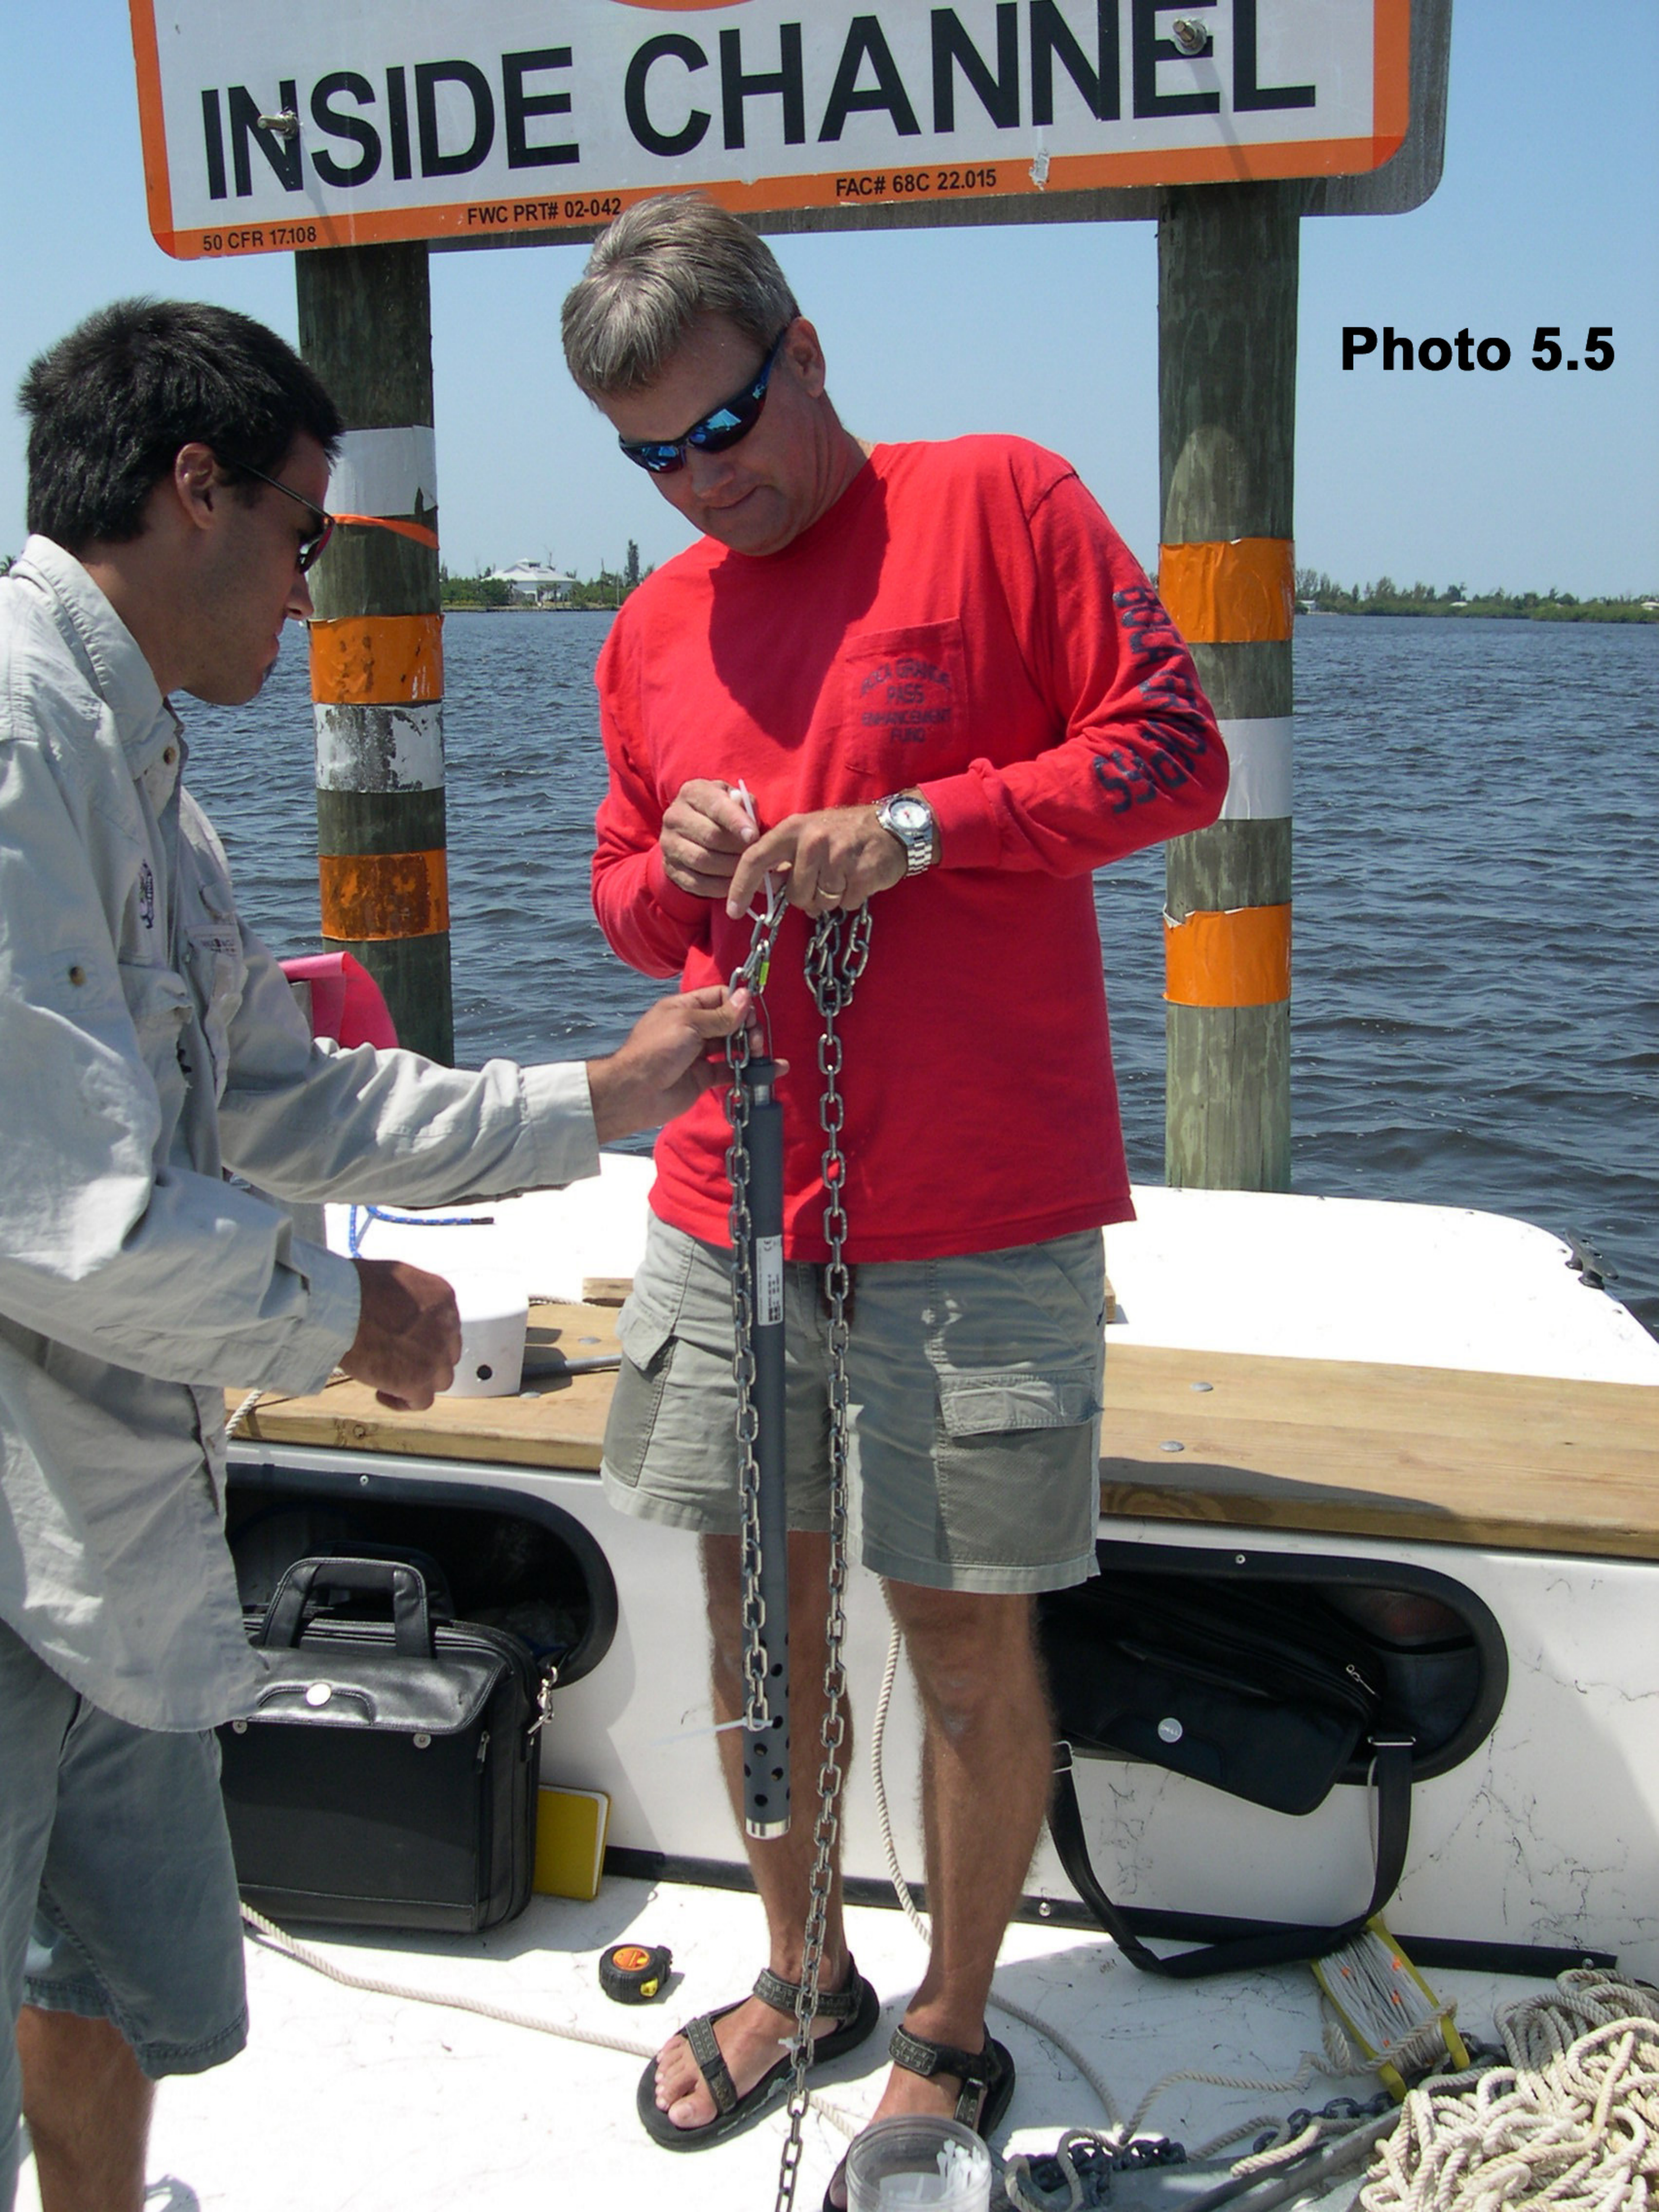
- **Photo 5.5** – This photograph shows deployment of the YSI meter near the bottom of the water column to at RK 12.7 to measure conductivity, temperature and dissolved oxygen.

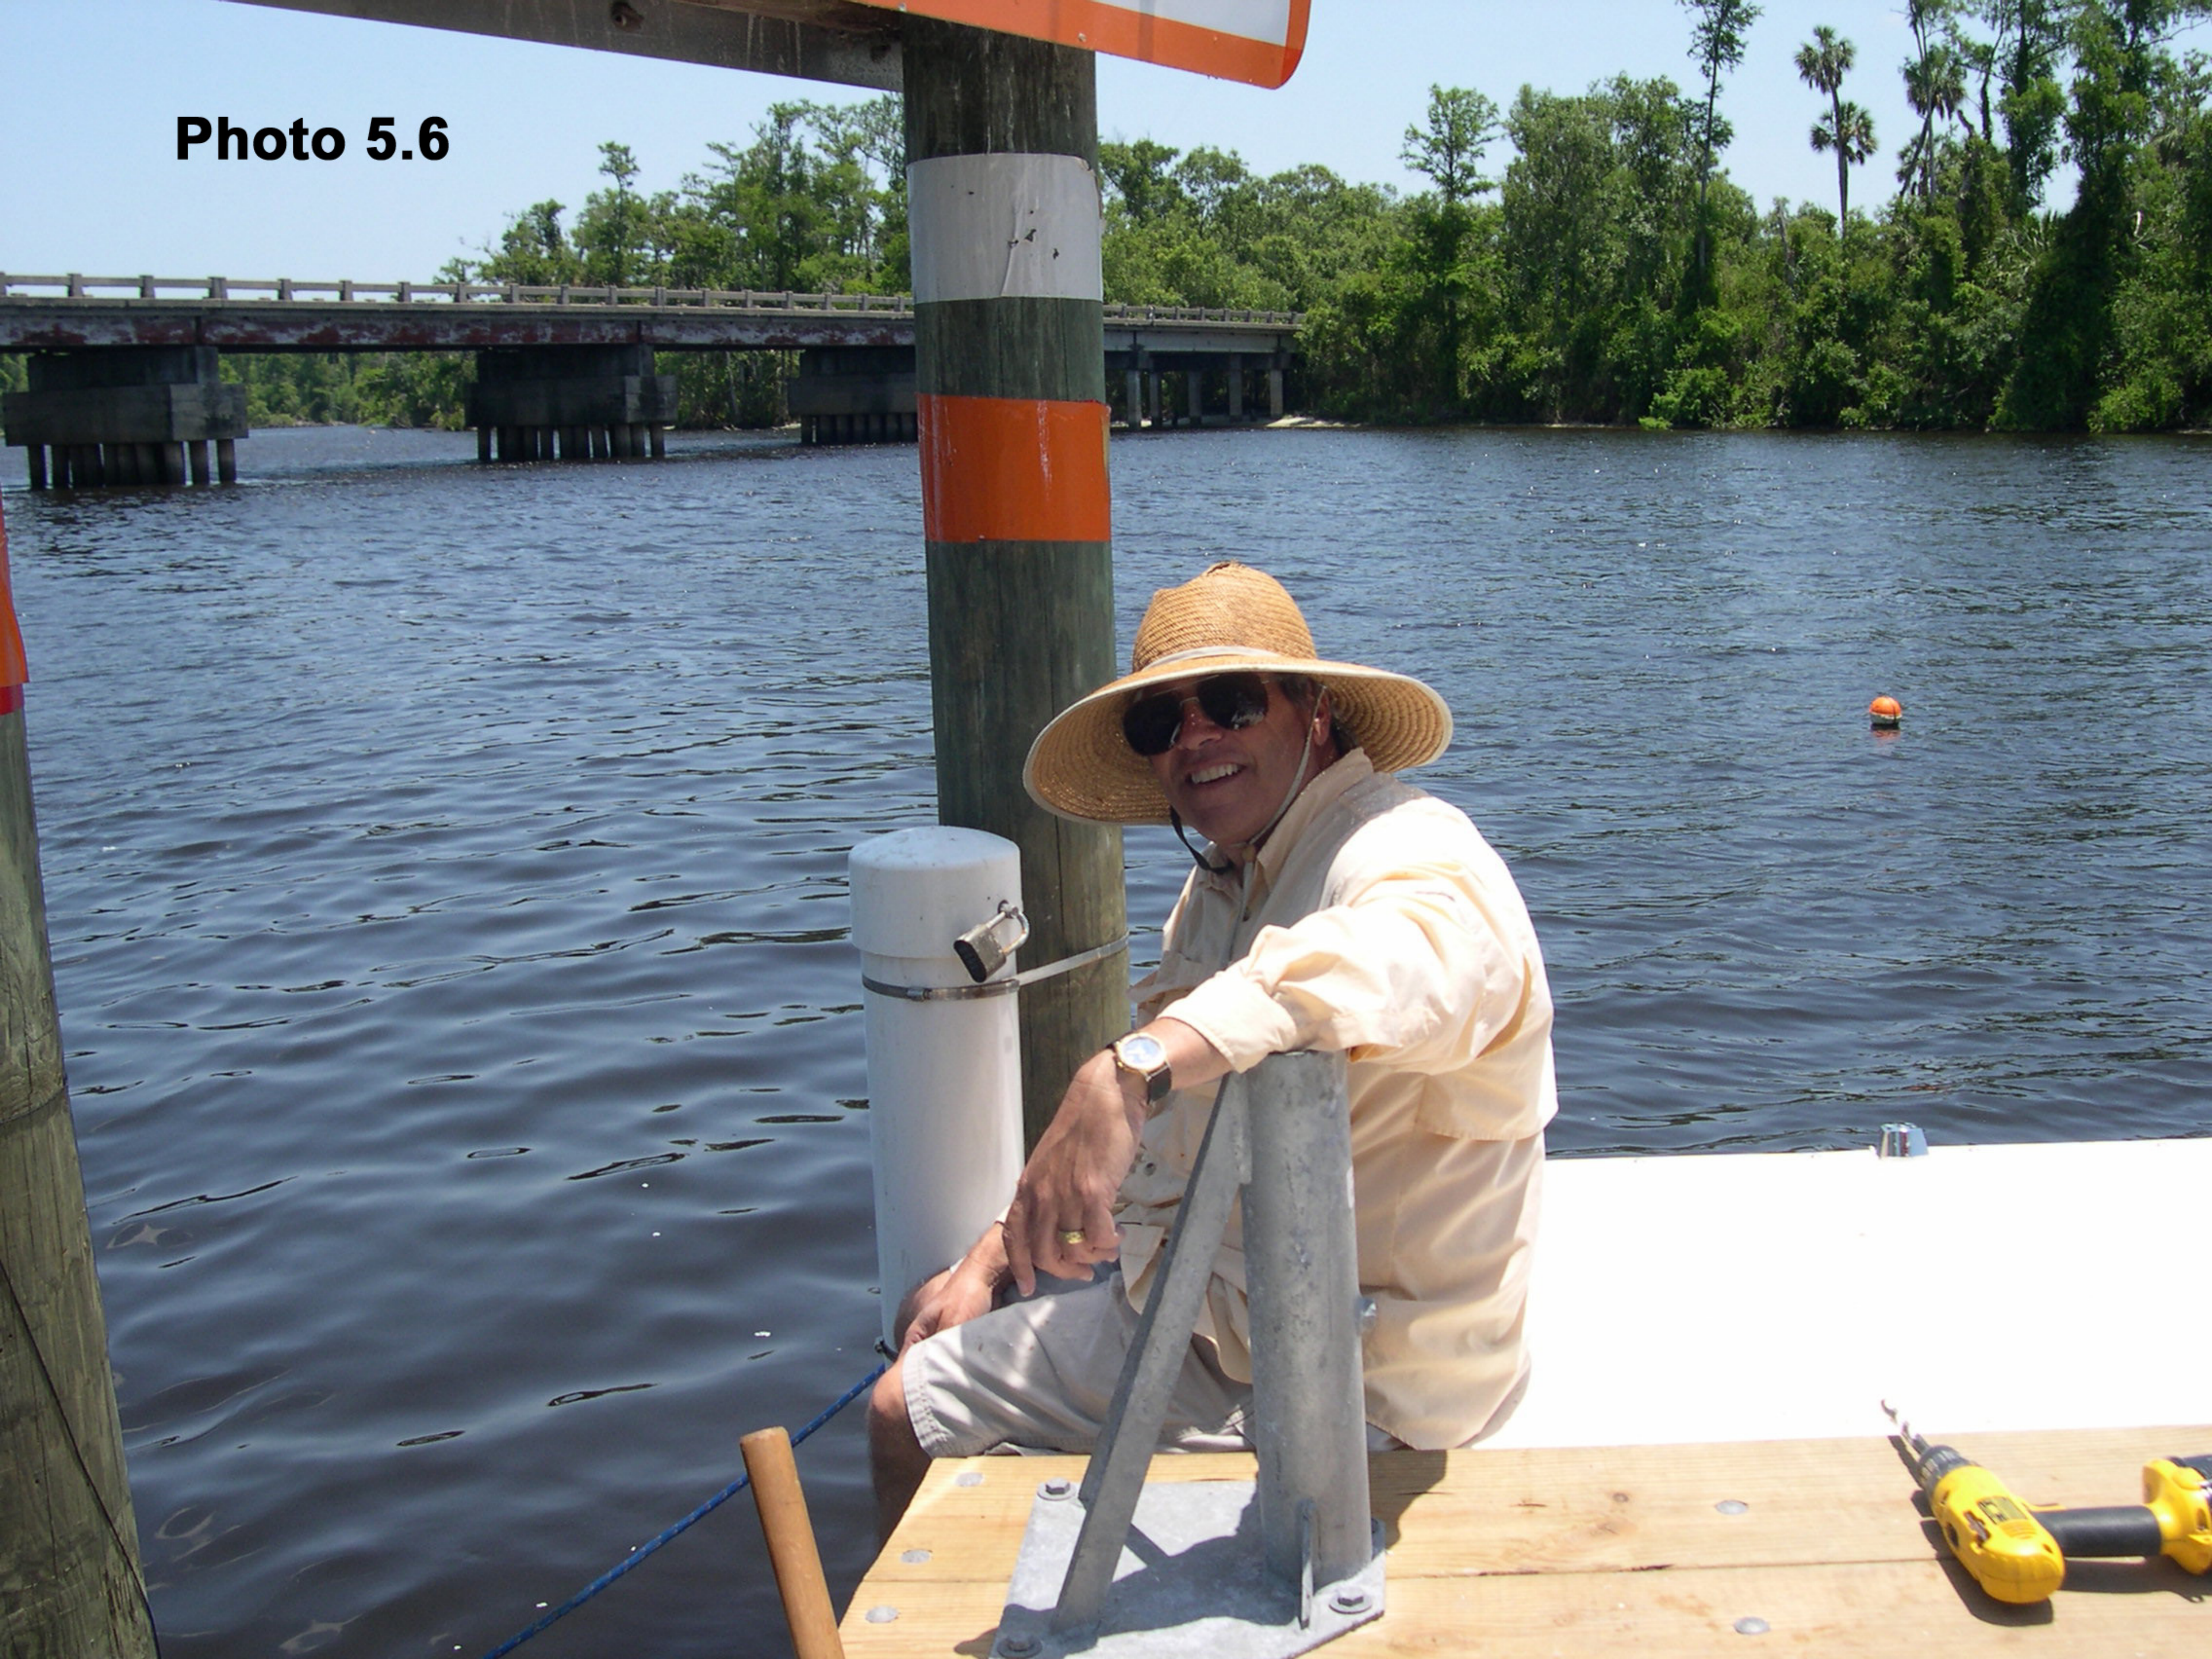
- **Photo 5.6** – This photograph shows the stilling well (with the locking cap) attached to the Manatee Speed Zone marker at RK 30.6 just upstream of the Facility and immediately downstream of the SR 761.

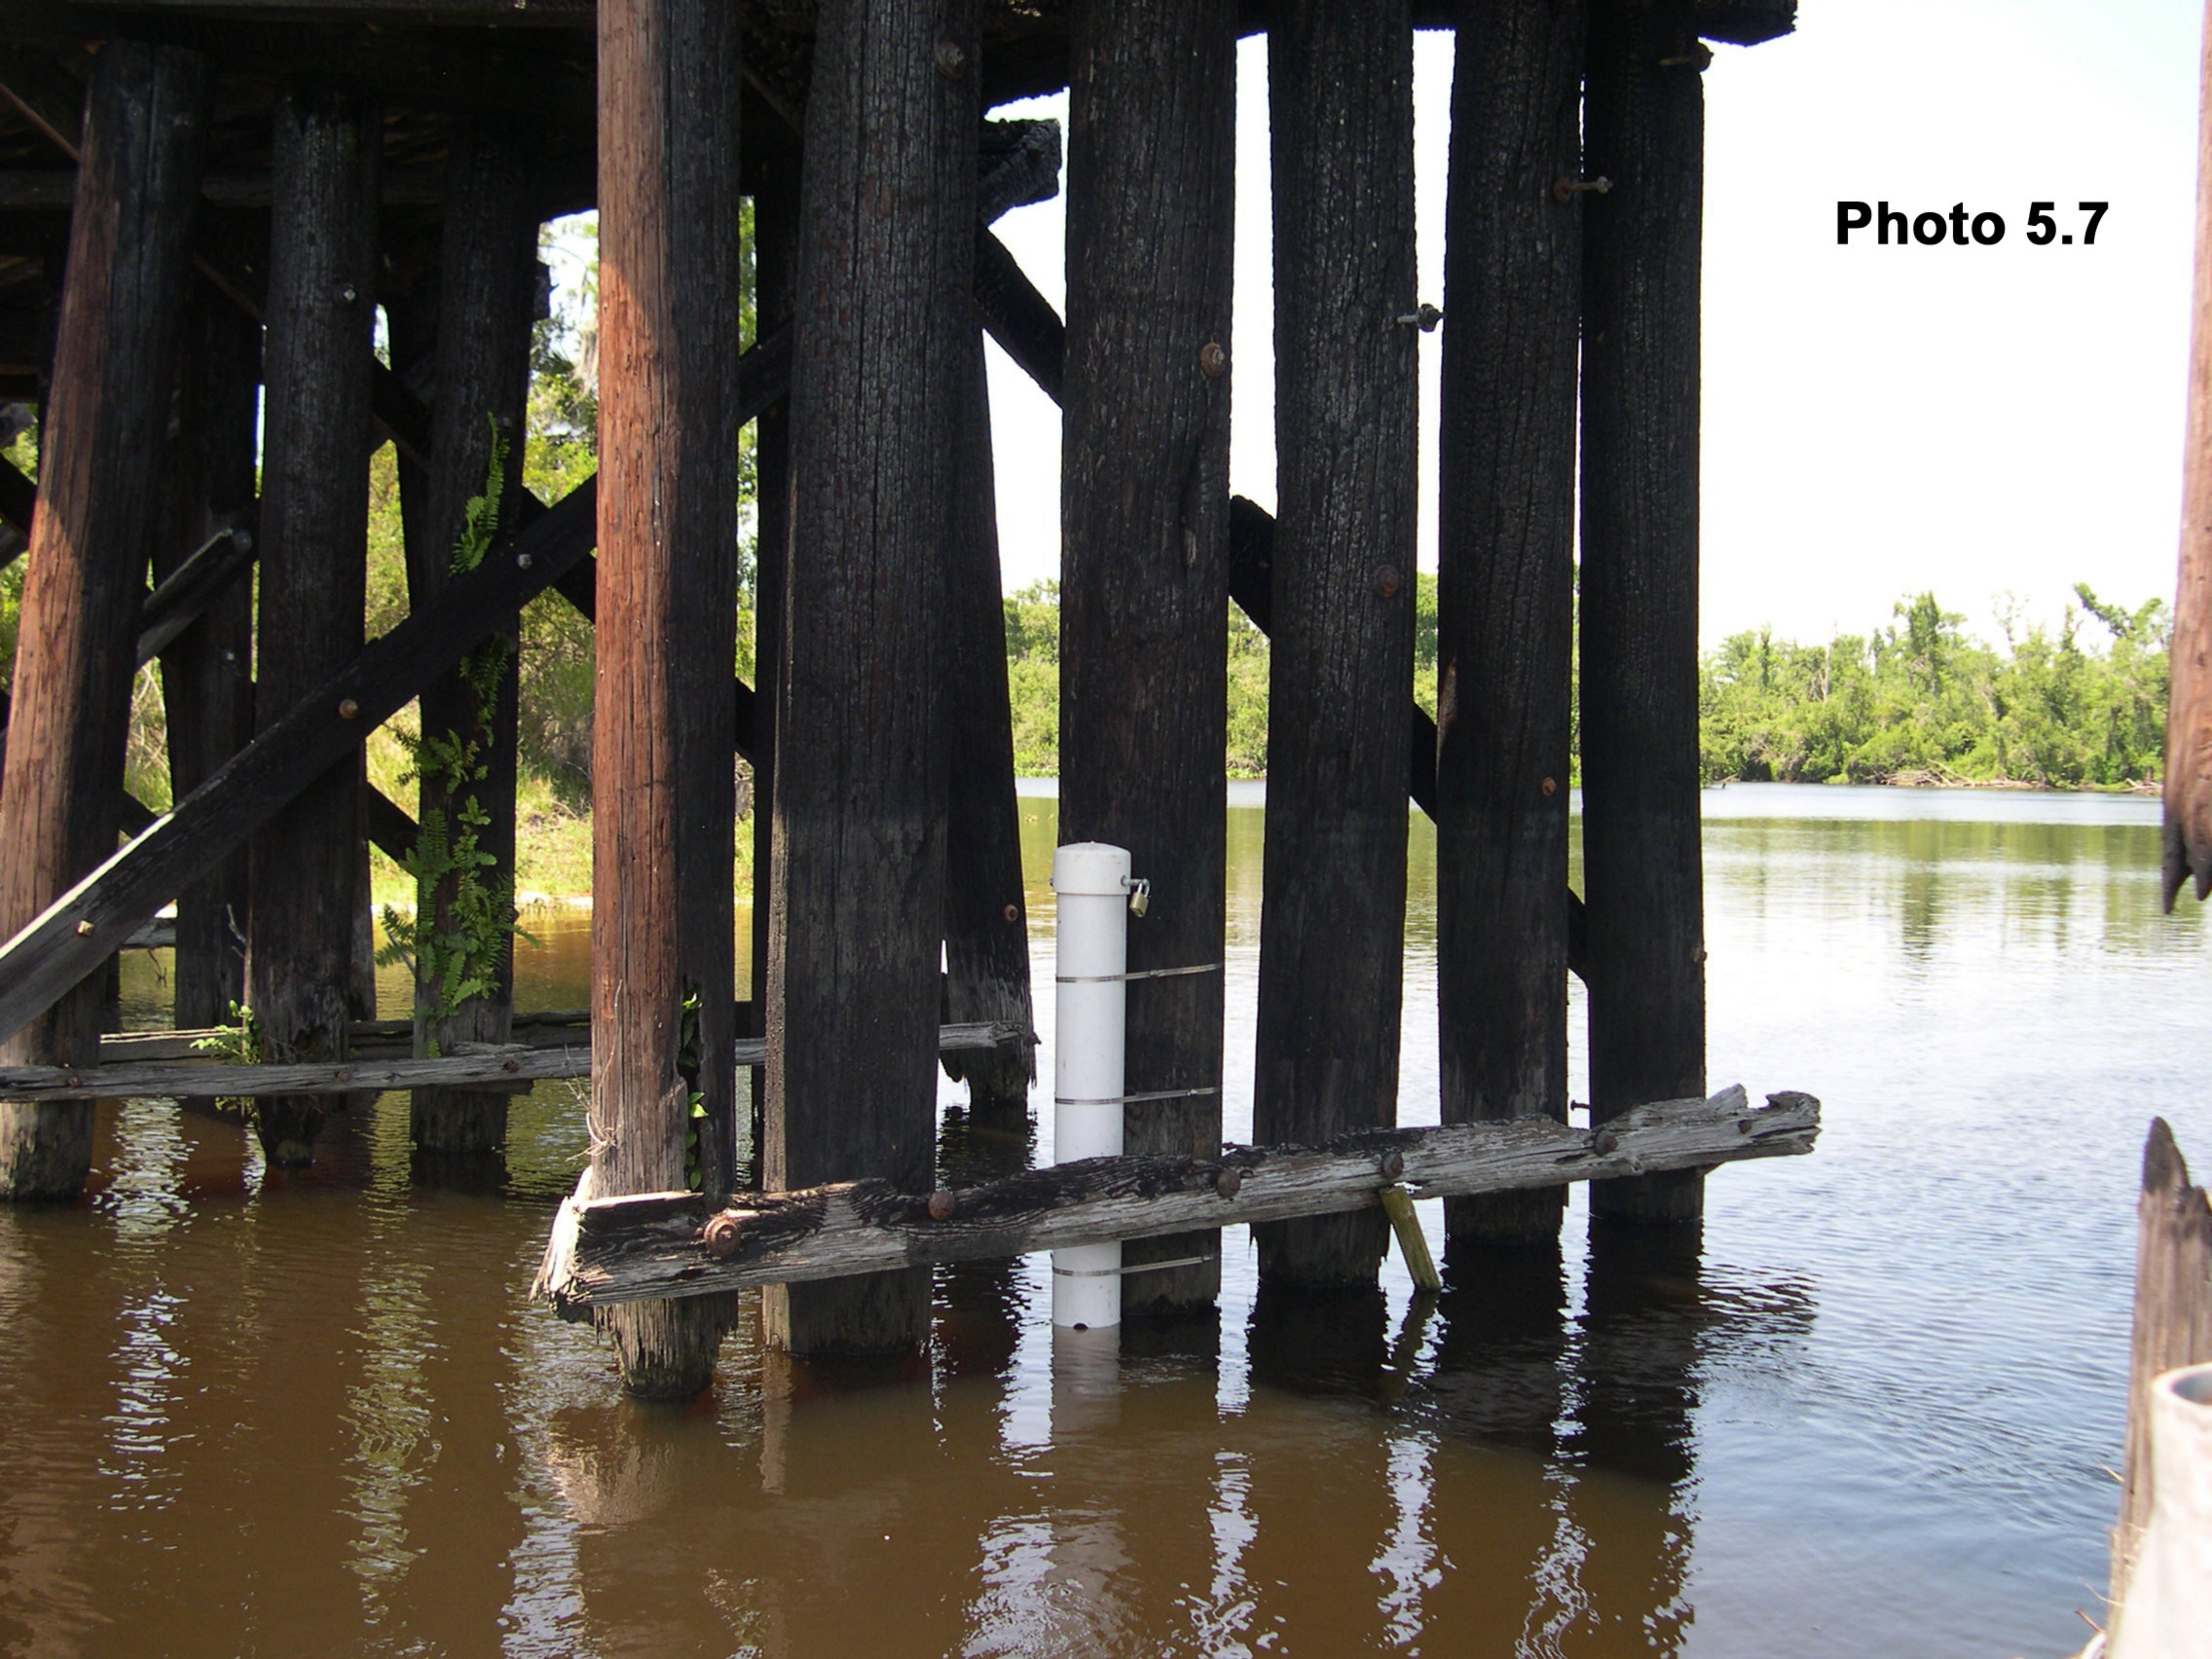
- **Photo 5.7** – This photograph shows the most upstream continuous recorder stilling well (with the locking cap) attached to the old railroad trestle at RK31.7.
