Lemon Bay

WATERSHED MANAGEMENT PLAN

Chapter 3

Natural Systems

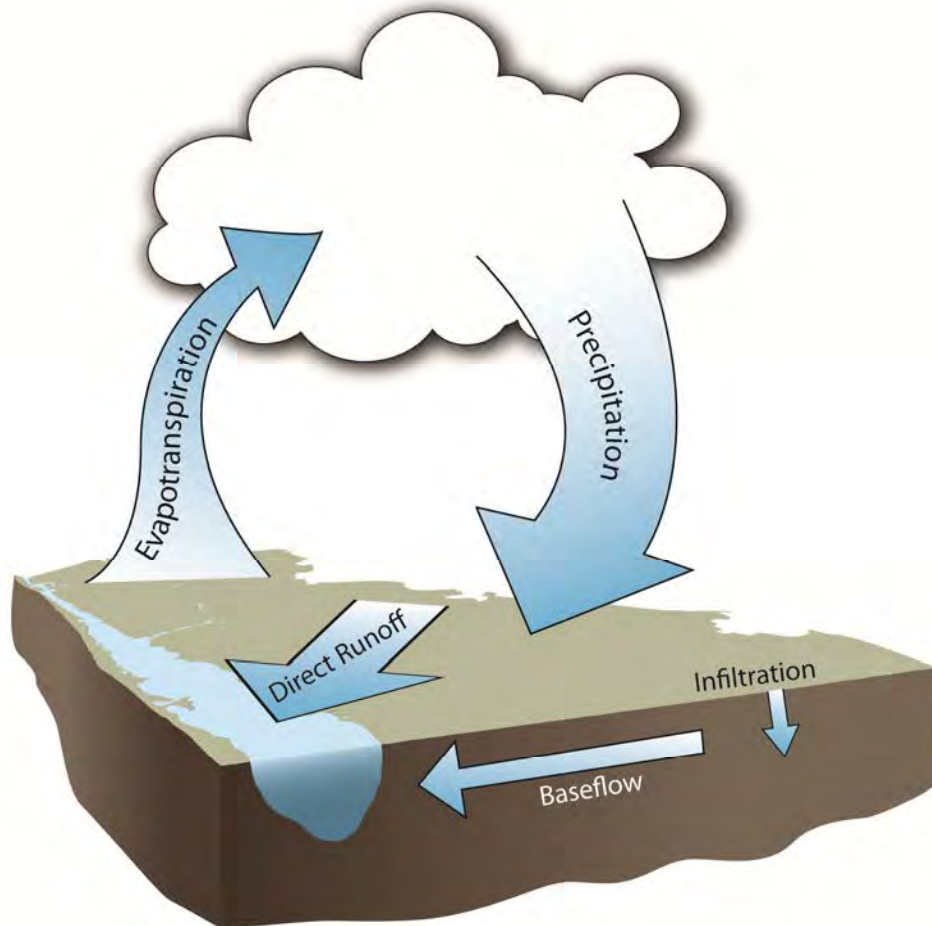
Figure 3-3 Lemon Bay Water Budget Schematic

Water resources are increasingly stressed throughout the watershed by urbanization. Urban growth produces an increase in impervious surfaces, greater water withdrawals, and movement of water and wastewater farther away from their sources of origin. Freshwater flow patterns drive physical, chemical, and biological conditions in the estuary. The condition of the freshwater and estuarine ecosystems in the watershed is directly linked to the natural variability in these freshwater flows and volumes that comprise the Lemon Bay watershed water budget. The water budget is the sum of the sources (additions) of freshwater to Lemon Bay minus the sum of the freshwater sinks (losses). There are many sources of freshwater inflows to Lemon Bay, including direct runoff, groundwater discharge, and direct precipitation on the estuary. The primary natural loss of water from the watershed is evapotranspiration (Figure 3-3).

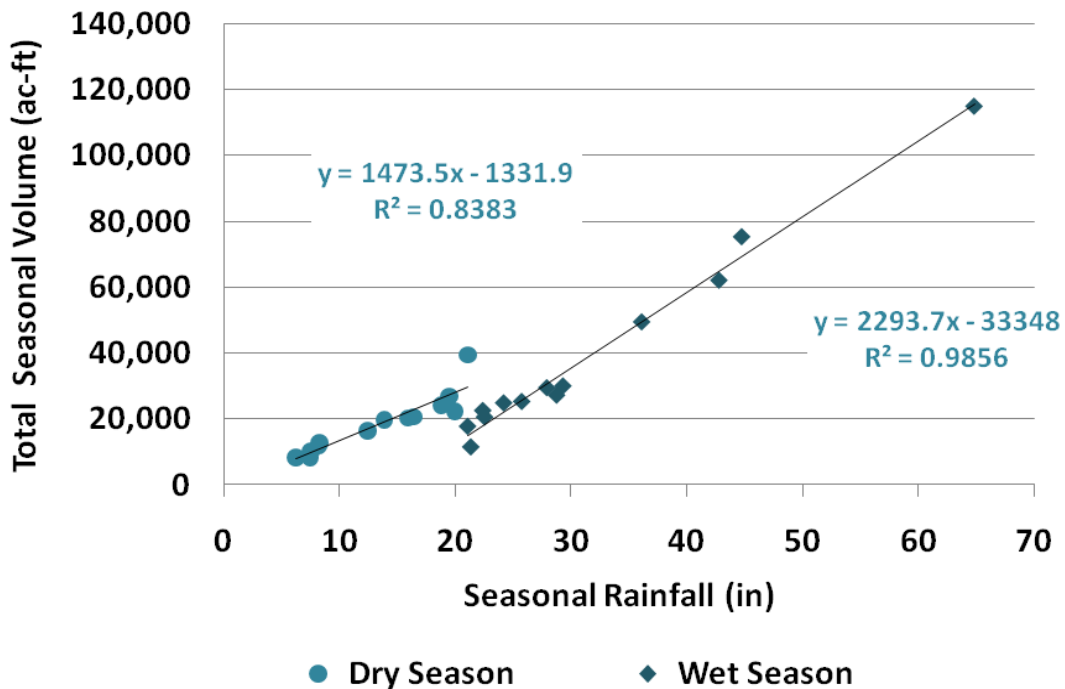
Figure 3-12 Correlation of Seasonal Rainfall to Total Volume in the Lemon Bay Watershed

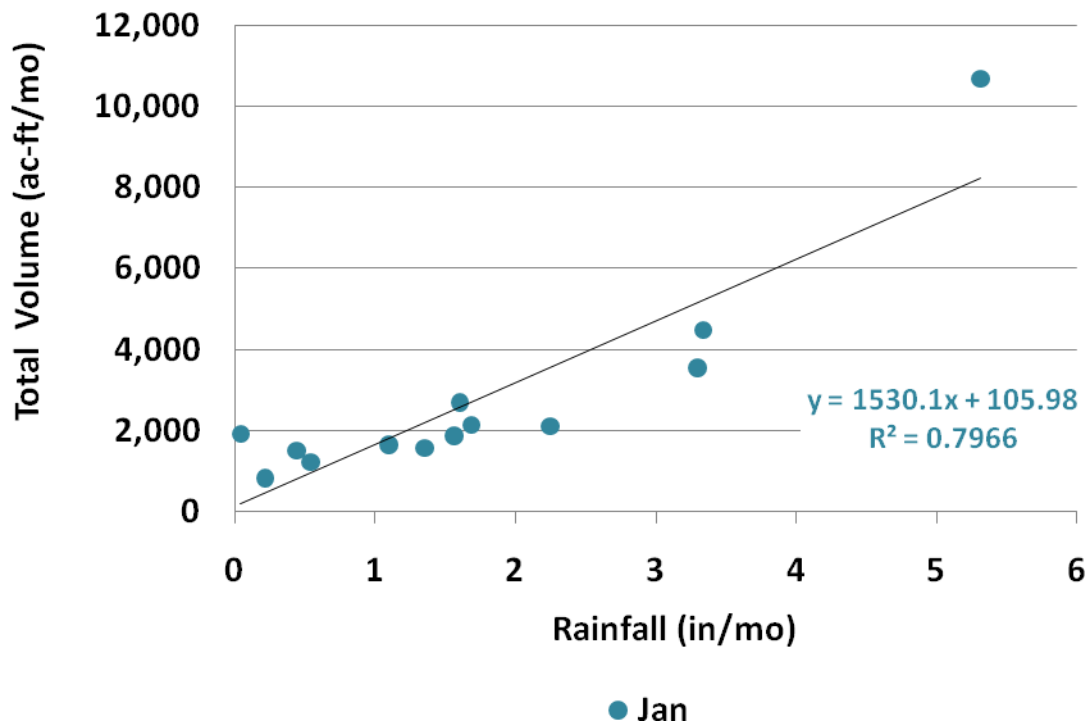
Figure 3-13 Correlation of Rainfall to Total Volume in the Lemon Bay Watershed for January

The relationship between rainfall and total volume at a monthly scale varies. The dependability varies from 0.75 in April up to 0.97 in June (Figures 3-13 through 3-24). The average monthly rainfall to total volume conversion factors for the Sarasota County portion of the Lemon Bay watershed are shown in Table 3-3.

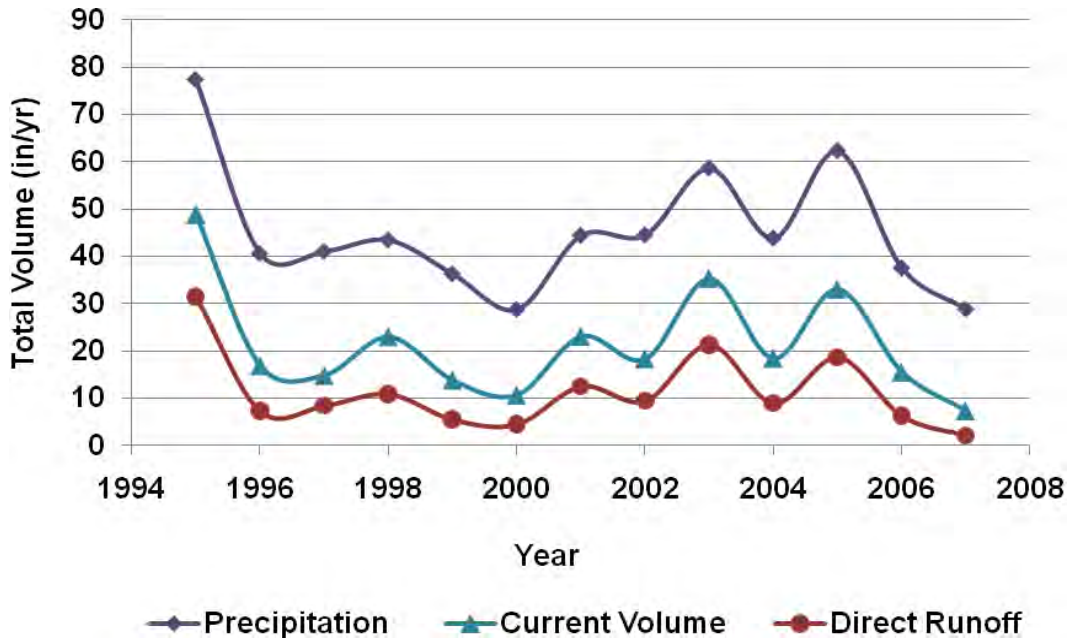
Figure 3-28 Variability of Annual Total Volume, Direct Runoff, and Rainfall in the Lemon Bay Watershed

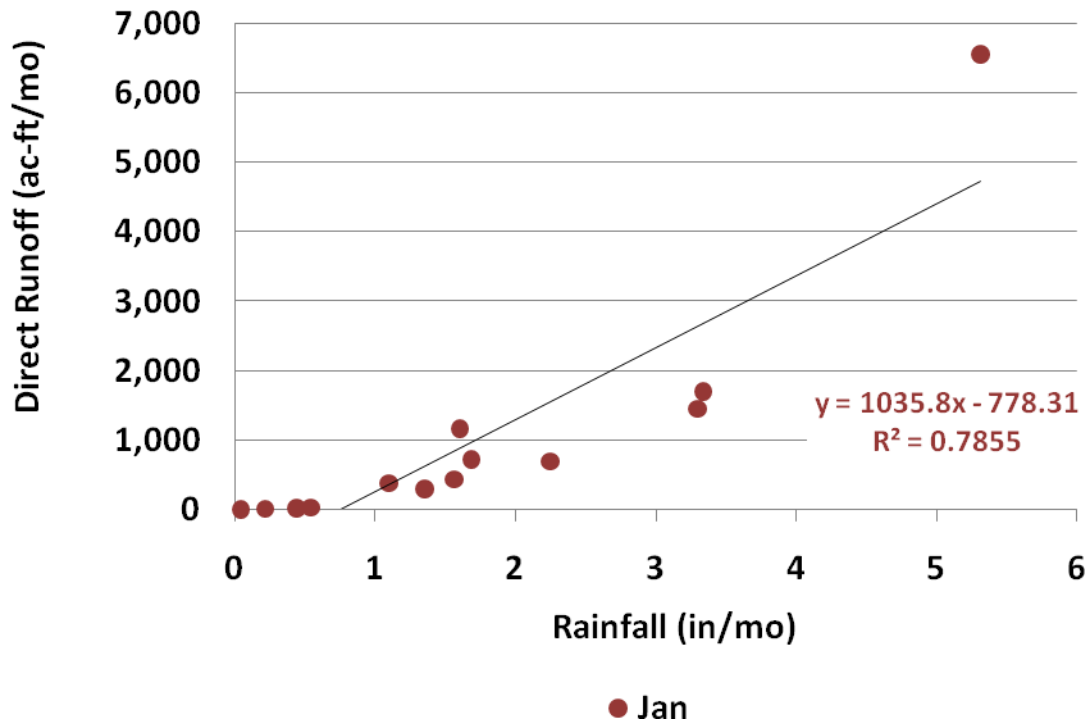
Figure 3-32 Correlation of Rainfall to Direct Runoff in the Lemon Bay Watershed for January

The relationship between rainfall and runoff at a monthly scale varies. The dependability varies from an R^2 value of 0.75 in April up to 0.95 in June (Figure 3-32 through Figure 3-43). The average monthly direct runoff to rainfall coefficients for the Sarasota County portion of Lemon Bay are shown in Table 3-5. Table 3-6 summarizes these and the total volume to rainfall coefficients.

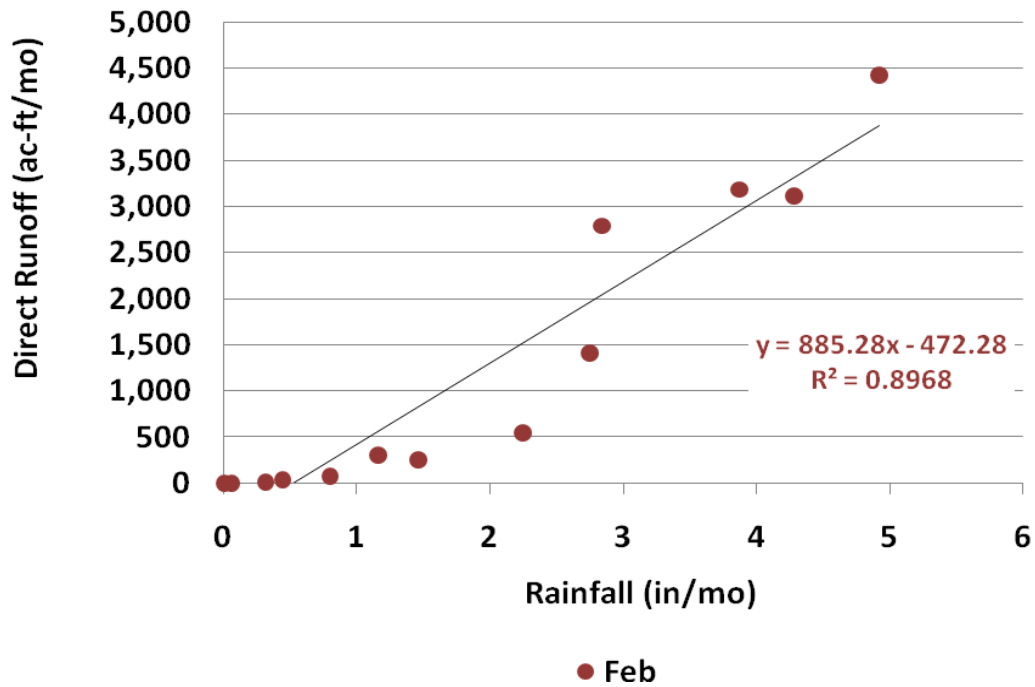
Figure 3-33 Correlation of Rainfall to Direct Runoff in the Lemon Bay Watershed for February

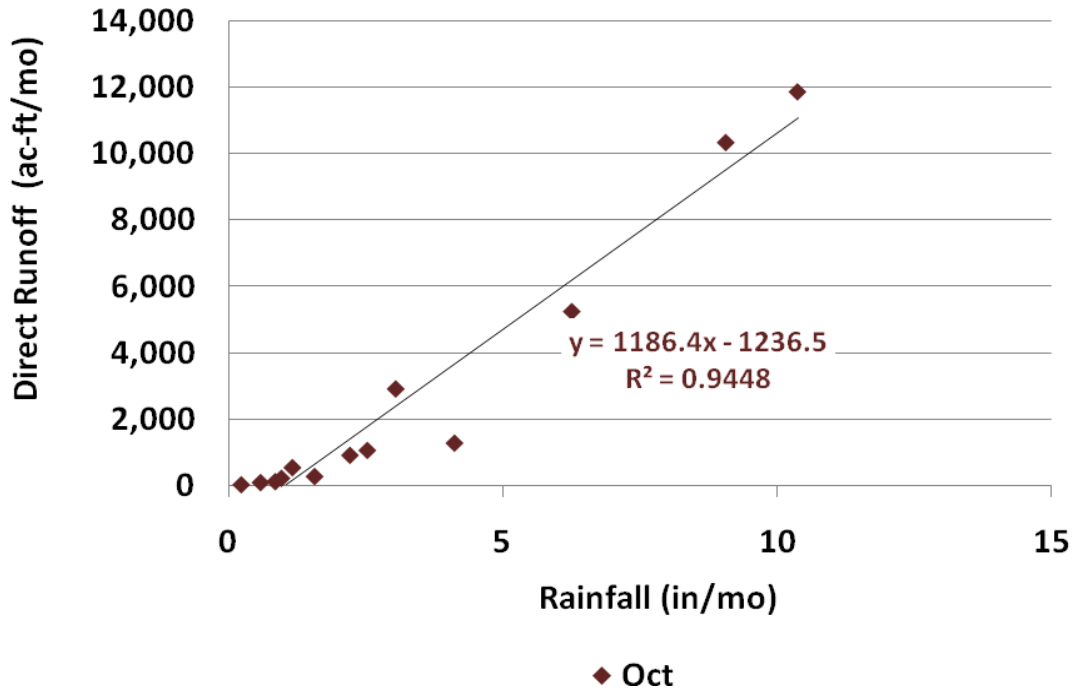
Figure 3-41 Correlation of Rainfall to Direct Runoff in the Lemon Bay Watershed for October

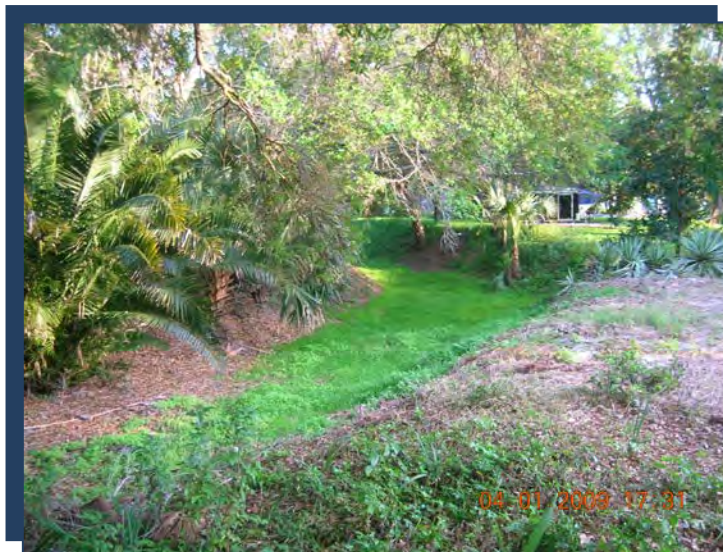
Figure 3-56 Large Perimeter Ditch at Venice Park 5

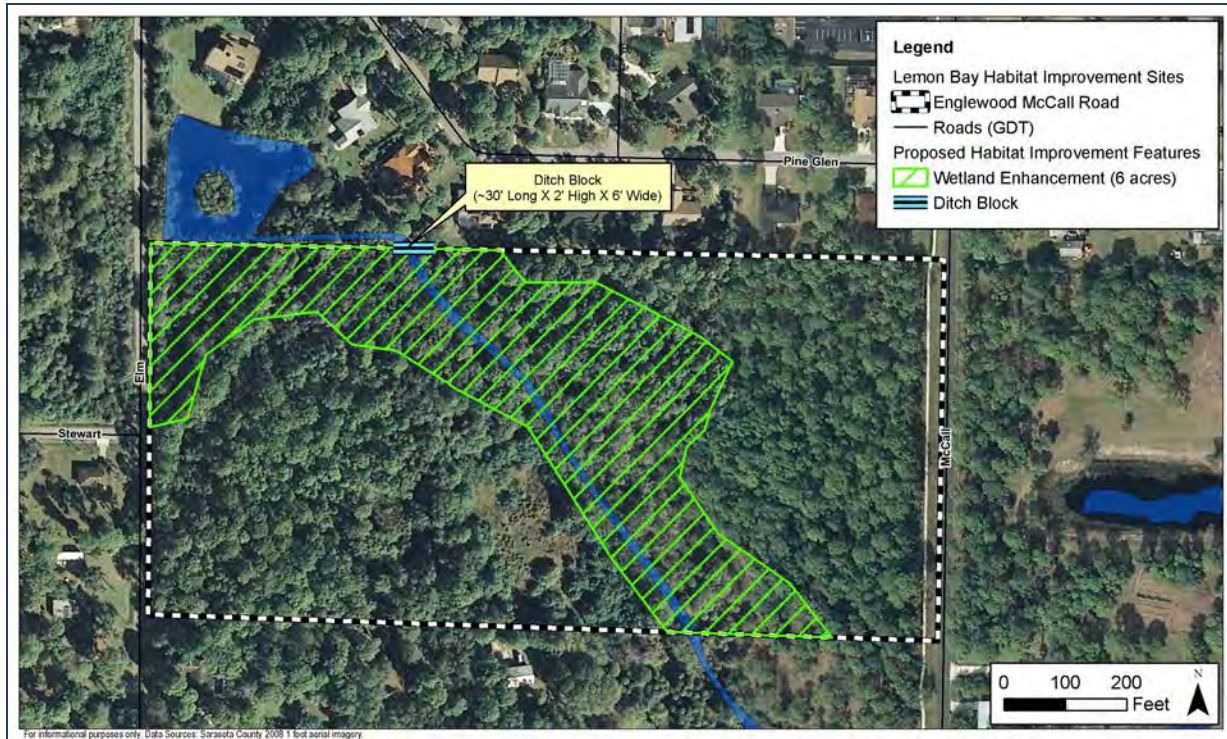
Figure 3-61 Englewood McCall Road Habitat Improvement Conceptual Design

The Englewood McCall Road site is an approximately 18-acre County-owned property in the central region of the Lemon Bay watershed (Figure 3-55). It is bound on the west by North Elm Street and the east by North McCall Road (Figure 3-61). The on-site uplands are dominated by Pine Flatwoods (FLUCCS Code 4110) (Figure 3-62). Dominant species include longleaf pine (*Pinus palustris*), saw palmetto (*Serenoa repens*), gallberry (*Ilex glabra*), bracken fern (*Pteridium aquilinum*), rusty lyonia (*Lyonia ferruginia*), and grape vine.

An approximately 6-acre medium-quality Mixed Wetland Hardwoods (FLUCCS Code 6170) is located in the central region of the site. This wetland is dominated by red maple (*Acer rubrum*), cabbage palm (*Sabal palmetto*), dahoon holly (*Ilex cassine*), laurel oak, swamp dogwood (*Cornus foemina*), iris (*Iris* sp.), pepper vine (*Ampelopsis arborea*), and Brazilian pepper seedlings. The exotic and invasive species Australian pine (*Casuarina equisetifolia*), Brazilian pepper, and creeping oxeye (*Wedelia trilobata*) are scattered throughout the wetland. A channelized ditch runs from the southeast corner through this wetland to a stormwater pond in the northwest corner of the property (Figure 3-63). Much pepper vine is encroaching into the wetland, which may indicate that this ditch is affecting the hydrology.

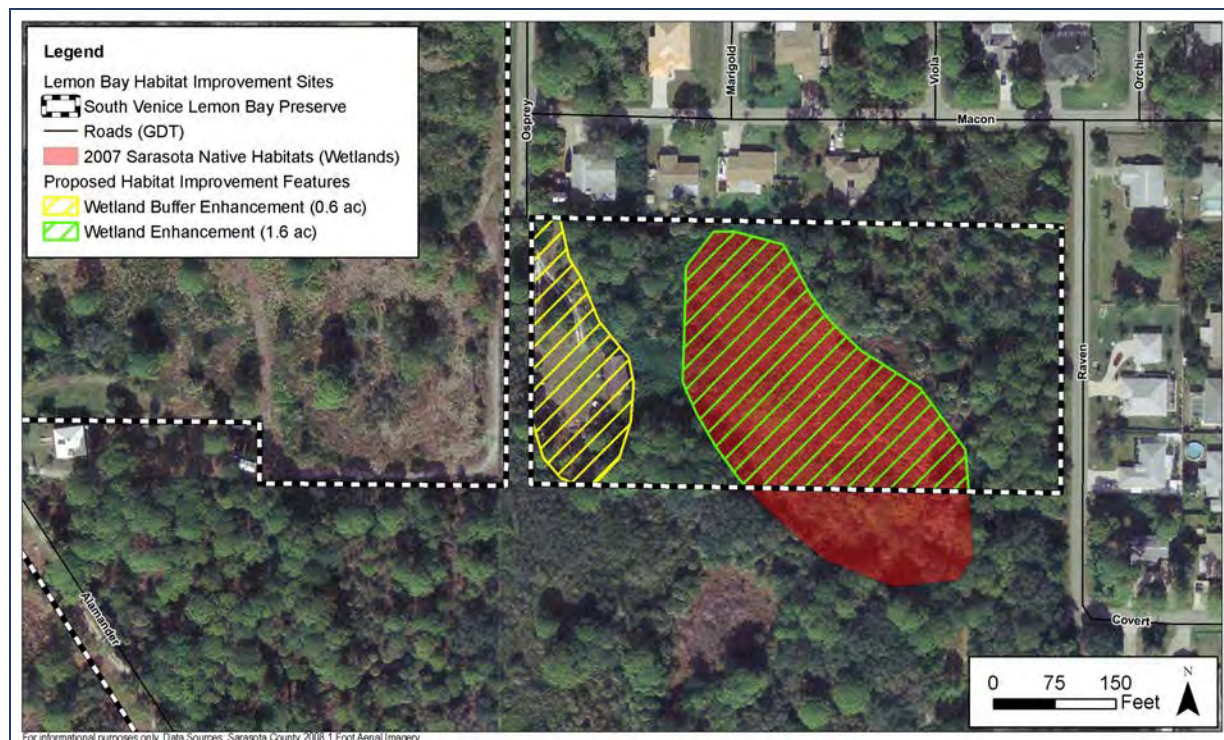
Figure 3-70 South Venice Lemon Bay Preserve South Site Habitat Improvement Conceptual Plan

South Venice Lemon Bay Preserve South site is in the northwest region of the Lemon Bay watershed (Figure 3-55). The approximately 5-acre portion of this preserve that was assessed is at the end of Osprey Road and fronts Raven Road on its east side (Figure 3-70). It was a former homestead and the County recently demolished the home. An open grassed area along the west side of the property was the former maintained yard of the residence (Figure 3-71).

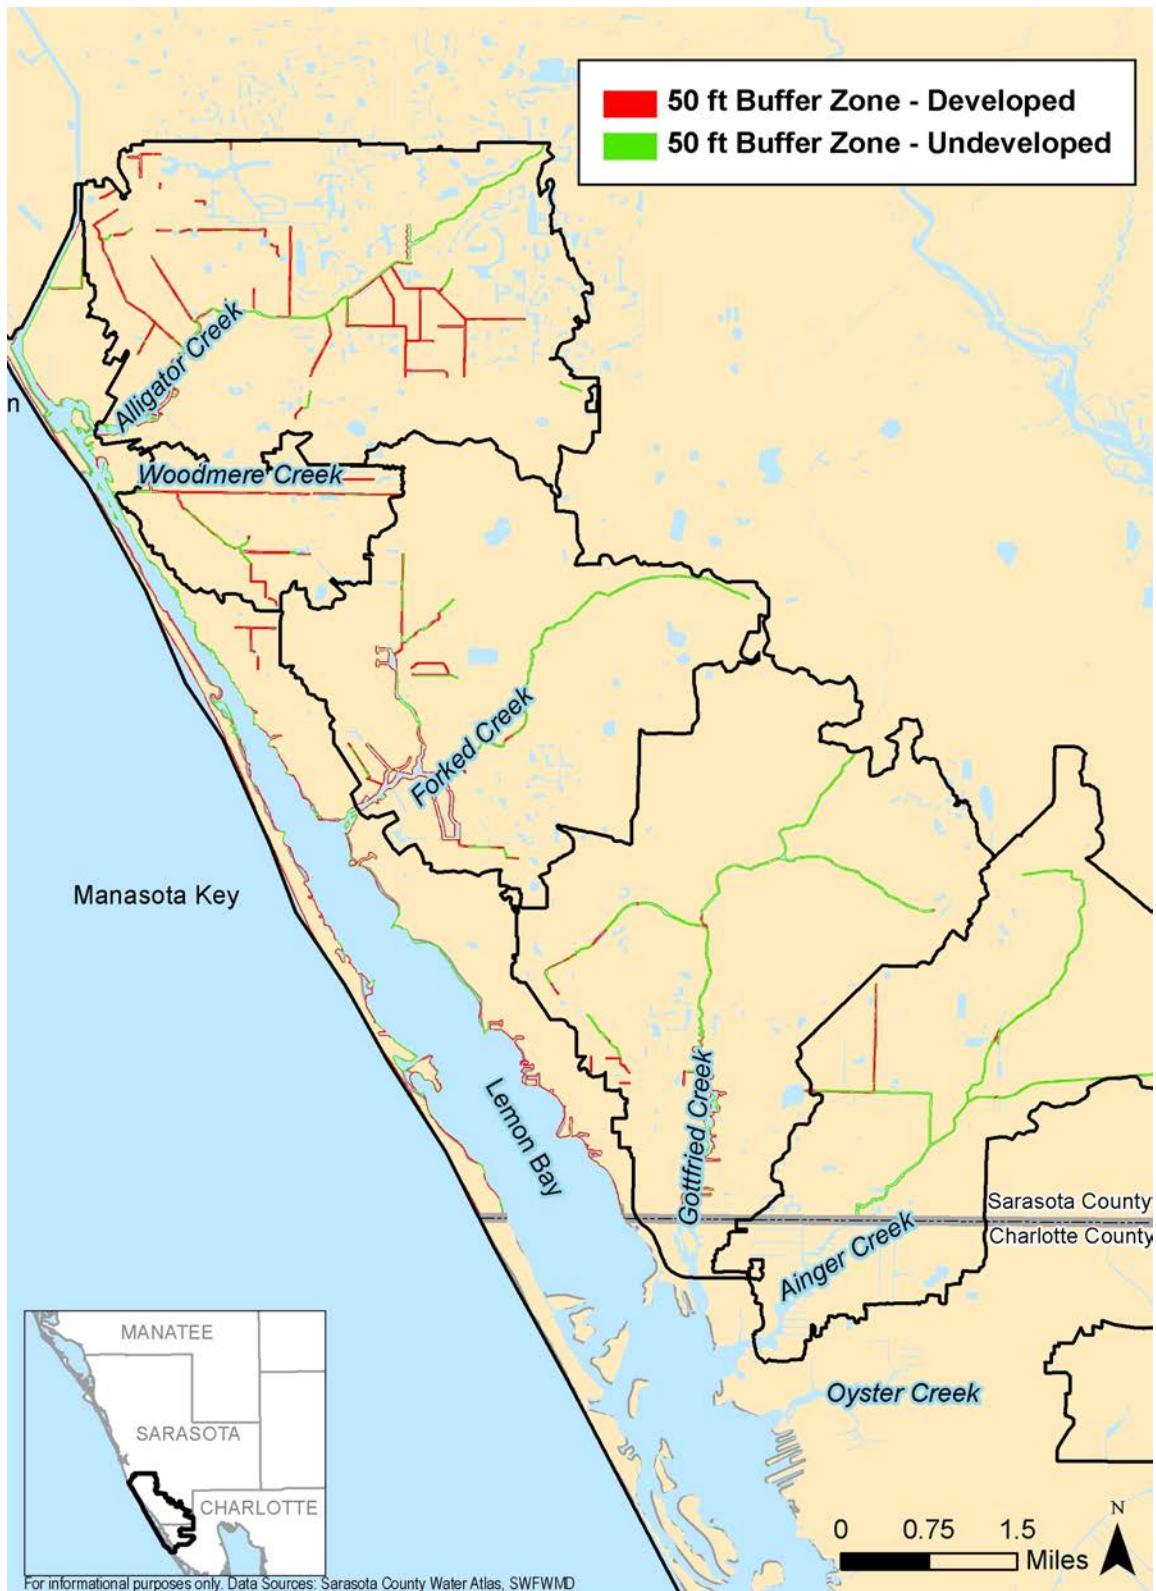
Figure 3-76 Lemon Bay Watershed – Waterway Buffer Zones

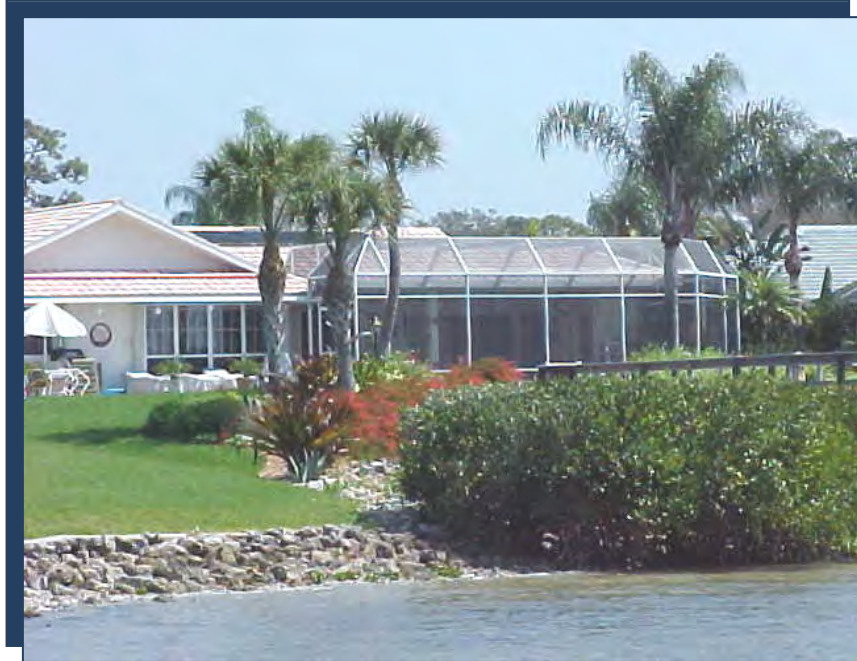
Figure 3-80 A Typical Non-Mangrove Shoreline on the Left Compared to a Trimmed Mangrove Shoreline on the Right

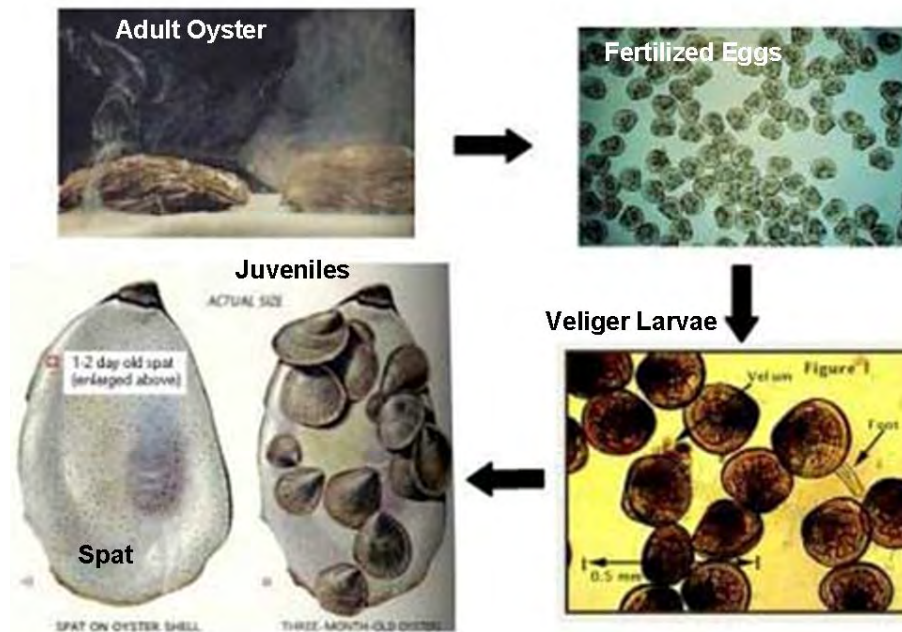
Figure 3-93 Illustration of the Life Cycle of the Eastern Oyster (*Crassostrea Virginica*)

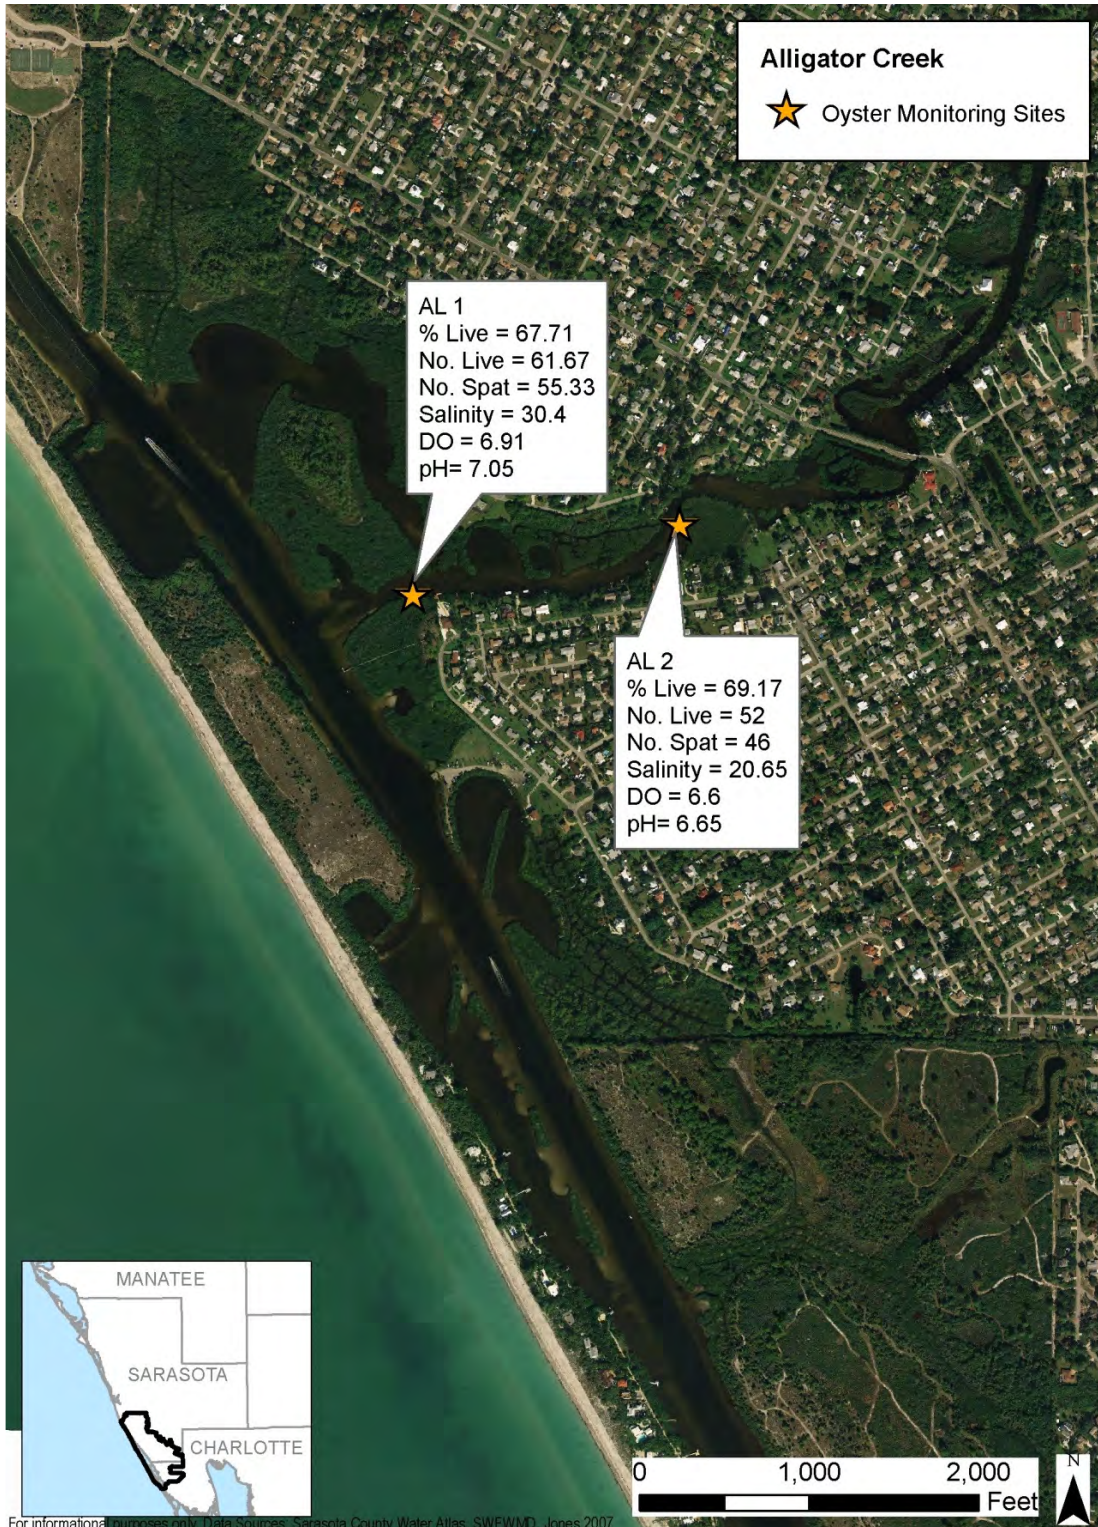
Figure 3-94 Alligator Creek Oyster Monitoring Site Locations and 2006 Results (Adapted from Jones 2007)

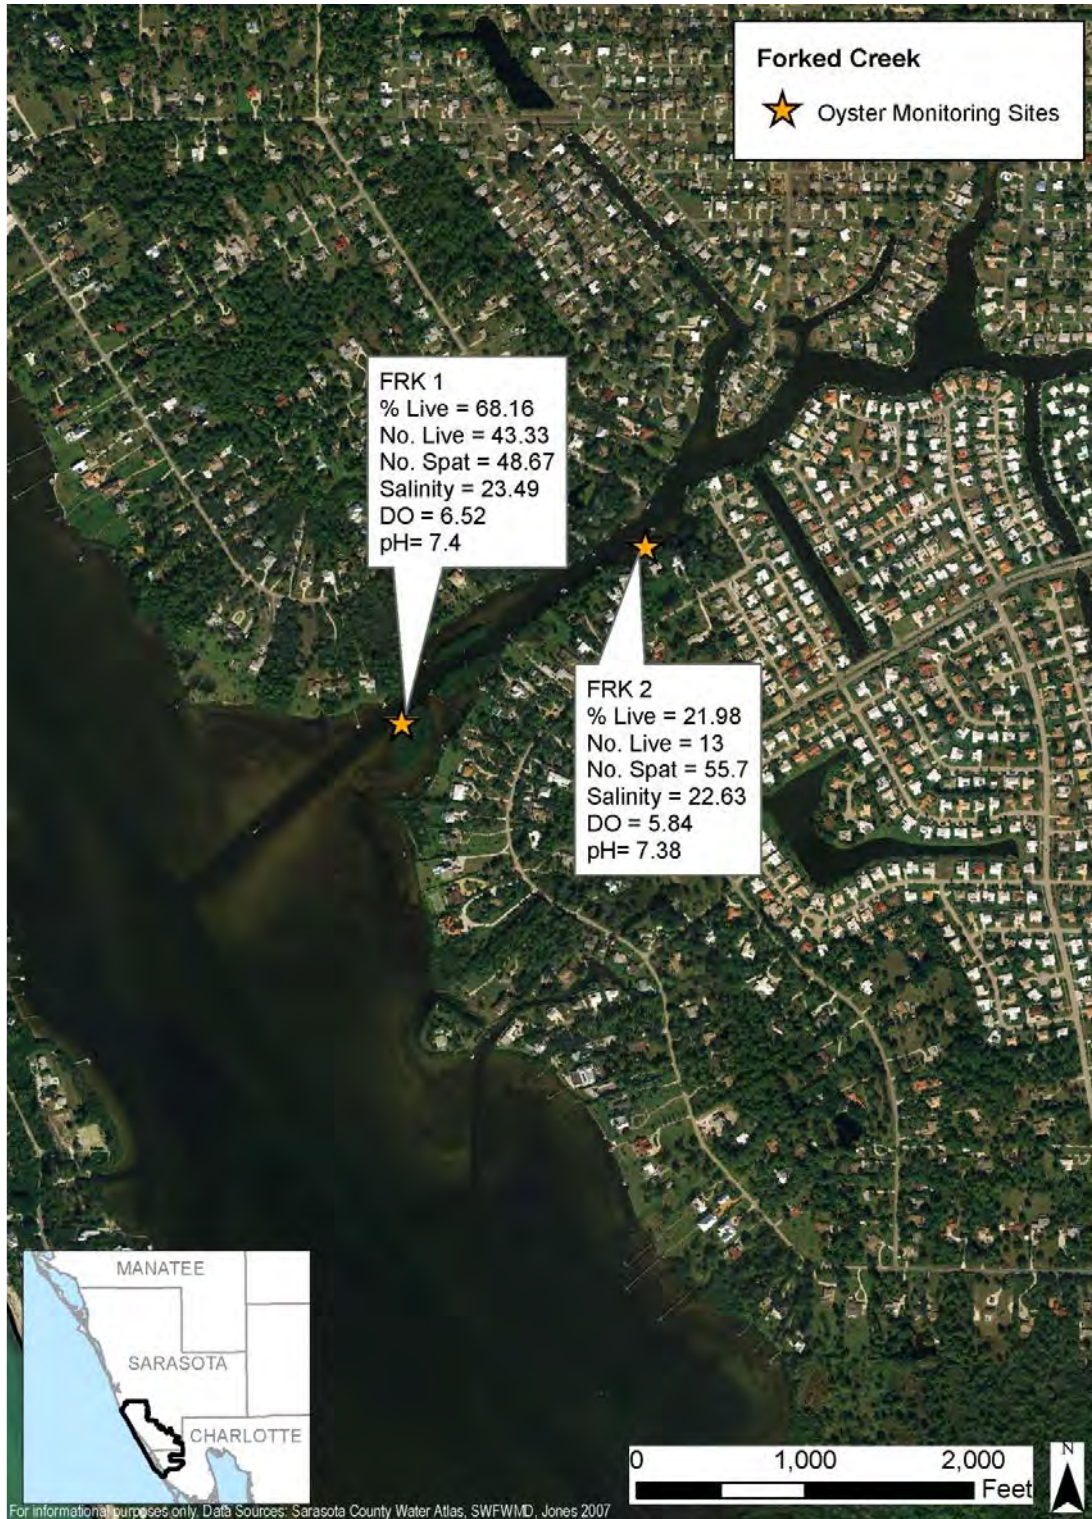
Figure 3-95 Forked Creek Oyster Monitoring Site Locations and 2006 Results (Adapted from Jones 2007)
