**Sea Turtle Monitoring, Nest Evaluation & Protection Measures
for the City of Sarasota**

**Year Two Post-Construction -
New Pass Inlet Channel Maintenance Dredging with Beach
Sand Placement on Lido Key
2005**

December 2, 2005
Mote Marine Laboratory Technical Report No. 1060

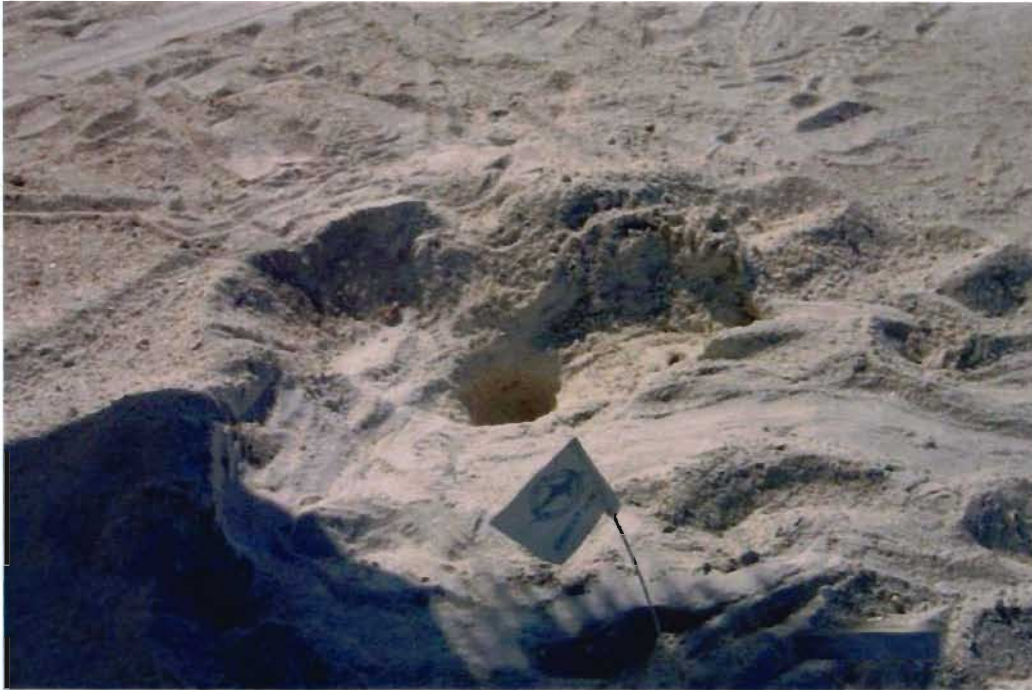
Figure 2. A non-nesting emergence with an abandoned egg chamber.

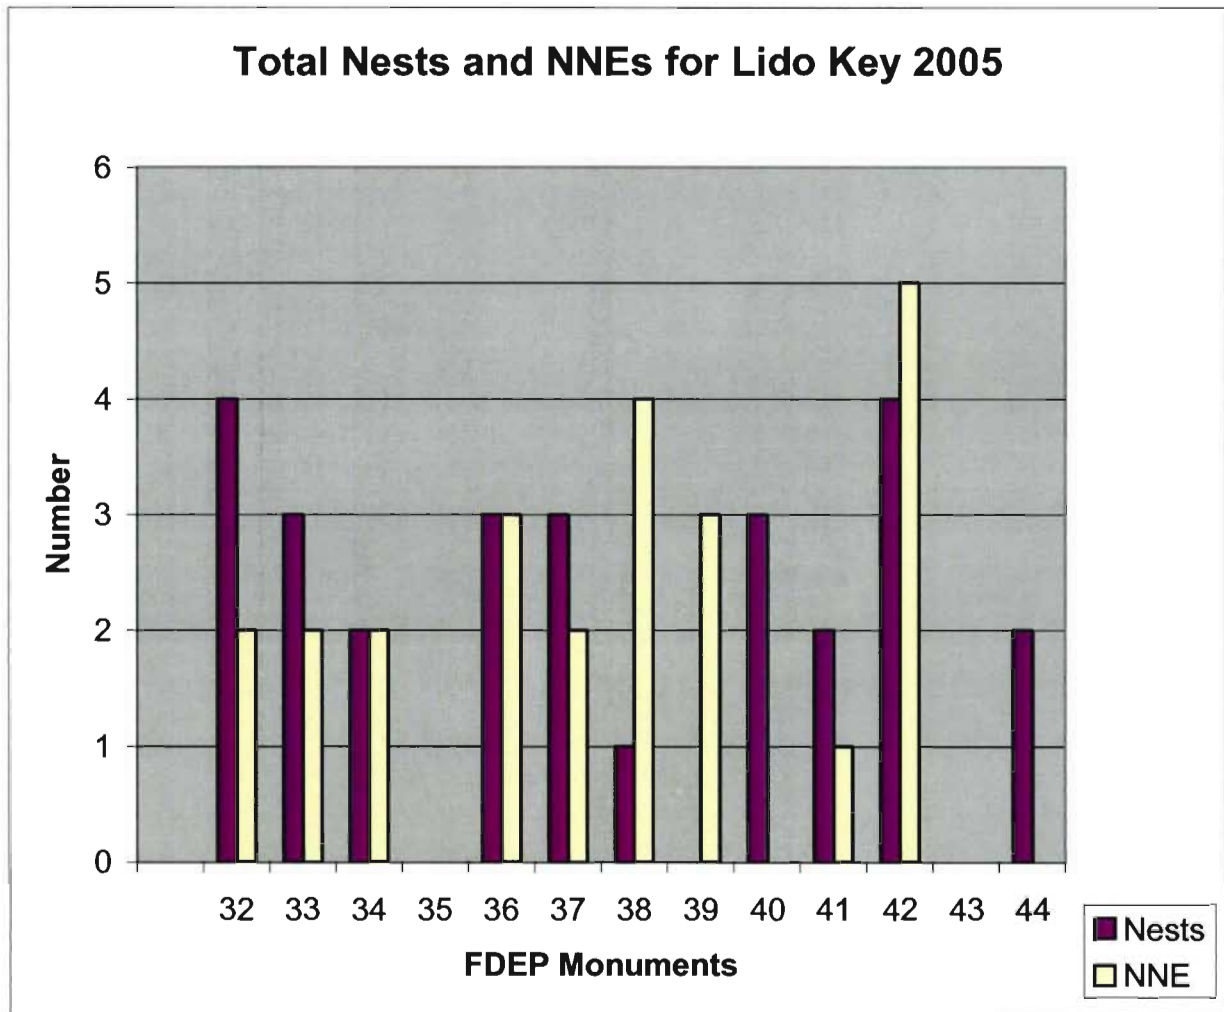
Figure 4. Nesting activity located between FDEP monuments on Lido Key in 2005.

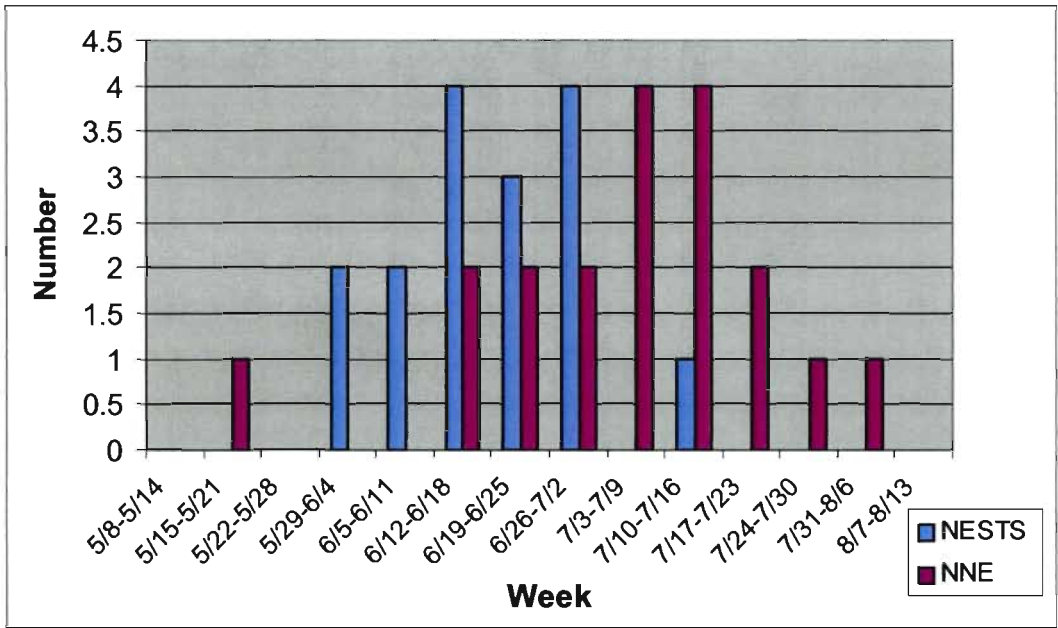
Figure 6. Turtle activities occurring inside the Project area on Lido Key in 2005.

The nesting success within the Project shoreline was 0.457 in 2005, 0.467 in 2004, and 0.222 in 2003. Nesting success outside the Project shoreline was 0.647 in 2005, 0.367 in 2004, and 0.449 in 2003. Within the Project shoreline, nesting activity was observed from May 31 to July 13 (**Figure 5**). Outside of the Project shoreline, nesting was observed between June 3 and July 30 (**Figure 6**).

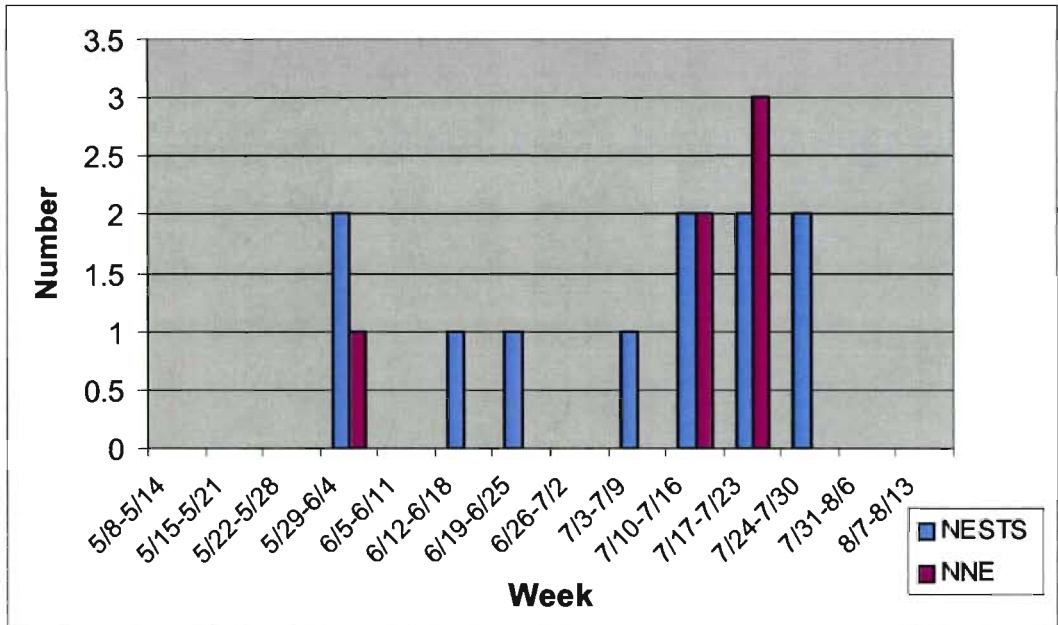
Figure 7. Turtle activities occurring outside the Project area on Lido Key in 2005.

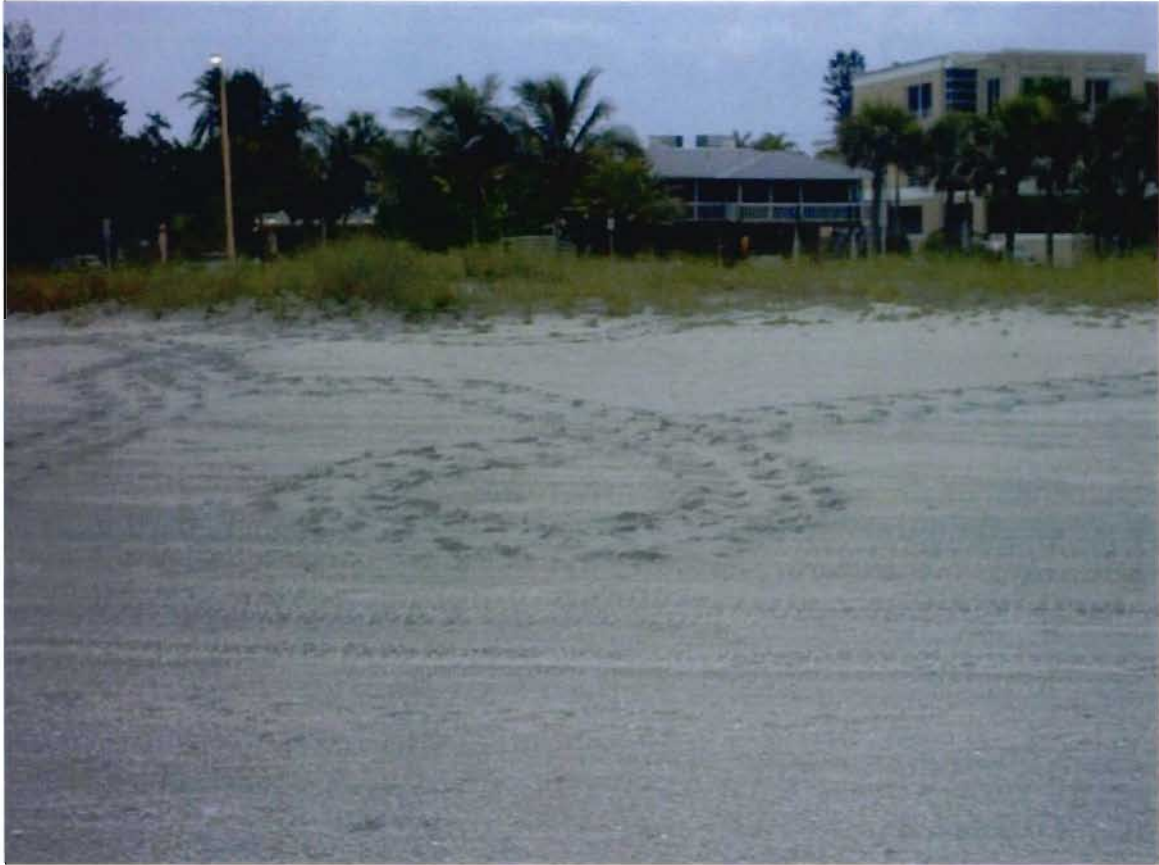
Figure 8. Adult sea turtle disorientation due to street light (seen on left) at 305 Ben Franklin Drive, Lido Key on 6/30/05.

Describe light source(s); include number & type of lights observed: There was one UN shielded street light at BFD was in front of where she tried to move landward. There were two exterior lights on the Holladay Inn to the north, but in street light.
