Trabue Harborwalk Oyster Habitat Restoration Project: Overview and One-Year Monitoring Results

April 2017

The Nature
Conservancy

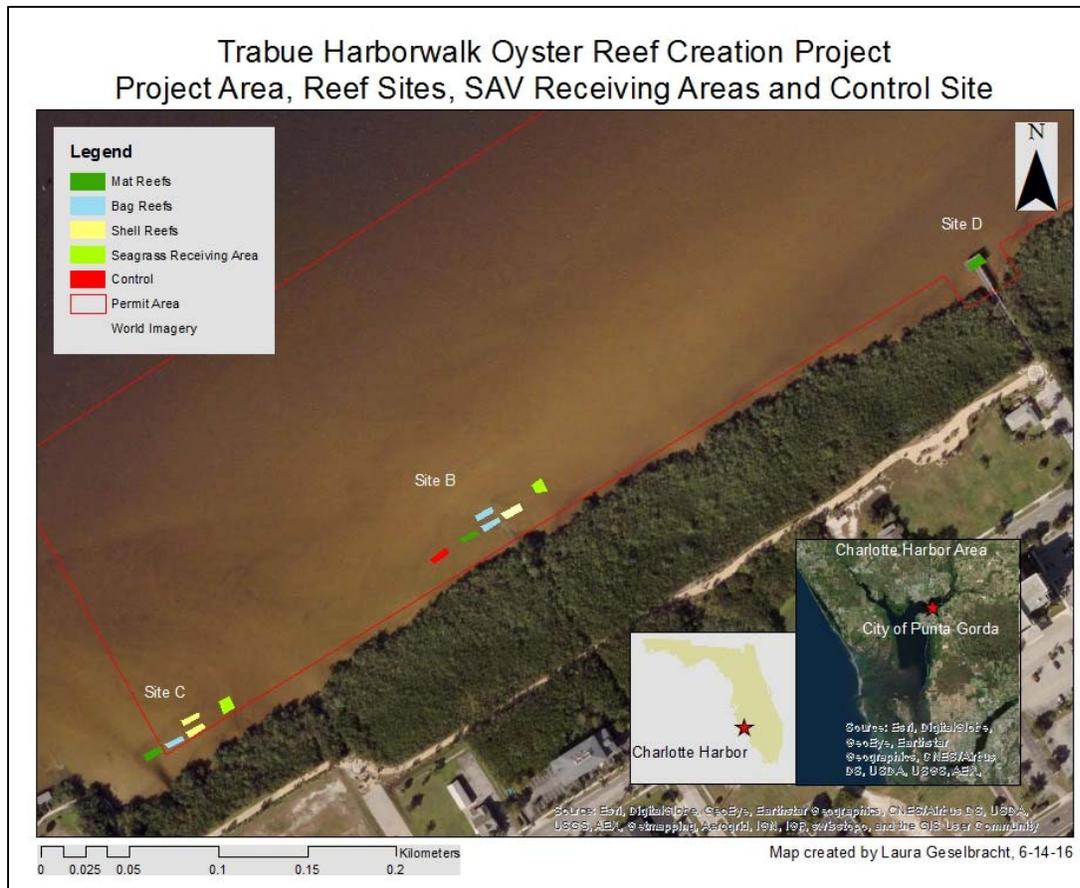
Figure 2. Location of constructed reefs, control area and seagrass receiving sites at Trabue Harborwalk oyster reef restoration site, Punta Gorda, Florida

A total of nine (9) small intertidal reefs were planned (3 reefs of each method). The original reef layout was modified prior to deployment due to the presence of low density seagrass at the site. A much larger area than was needed was permitted to allow for maximum flexibility in project design and future expansion of the project. Within this larger permit area, specific reef locations were chosen to avoid and minimize impacts on the seagrass as illustrated in Figure 2. One of the planned reefs was inadvertently located outside of the permit area boundaries (see far left of map at Site C). This small deviation in reef placement was accepted by the permitting agencies. All seagrass present within the reef footprints at Sites B and C were transplanted to the seagrass receiving areas identified in Figure 2. At Site D, under the pier at the end of Adrienne Street, no seagrass was present at the time of reef materials deployment.

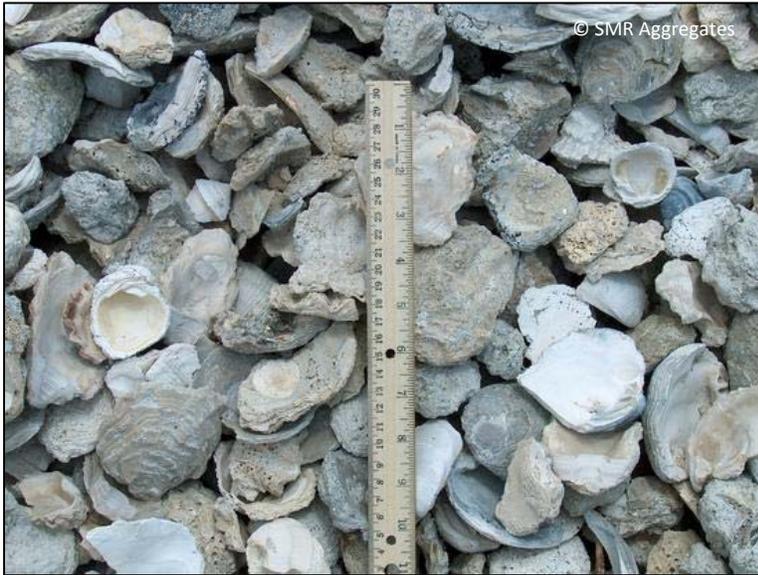
Figure 3. Sample large washed shell from SMR Aggregates.

Due to limitations on the availability of recycled oyster shell, fossilized shell was identified as a suitable alternative for the oyster bags and loose shell reefs. The fossilized shell was sourced from SMR Aggregates, a sand mining operation in Sarasota, FL where shell is a byproduct; and provides a clean cultch material (Figures 3 and 4B). More than 45 tons of fossilized shell was used to create the reefs. The shell material was ordered in two different grades, medium and large washed shell, to test which worked best for creating the shell-filled bags used to create the reefs. The large shell size was preferable because it allowed for “nooks and crannies” within the bags for recruitment and resulted in a lighter overall bag weight. The oyster bag material (bag mesh) is a flexible ¾ inch plastic diamond mesh material (Naltex DuroNet, Item 1142, by DelStar

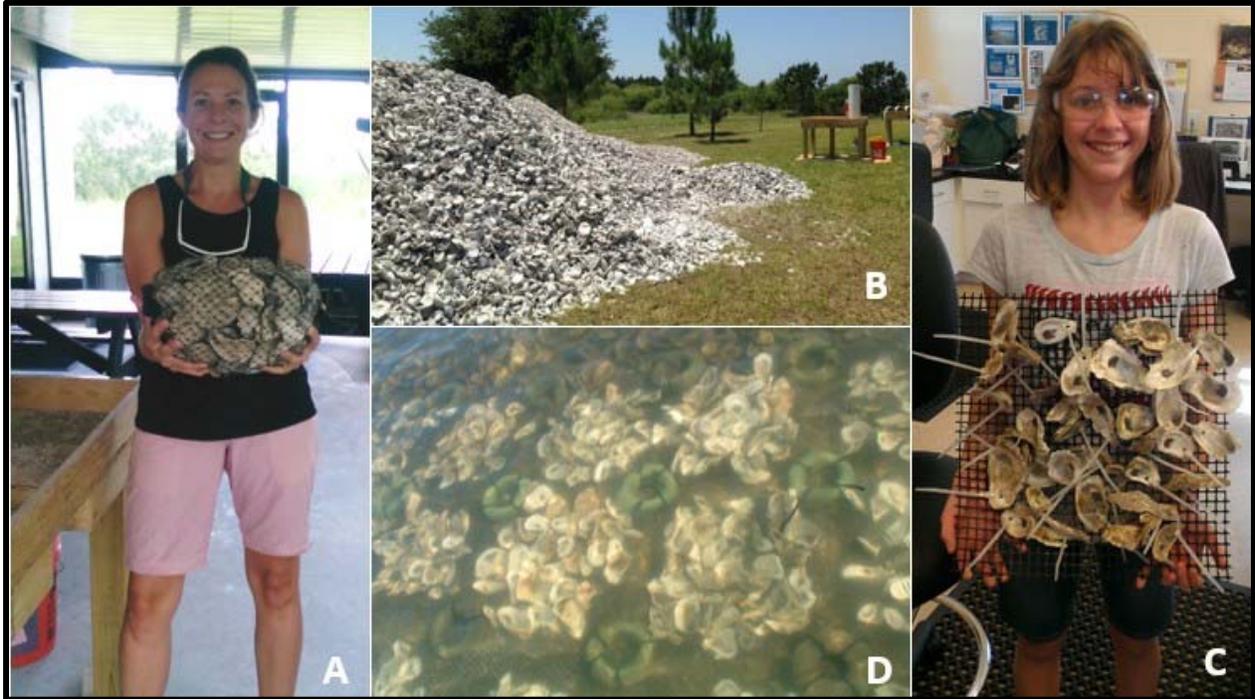
Figure 4. Material formats used for Trabue Harborwalk oyster reef restoration project: bagged fossil shell (A), loose fossil shell (B), mats with recycled shell attached (C) and mats with donut weights attached in water (D).

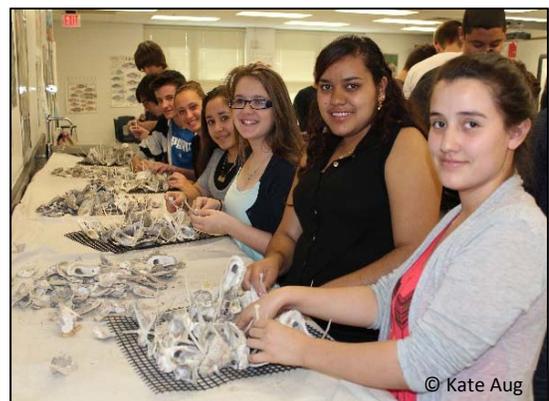
The oyster restoration mats used in the project were created by attaching 36 oyster shells of various sizes to a 40 cm by 40 cm sheet (0.16 m²) of the mesh material. This design was originally developed and tested by Dr. Linda Walters, University of Central Florida. A hole was first drilled in each shell to accommodate the cable ties. The shells were attached to the mat material in the same orientation as live oysters on reefs (perpendicular to the substrate, not lying flat on the mesh) using cables ties as noted above. The ends of the cable ties were trimmed close to the shell to reduce the amount of plastic in the

environment and prevent an unnatural appearance to the reef from cable tie ends sticking out of the water. Volunteers assisted with all aspects of mat making, including drilling shells, cutting mesh and attaching shells to the mats.

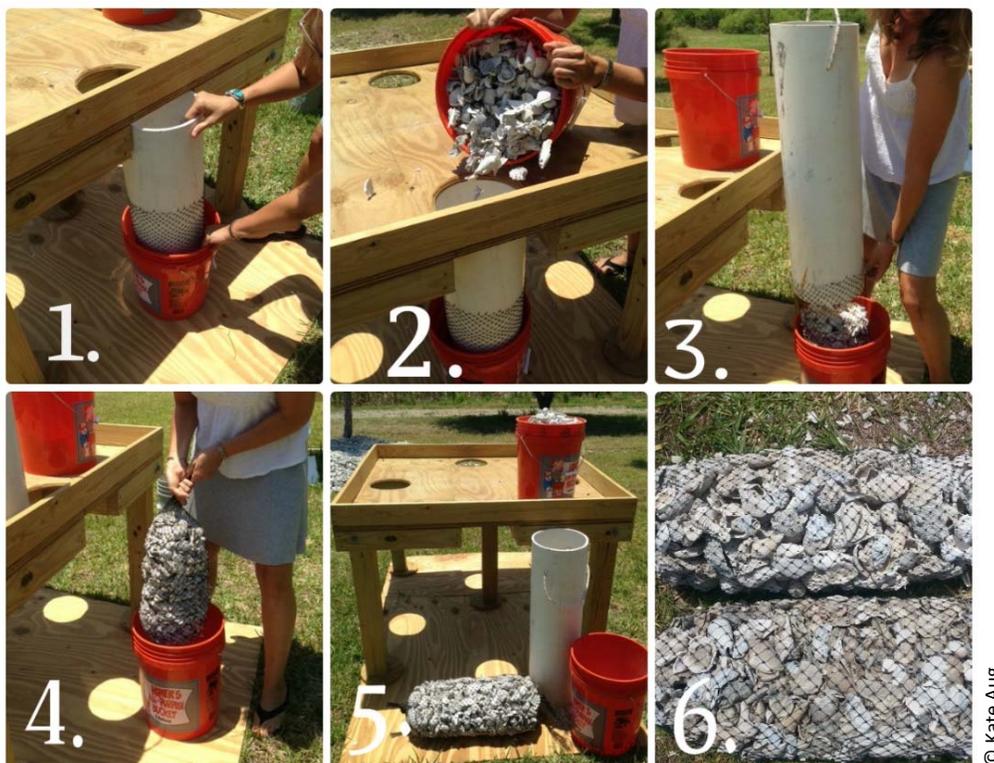
Figure 5. Steps to making an oyster bag.

Prior to bag assembly custom “bagging tables” were designed and built by a project volunteer. The method for bag construction is shown in Figure 5. The process consisted of shoveling fossilized shell into 5-gallon buckets, which were then emptied on the table and pushed into holes that fed into PVC tubes (approximately 20 cm in diameter). The tubes were pre-covered with bag mesh cut from rolls with the bottom end tightly knotted. Once the bags were filled the PVC tube was removed, the top end of the bag was tied and the knot ends were trimmed. The shell bags were stacked and later transported by truck to the storage site, with help from volunteers in loading and unloading the bags.

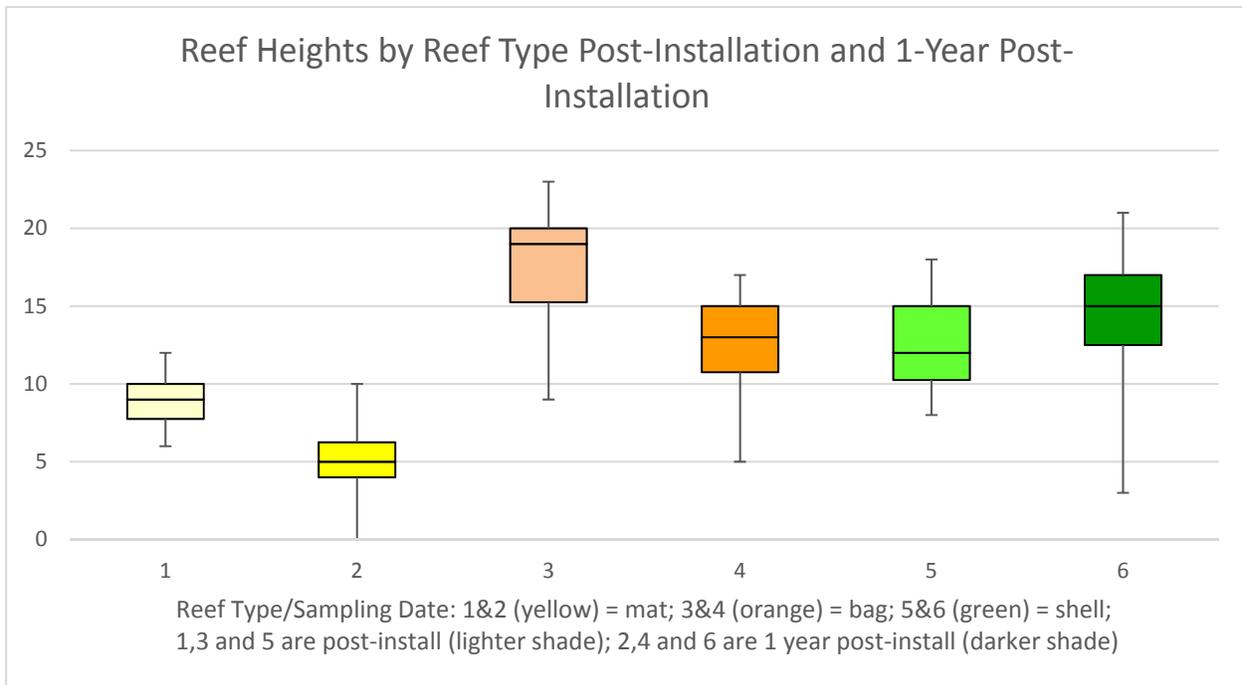
Figure 6. Change in reef height at installation and after 1 year.

- Reef Height - These metrics were collected during the post-installation monitoring and at the 6-months and 1-year post-installation monitoring. Some changes from the post-installation monitoring were observed and are summarized in Table 2 below (see also Figure 6). Averaged height measurements for each reef during each sampling event are included in Appendix B (Tables B-4 – B-6). Conditions during collection of the 6-months post-installation data were windy causing wave chop that made collection of reef height data during high tide challenging. Consequently, the measurement procedures for reef height were modified by collecting the data at low tide. Wave chop is now less of a concern and increased confidence in the revised methodology. At the time of the 1-year post-installation monitoring, mat reefs and bagged shell reefs lost height (-3.7 cm and -5.4 cm, respectively) due to settlement into the underlying sediments. We know the result of lost reef height was primarily due to settling versus sedimentation because trays with reef materials placed in the same areas remained mostly on top of the sediments (see discussion of sampling methods changes under oyster density below). The measured difference in the loose shell reefs from installation to approximately 1 year later was 1.7 cm, likely falling within the range of sampling error. Additional, years of monitoring will clarify whether the changes observed in reef height are a trend.

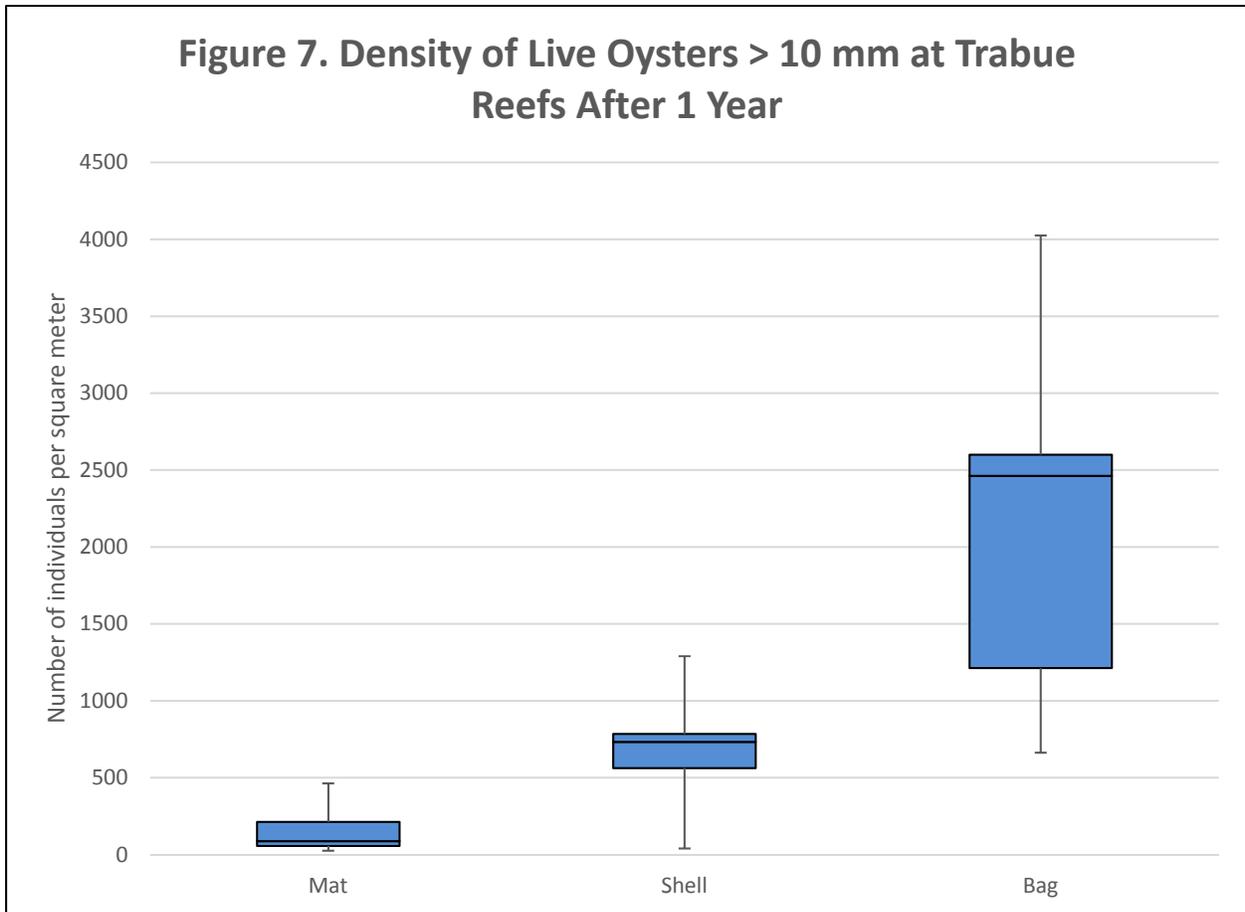
- Live oyster density - Our initial sampling method employed a sampling tray filled with the reef material. Trays were pre-placed randomly along the perimeter of the reef and randomly selected for processing at the time of sampling. Sample trays were only processed once during either the 6-months or 1-year sampling events. As a means of testing whether sampling trays were influencing recruitment results (i.e., reducing the settling of materials into the sediments), sampling during the 1 year sampling event was also conducted on randomly selected reef material removed directly from the reefs (i.e., no sampling tray). The results indicate that the sampling trays did have an impact on results. Sampling tray impacts were most notable on the mat reefs where 348 recruits/m² were observed with the sampling trays versus 154 recruits/m² without sampling trays (Table 3). The sampling trays also had a large effect on bagged shell results (4,494 recruits/m² with the trays versus 2,186 recruits/m² without the trays). The sampling trays had less effect on the loose shell reef results (950 recruits/m² with the sampling trays and 714 recruits/m² without the trays). Below, we use the “no sampling tray” results to evaluate reef success. Overall, the bagged shell reef performed the best on a per area basis (Table 3; Figure 7).

We suggest establishing a restoration target, as recommended by Dr. Loren Coen (pers. comm. on 1/24/17), based on observations of oyster densities on natural reefs located nearby the restoration project. As no reference reef could be identified near the Trabue reef restoration area (i.e., the Lower Peace River), we used the densities found on reference reefs at three sites further south in the Charlotte Harbor system as observed by the Sanibel Captiva Conservation Foundation (SCCF). The average density of live oysters at the three reference reefs in the southern portion of Charlotte Harbor (Matlacha Pass, San Carlos Bay and Tarpon Bay) prior to restoration taking place in these areas ranged from 413 to 1488 oysters/m² (Mark Thompson, SCCF, pers. comm.) Given these results, we set our success target at the lowest of these measured reference densities, 413 oyster/m². Recruitment (live oysters > 10 mm) exceeded this restoration target on the bagged shell and loose shell reefs (2,186 recruits/m² and 714 recruits/m², respectively) and fell short on the mat reefs (154 recruits/m²; Table 3; Figure 7). Detailed results are presented in Appendix B, Table B-7.

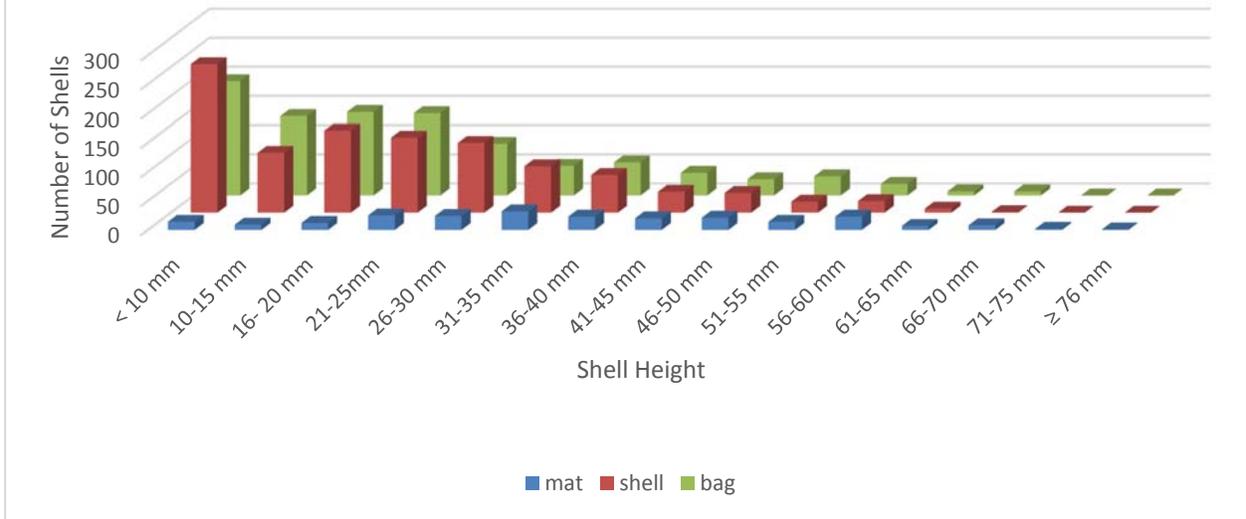
Figure 8. Year 1 Size Frequency Distribution of Live Oysters by Reef Type (no tray samples)

- Oyster size frequency – Recruit (>10 mm) shell height was measured for up to 84 oysters per sample. Samples randomly collected directly from the reef were used (i.e., not in sampling trays). Oysters with a height less than 10 mm were recorded as “spat”. Shell heights of live oysters for each reef type were placed into the size classes recommended in the Monitoring Handbook and included in the Monitoring Plan (<10 mm (spat); 11-15 mm; 16- 20 mm; 21-25mm; 26-30 mm; 31-35 mm; 36-40 mm; 41-45 mm; 46-50 mm; 51-55 mm; 56-60 mm; 61-65 mm; 66-70 mm; 71-75 mm; and, ≥ 76 mm; See detailed results in Appendix B, Table B-10). A histogram of the results is illustrated in Figure 8). The 3 reef types all showed the presence of multiple size classes. The bagged shell and loose shell reefs, however, had a greater concentration of oysters in smaller size classes which indicates strong, continuing recruitment and actively growing reefs.

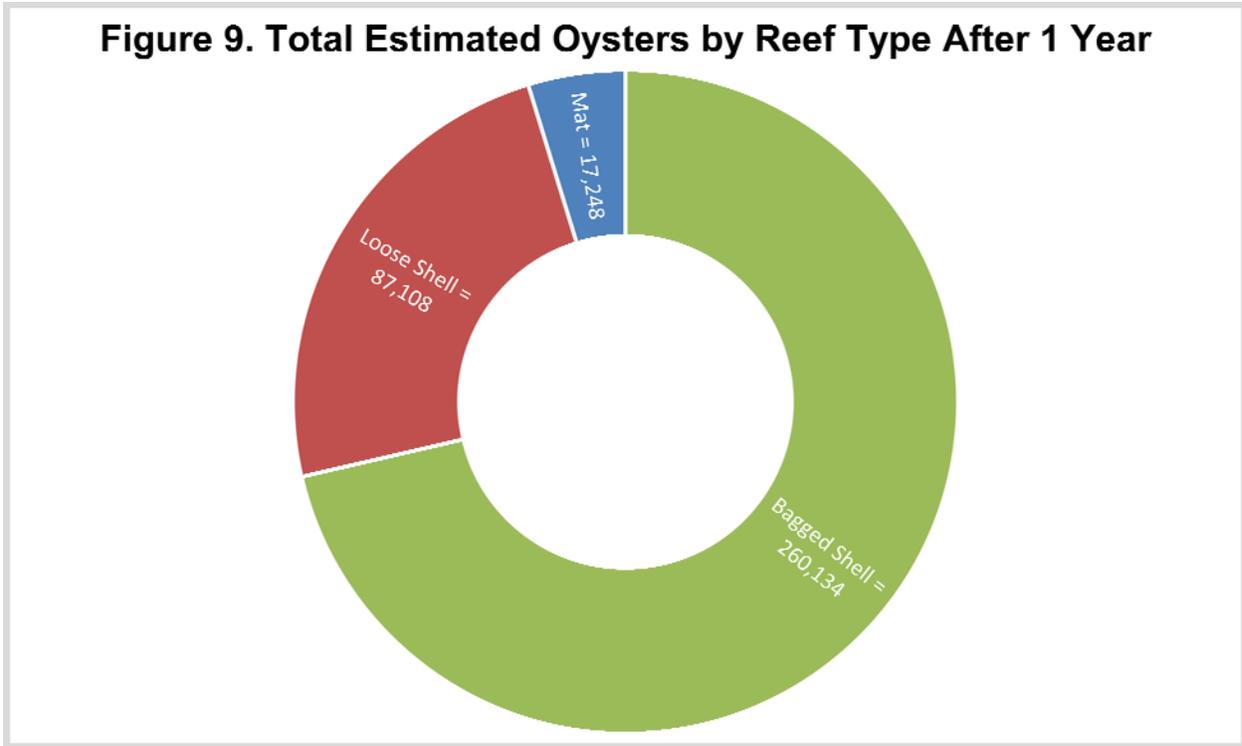
Figure 9. Total Estimated Oysters by Reef Type After 1 Year

- Total estimated live oyster recruits by reef type – The number of live oyster recruits (>10 mm) from the samples randomly collected directly from the reef (i.e., no sampling tray) varied by reef type (Table 4; Figure 9). In general, the mat reefs had the fewest recruits and the bagged shell reefs had the most recruits. The number of recruits on the loose shell reefs fell in between the other two reef types. Total live oyster recruits by reef type were estimated at 17,248 for the mat reefs, 87,108 for the loose shell reefs and 260,134 for the bagged shell reefs (See Appendix, Table B-11 for more detailed results). Total estimated oysters produced at reefs at the 1 year mark were estimated to be 364,490 (Table 4). The range in the number of oysters generated by each reef type is likely mostly due to two factors: surface area available for larval settlement and propensity of the material to settle into the sandy-mud substrate.

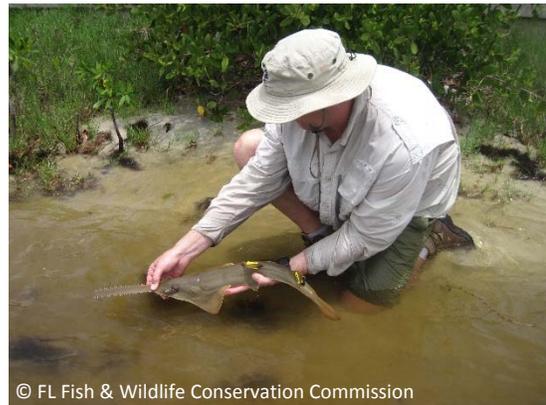
- Smalltooth sawfish, *Pristis pectinate*, utilization of the reefs - The Florida Fish and Wildlife Conservation Commission (FWC) has been monitoring sawfish in the Lower Peace River as part of their grant with the National Marine Fisheries Service (NMFS) over the last several years. TNC provided some additional funding to FWC so that these grant funded studies could be extended to the portion of the Lower Peace River near the reef restoration area. In first year of our commissioned work (2014) and prior to reef installation, 24 juvenile sawfish were tagged in the Lower Peace River mostly near their known “hotspot” on the north side of the Peace River near where it intersects I-75.

FWC found that during the day, the juvenile sawfish remained along the north shore of the Lower Peace River tending to be close (< 25 m) to mangrove stands (predominantly red mangroves). At night, sawfish left the north shore and headed toward the south shore of the Lower Peace River. Of the 24 juveniles tagged in the Peace River during 2014, 17 were detected on the acoustic receivers moored near the Trabue project area, nearly always at night (96%). Because of the information collected during TNC funded work, the sawfish hotspot in the Lower Peace River was extended to the entire area between the I-75 and US 41 bridges.

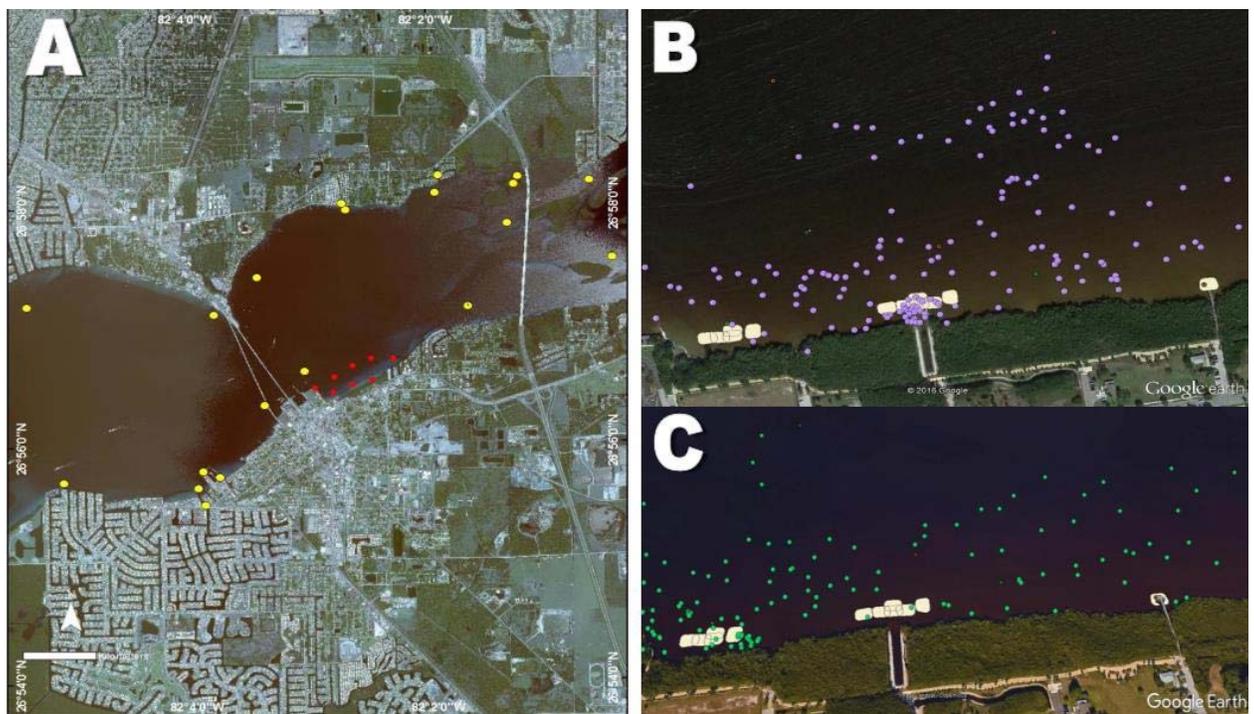
During a second year of monitoring and post reef installation (fall 2016 through spring 2017), a more intensive array of listening stations (which include receivers) was installed near the reef sites (Sites B, C and D; Figure 15). Nineteen juvenile fish were tagged and 11 were picked up by the receivers. The more intensive array of listening stations enabled triangulation of the results and a much more detailed assessment of where juvenile sawfish are traveling in relation to the reefs. Six of the fish picked up by the receivers were reliably detected by the listening stations. Overall, these fish did not exhibit a statistically significant preference for the restored reefs as compared to the surrounding sandy-mud flats with sparse seagrass (Poulakis et al. 2017). However, two of the juveniles observed were one-year-olds and demonstrated activity around and on top of the reefs (Figure 15). Additional years of research and more observations will be required to definitively determine the extent to which sawfish utilize the restored reefs as compared to other available ecosystems.

Figure 15. Acoustic receiver array (red and yellow dots) in the Lower (Tidal) Peace River between the US 41 and I-75 bridges (panel A). Red dots represent the TNC funded array. The yellow dot with the red circle is a receiver purchased with NMFS funds, but included in the receiver array around the restored reefs due to its proximity. Panels B and C illustrate the location of the two 1-year old juveniles in relationship to the reefs (yellow rectangles) over a 12 to 24-hour period.

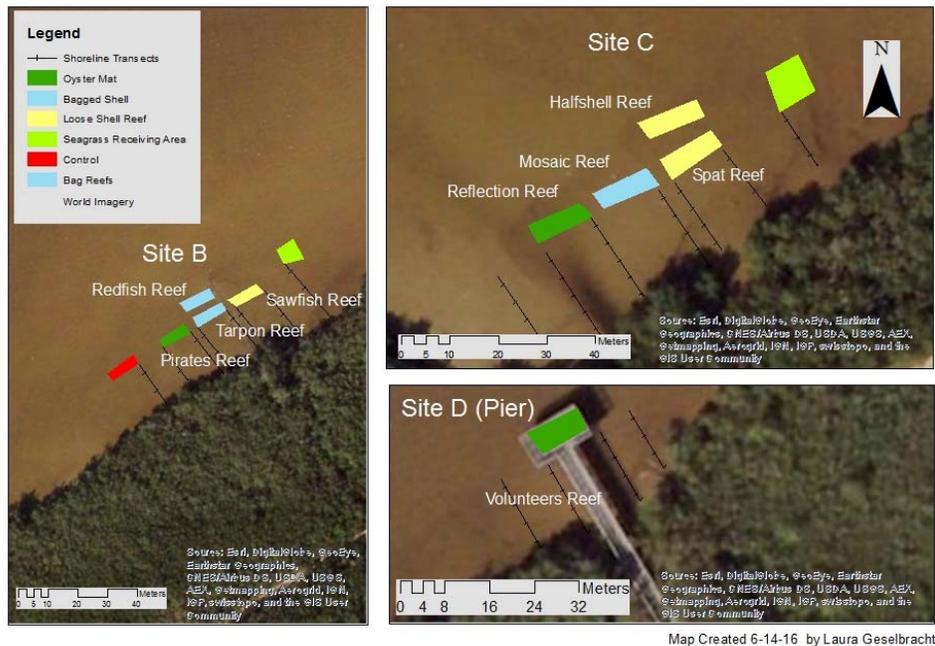
Figure 16. Reef sites showing habitat stability transects used to measure the distance between the reefs and the shoreline over time.

Habitat stability - Accretion/erosion between reef and mangrove shoreline and change in distance between the reefs and the shoreline was surveyed on November 27, 2015 to collect baseline information. This date was selected because there was a negative tide during daylight hours (-0.13 m at 10:34 am). A negative tide was required for the intertidal area between the reefs and the shore to be exposed. Figure 16 below shows the transect lines (in black) used to conduct the two surveys. Existing markers such as the PVC reef corner markers and seagrass survey markers were used rather than adding additional markers to the intertidal zone or mangrove area. Photos were taken from the shoreline out to the reef along each survey line. An example of these photos

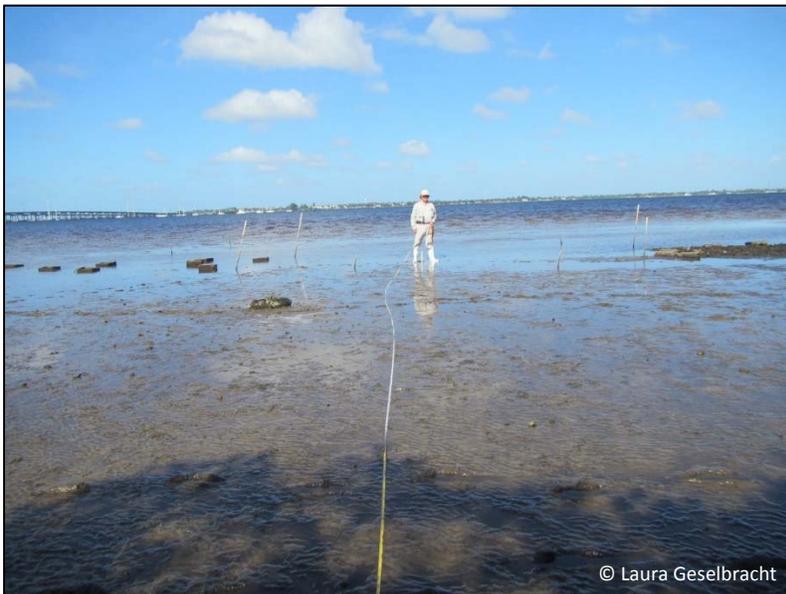
Figure 17. Sample photo of shoreline survey. Photos are taken from shore out to the reef area along a transect line. Photos will be repeated every year or so to determine if the oyster reefs are affecting sedimentation or change in shoreline position relative to the reefs over time. Length measurements are also taken.

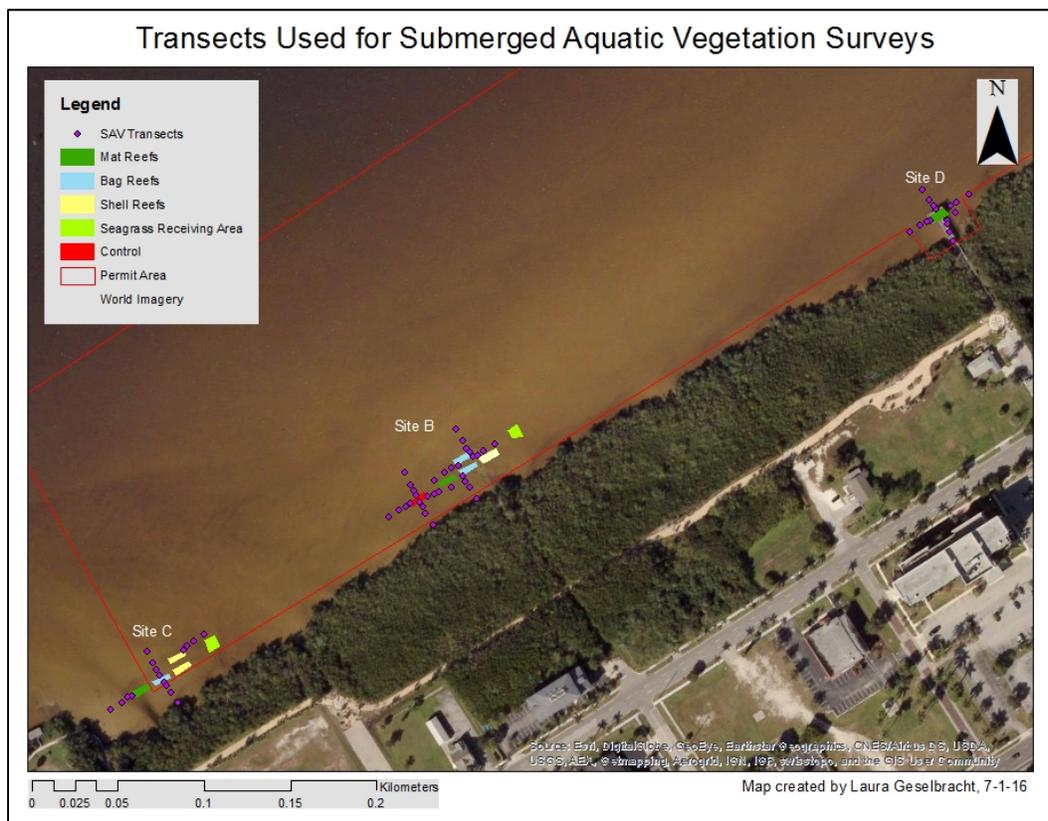
Figure 18. Location of transects for surveying the effect of oyster reef installation on surrounding SAV.

- Submerged aquatic vegetation (SAV) - FDEP-CHAP staff established transect lines (Figure 18) and conducted a SAV survey in August 2015 prior to reef installation to collect baseline information and again in June 2016 and October 2016 using the same techniques. Transects were established at each reef area (B, C and D) and the control area. Fifty-foot long transects were established in each cardinal direction (N, S, E and W) with sampling stations at 0, 10, 25 and 50 feet. After 1 year, the change in shoot count at the reef sites and at the control site were not significantly different (P-value = 0.33 and 0.92, respectively; see Figures 19 and 20). Appendix B, Table B-14 provides detailed information on total shoot counts. There was also no significant change found in SAV abundance at the 1 year post-installation timeframe at either the reef sites or control (P-values = 0.83 and 0.12, respectively; Table 11). Blade lengths decreased at both the reef and control sites, however, these changes were not significant either (P-Values 0.06 and 0.98, respectively; Table 12). SAV abundance varies seasonally and spatially. Additional years of monitoring may help to determine if SAV at the reef sites is changing in density, abundance and blade lengths as compared to the control site.

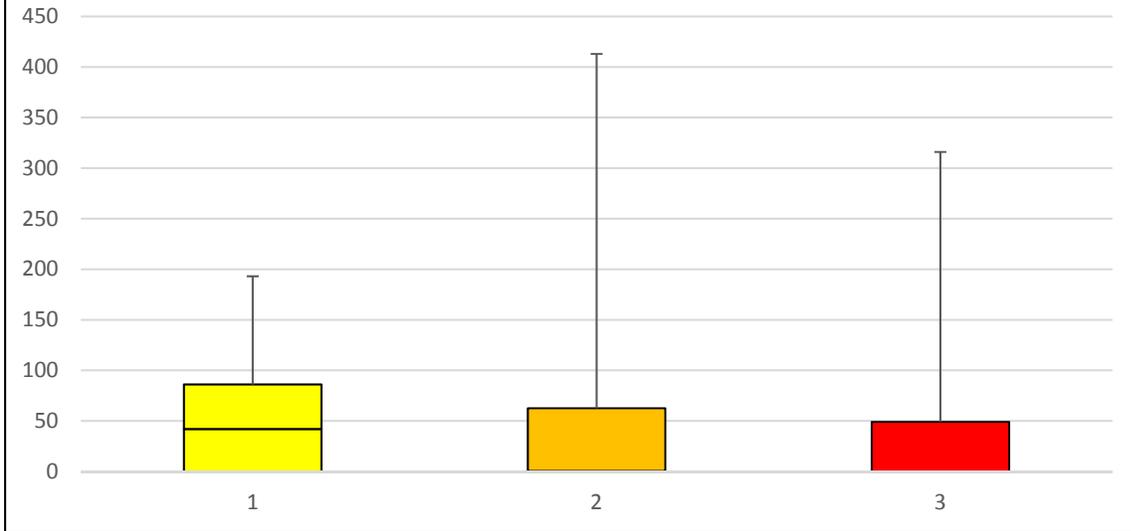
Figure 19. Oyster Reef Sites, SAV Total Shoot Counts

1 = Pre-restoration, 2 = 6-months post-restoration,
3 = 1-year post-restoration

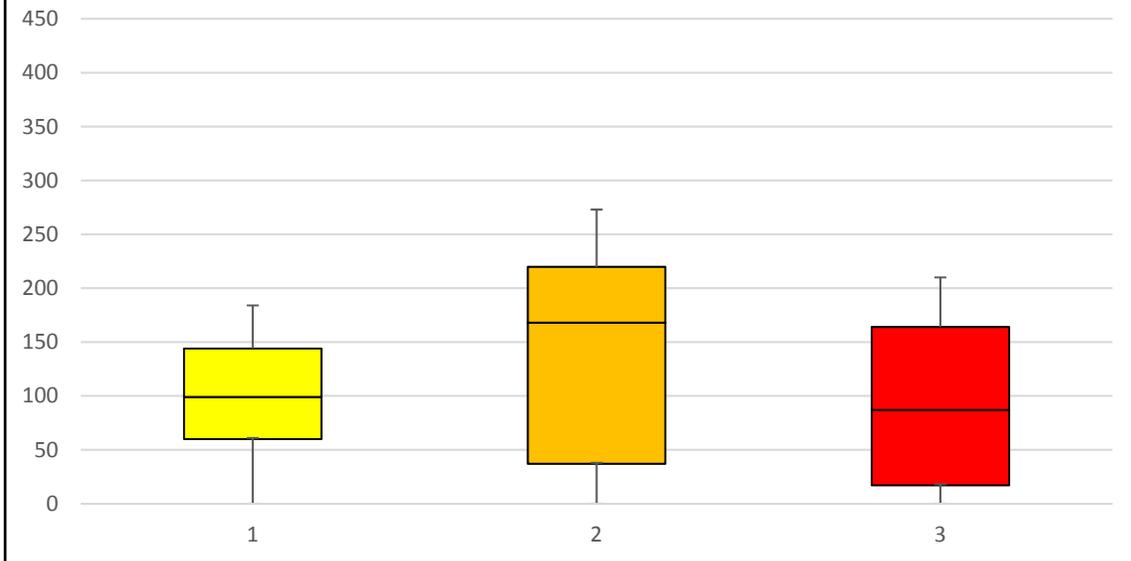
Figure 20. Control Plot, SAV Total Shoot Counts

1 = Pre-restoration, 2 = 6-months post-restoration,
3 = 1-year post-restoration

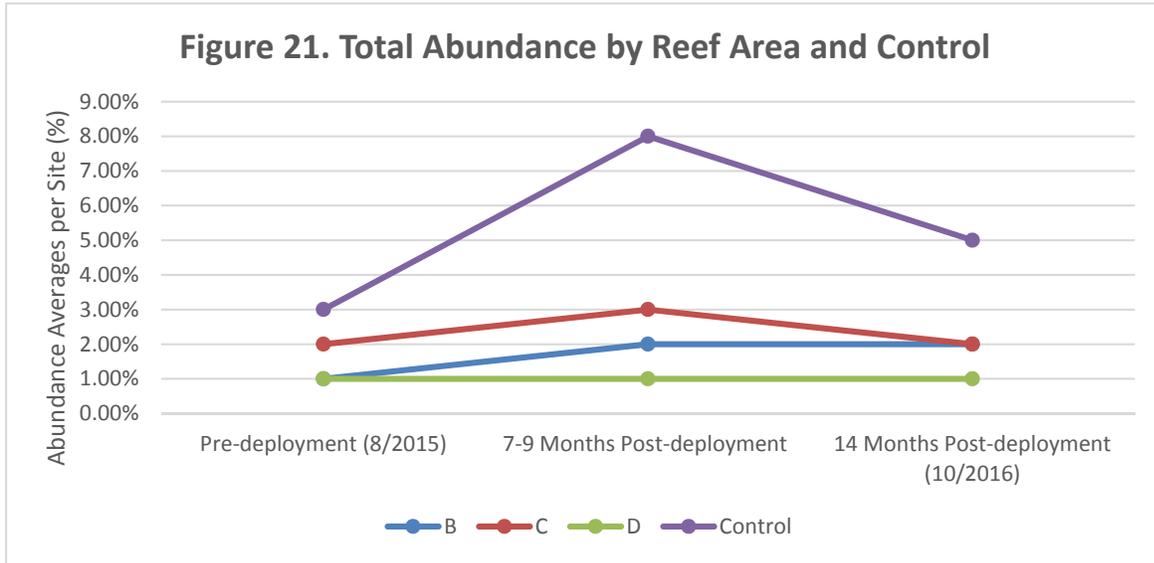
Figure 21. SAV abundance at reef and control sites at each sampling event.

Site	Average Total abundance, August 2015	Average Total, April - June 2016	Average Total abundance, October 2016	P Value
Reef Sites	0.01	0.02	0.01	0.83
Control	0.03	0.08	0.05	0.12

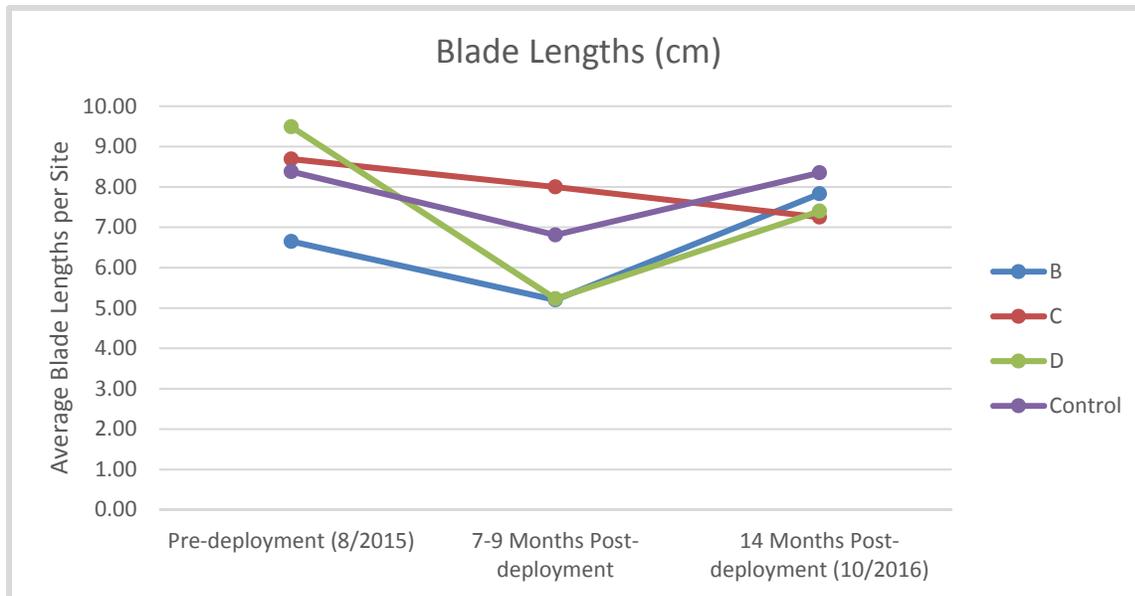
Figure 22. Blade lengths of SAV at control and reef sites during the project period.

Average Blade Length (cm), August 2015	Average Blade Length (cm), April - June 2016	Average Blade Length (cm), October 2016	P Value
Reef Sites	8.3	6.5	7.5	0.06
Control Site	8.4	6.8	8.3	0.92
